RAILWAY INVESTIGATION REPORT

R03D0042

MAIN-TRACK TRAIN DERAILMENT

TRAIN M394 21-27

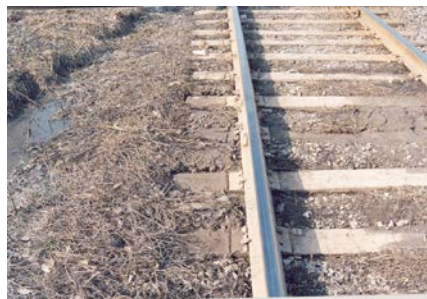
The track structure consists mainly of 100-pound jointed rail, in 39-foot lengths, manufactured and laid in 1955. The track was laid on hardwood ties with double-shouldered tie plates secured by four spikes per tie. The rail was box-anchored every third tie. In the derailment area, the ballast was contaminated and waterlogged as the roadbed was not adequately drained (see Figure 1). Evidence of track pumping,¹ particularly at the approach to the Dépôt Street crossing, was observed.

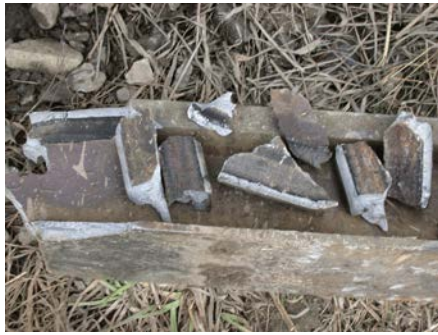
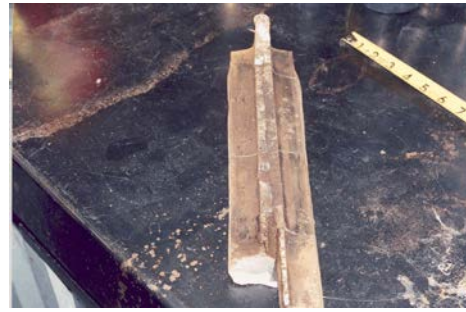
Several small fragments of the running surface of the rail and two 75 cm-long pieces of rail were recovered on the east side of the south rail joint. Examination of the recovered broken rail pieces revealed a horizontal fracture of the rail between the head and the web (head-web separation), a vertical fracture in the head, along with transverse cracks (see Figures 3 and 4). The location of the fractures was between the rail joint splice bars, and the fracture surfaces were significantly oxidized. Also, the rail joint bolt holes were ovalized and the spikes that held the rail joint in place were worn. The tie under the east rail end of the joint showed deterioration.

The heavy oxidation on the surfaces of the rail fractures indicate that the track had pre-existing cracks for some time and gave way under the train. Because of the relatively light weight of the platforms (platform C—12 tons), it is most likely that the rail failed under the weight of heavier cars that passed before the platforms.

The rail fractures occurred at the rail end, between the rail joint splice bars. Therefore, pre-existing horizontal and vertical rail cracks were not visible and thus would be undetectable during a visual inspection. In addition,

1. The rail fractures were discoloured and oxidized, indicating that the cracks had been present for some time.

On 07 April 2003, St. Lawrence & Atlantic Railroad reduced train speed to 10 mph in all urban areas it serves. The frequency of ongoing inspections by the internal rail defect detection cars and of track geometry testing have been increased to twice annually.
