RAILWAY INVESTIGATION REPORT

R03T0047

YARD COLLISION

CANADIAN NATIONAL
TANK CAR PROX 77811
MILE 25.0, YORK SUBDIVISION
TORONTO, ONTARIO
22 JANUARY 2003

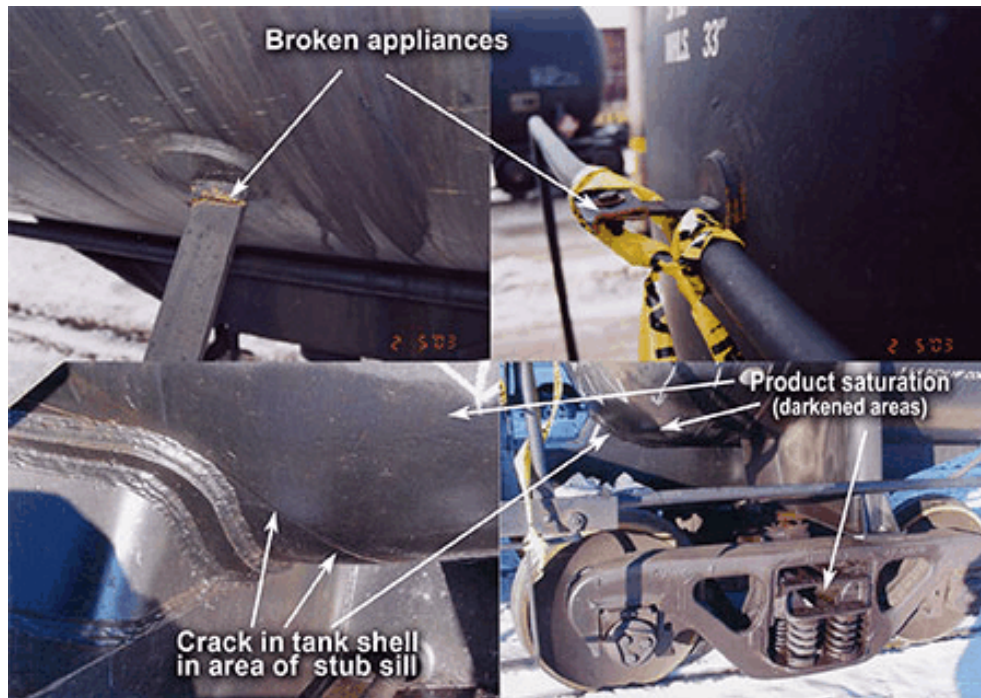
A post-incident examination of the tank car determined that there was a 20-inch crack in the tank shell at the A-end of the car in the area of the stub sill (see Photo 1). In addition, there were numerous broken safety appliances at the A-end.

A portion of the tank shell, which included the crack, was cut from the tank car and sent to the Transportation Safety Board of Canada (TSB) Engineering Laboratory for analysis. The examination (report LP 048/2003) determined that there was a pre-existing crack in the tank shell that had been present for a considerable length of time, likely initiated during welding. During the service life of the tank car, it had been subjected to normal service loads without previously failing.

A pre-crack was present in the tank shell of car PROX 77811. This pre-crack, which was likely initiated by welding, may have existed since the initial construction of the car in 1969. Despite the presence of this pre-existing crack and the many years of revenue service for this tank car, it is likely that the final fracture of this crack was caused by a high-impact load from an overspeed coupling.

1. The cracked tank shell and subsequent loss of the product from car PROX 77811 was likely caused by the final fracture of a pre-existing crack in the stub sill area following a high-impact load from an overspeed coupling.
2. On the day of the occurrence, tank car PROX 77811 had been incorrectly categorized as a non-regulated empty rail car in the hump process control system (HPCS), thereby allowing it to be released from the hump as a two-car movement with a target coupling speed of 7 mph rather than 6 mph.
3. After the humping operation on 22 January 2003, when the coupling speed was estimated to be 13.54 mph, tank car PROX 77811 was not identified as being involved in an overspeed coupling, allowing it to continue in service without a mechanical inspection and resulting in the subsequent loss of the product.

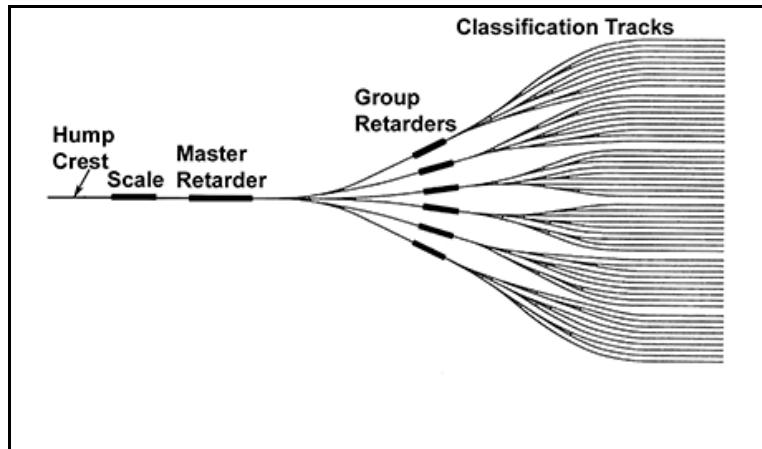
Figure 3 shows the location of the various facilities for a typical hump operation. Rail car speed is initially controlled at the master retarder where braking pressure is applied on the wheels using four hydraulically operated sections. Retardation force is calculated based on rail car rollability, wind speed and direction, temperature, rail car type, and rail car weight. After exiting the master retarder, rail car speed is measured by radar and wheel sensors. Speed is further adjusted at the group retarder. Once the rail car leaves the group retarder, there are no other locations to adjust speed before it reaches the designated coupling location.
