RAILWAY INVESTIGATION REPORT
R04T0008

MAIN-TRACK DERAILMENT

CANADIAN PACIFIC RAILWAY
TRAIN NO. 239-13
MILE 178.20, BELLEVILLE SUBDIVISION
WHITBY, ONTARIO
14 JANUARY 2004

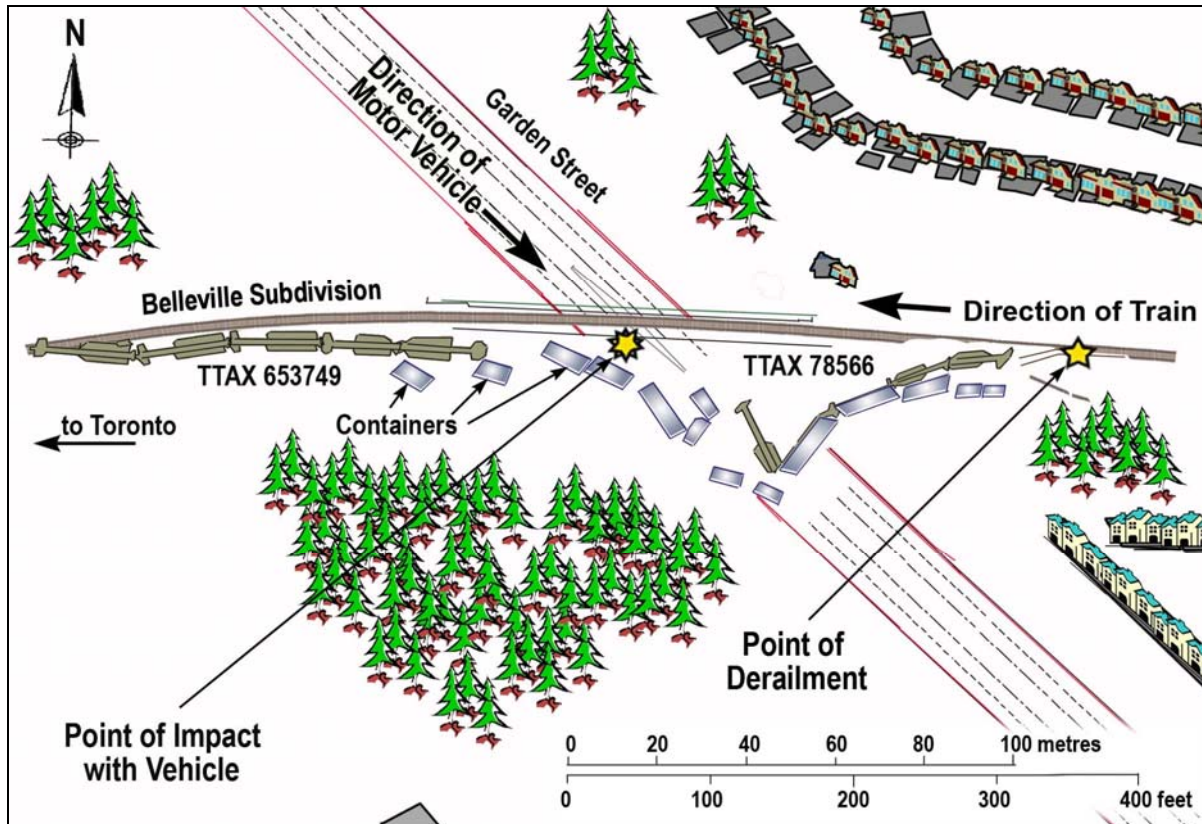
Figure 2. Derailment site diagram

Subsequent site examination determined that the L4 wheel on car CP 521173 was damaged. Approximately 60 per cent of the outer rim was missing.¹¹ The south wheels on the lead truck had dropped to the gauge side of the rail and the north wheels had dropped to the field side. Wheel marks on the ties and tie plates indicated that car CP 521173 had derailed east of the Garden Street overpass. The following two cars had uncoupled from the train. The trailing truck of the lead platform on car TTAX 653749, an articulated spine car, had derailed and came to rest just west of the Garden Street overpass. The remaining four platforms on car TTAX 653749 had derailed and lost their loads to the south side of the track. The last car, TTAX 78566, had also derailed and came to rest to the east and south of the overpass (see Figure 2).

Approximately 200 feet of track at the derailment site was destroyed. Further site examination revealed that the south rail had fractured at Mile 178.20, approximately 300 feet east of the Garden Street overpass. Continuing east from that location, impact marks were observed on the gauge side of the head of the south rail.

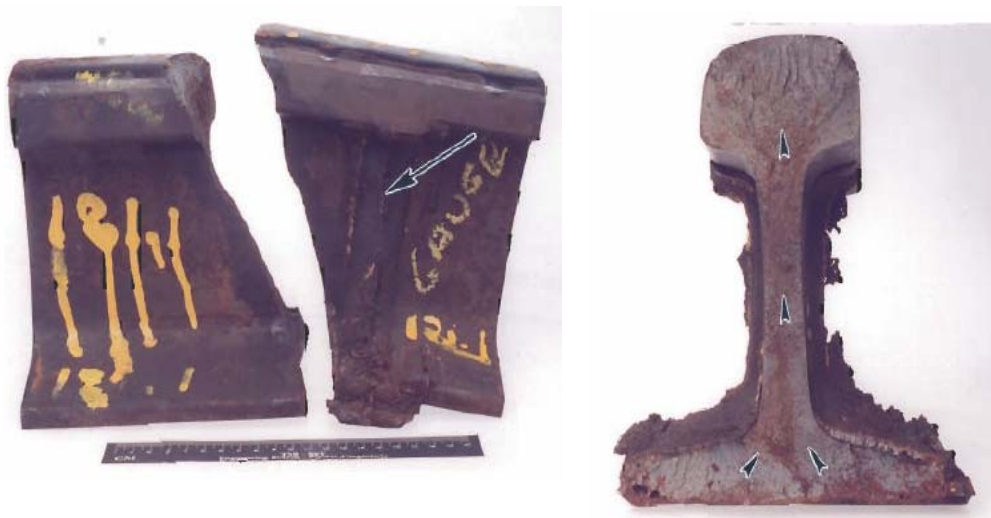
The fractured rail sections between Mile 121.10 and Mile 155.80 were analysed. The examination revealed the following:

- Both fractures were fresh overstress ruptures. The fractures occurred at thermite welds, with the fracture occurring in an upward direction from the base of the rail to the head of the rail (see Photo 1).
- The fracture at Mile 121.10 showed porosity at the field side base.
- The fracture at Mile 155.80 showed porosity and large slag inclusions at the centre of the base.
- No pre-cracks or signs of a progressive failure were observed in either rail fracture.

Photo 1. Broken rail from Mile 121.10. The arrow on the left image shows the location of the thermite weld. The arrows in the right image show the direction of the chevron fracture pattern.

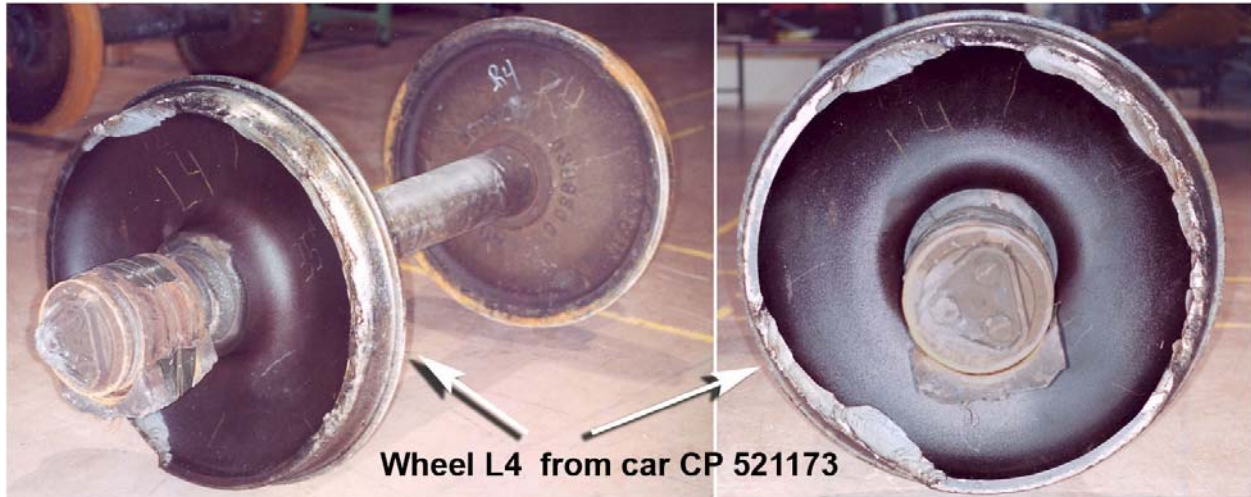
An examination of the wheel set (see Photo 2) verified that the wheels were class “C,” cast, curved-plate Abex Southern Corporation (Southern) wheels that had been built to design CH 36. Design CH 36 is a “one-wear” wheel that is normally used on 100-ton capacity freight cars. The broken wheel (that is, L4 position) had been manufactured by ABC Rail (formerly Abex Southern Corporation) in Calera, Alabama, United States (code SO), in March 1988. The wheel had been mounted in June 1988 and the bearings had been reconditioned in October 1999. The wheel set was mounted to car CP 521173 in November 1999.

Photo 2. Broken wheel from car CP 521173

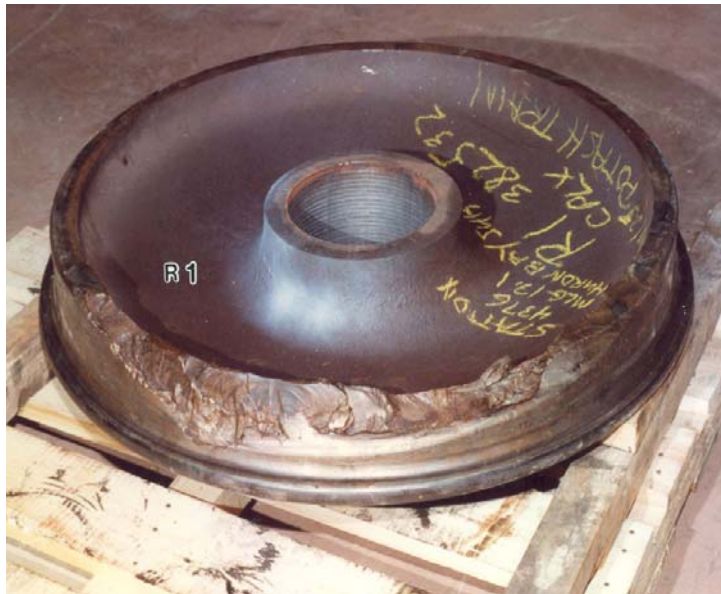
On 25 January 2002, CPR train 638-001, proceeding eastward at a speed of 37 mph, experienced a train-initiated emergency and derailed 30 potash cars at Mile 13.1 of CPR's Heron Bay Subdivision. At the time of the occurrence, the temperature was -20°C. Post-derailment examination determined that the train had derailed as a result of a broken Southern wheel (see Photo 3).

The broken wheel was a class "C," cast, curved-plate wheel, built to design CH 36, and had been manufactured by ABC Rail in Calera (code SO) in March 1996. The wheel was mounted new by ABC Rail in April 1996.

Photo 3. Broken R1 wheel from car CPLX 382532

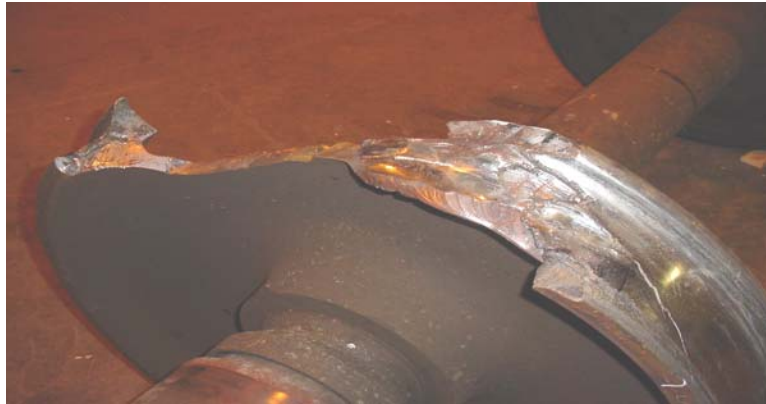
Photo 4. Broken wheel from car CNWX 111231

The broken wheel was a class “C,” cast, curved-plate wheel, built to design CH 36, and had been manufactured by ABC Rail in Calera in September 1995.

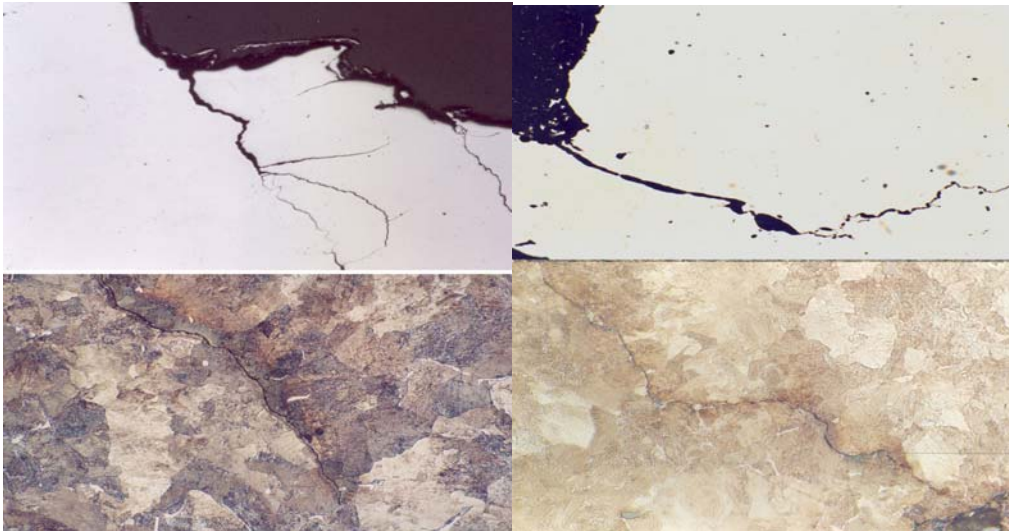
- The wheels had not experienced an extreme overheating event.
- The wheels failed when a large progressive sub-surface crack reached a size such that a portion of the tread detached.
- Sub-surface fatigue cracking had been present in the wheels for some time.
- The cracking had initiated at several locations in the wheel that contained material deficiencies, including porosity and inter-granular cracking (see photos 5 and 6).

Photo 5. Wheel L4 from car CP 521173 (Whitby derailment)

Top: Unetched micrograph of sub-surface cracking coincident with the fracture origin area, X 25
