RAILWAY INVESTIGATION REPORT
R04V0100

**UNCONTROLLED MOVEMENT OF RAILWAY ROLLING
STOCK**

CANADIAN NATIONAL
TRAIN M-359-51-07
MILE 57.7, FRASER SUBDIVISION
BEND, BRITISH COLUMBIA
08 JULY 2004

Report Number R04V0100

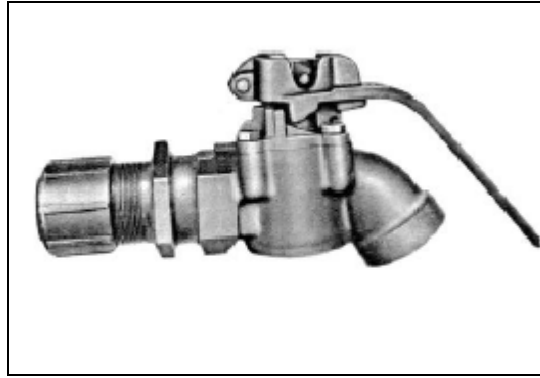
Figure 2. Angle cock

The angle cock (see Figure 2) is a valve located along the brake pipe at both ends of a car or locomotive. In the fully open position, the handle is in line with the brake pipe, and in the fully closed position, the handle is at right angles to the brake pipe. It can be opened or closed by the train crew to vent or preserve the air pressure in the brake pipe when cars or locomotives are uncoupled. Although not an approved practice, some railway personnel have been known to partially open an angle cock, on the standing portion of a train, to facilitate slow venting of the brake pipe. Trains proceeding in service with a partially open angle cock may have a reduced ability to apply the train brakes, or may not be able to apply the train brakes at all.

1. When setting out the tie car at the Omaha Siding, the lead angle cock on the portion of the train standing on the main track was placed in a partially open position and never restored to the required fully open position upon re-coupling.

2. The partially open angle cock prevented the application of the train brakes when the crew attempted to slow the train in preparation for a meet with an opposing train at Bend.
