RAILWAY INVESTIGATION REPORT
R04V0173

MAIN-TRACK TRAIN DERAILMENT

CANADIAN PACIFIC

MILE 41.30, CANADIAN NATIONAL YALE SUBDIVISION

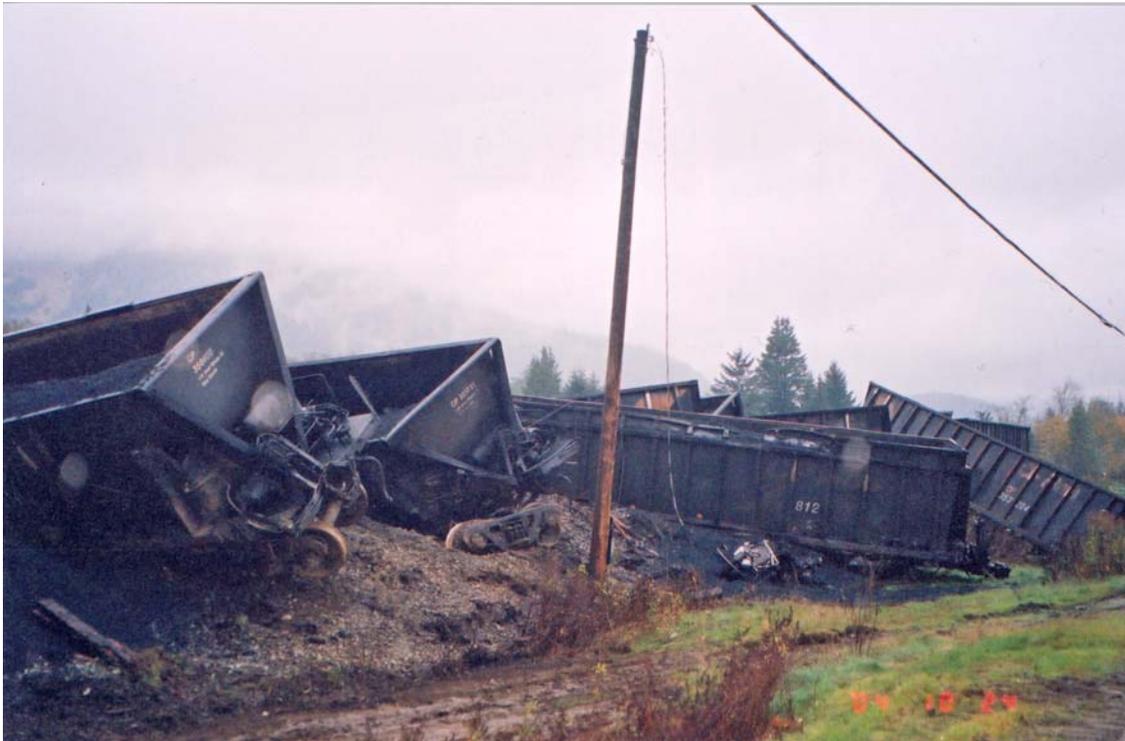
Approximately 1500 feet of track, a signal bungalow, and two small out buildings on private property were destroyed, and a public crossing at Mile 42.28 was damaged (see Photo 1).

Photo 1. Derailed bathtub coal cars from the middle of the consist

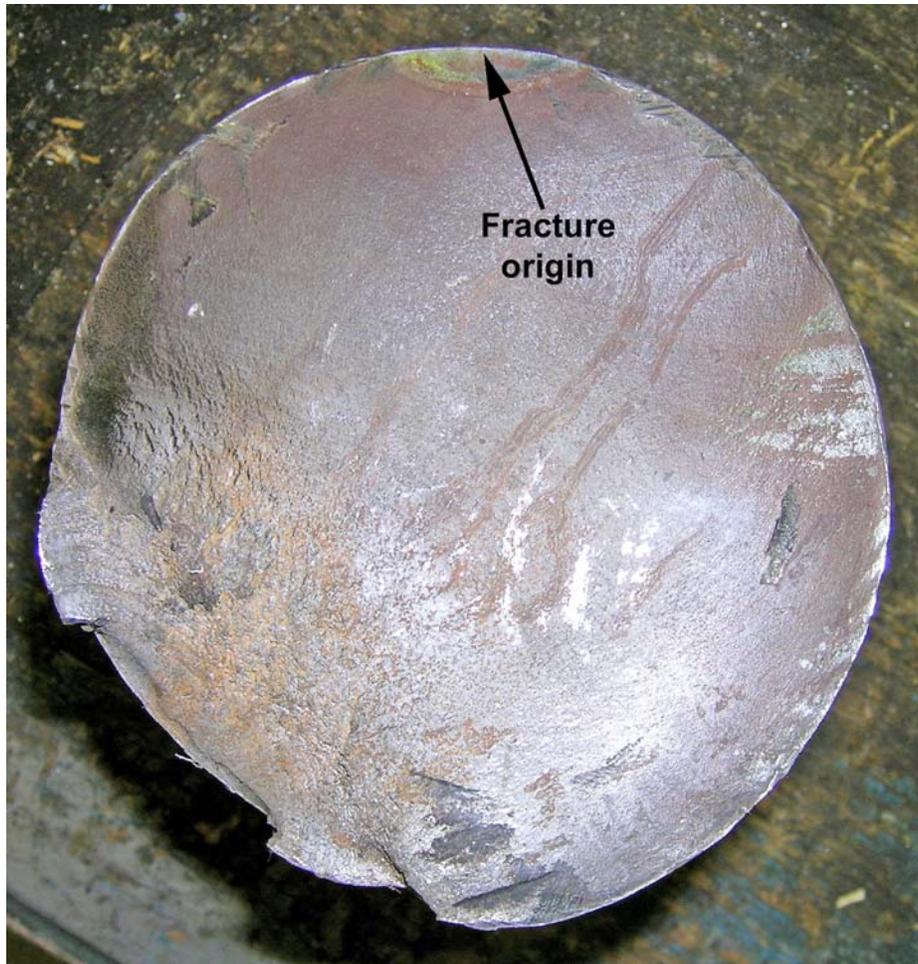
- The axle fractured in the area of the L-3 journal fillet radius, approximately three inches from the outboard face of the wheel hub. The fracture was perpendicular to the axle's longitudinal axis and displayed a fatigue fracture zone and a brittle fracture zone.
 - The fatigue fracture zone was characterized by beach marks. The beach marks were traced back. They indicated that the failure originated from the surface of the L-3 journal fillet radius and progressed in fatigue through approximately 60 per cent of the axle's cross-section (see Photo 2).

Photo 2. Fracture surface of failed axle

- The brittle fracture zone was characterized by a fibrous appearance. It occurred catastrophically under normal service conditions when the load exceeded the strength of the axle's reduced cross-section.
- Visual examination of the axle's two journal fillet radii revealed a profile discrepancy. The failed L-3 journal fillet radius exhibited an abrupt surface profile irregularity at the root of the radius that resulted in an obvious circumferential demarcation (see Photo 3). The R-3 (mate) journal fillet radius exhibited a smooth continuous curve extending from the dust collar to the journal surface.

Failure analysis identified that the fatigue fracture origin corresponded to a circumferential surface profile irregularity located at the root of the journal fillet radius. The observed surface profile irregularity was likely introduced during axle reconditioning, yet the axle met the current AAR standard. The profile irregularity resulted in a slightly angular transition between the journal fillet radius and the journal surface with the root of the angle coinciding with the root of the journal fillet radius. With this profile, the surface irregularity became a nucleation point for service stresses at the root, acted as a stress raiser, and facilitated the initiation of the

fatigue fracture. Once initiated, a fatigue fracture progressed through 60 per cent of the journal cross-section. Final catastrophic failure occurred under normal service conditions when the load exceeded the diminished strength of the journal's reduced cross-section.

2. A fatigue fracture originated at a circumferential surface profile irregularity located at the root of the L-3 journal fillet radius and progressed through 60 per cent of the journal cross-section. Final failure occurred catastrophically, under normal service conditions, when the load exceeded the diminished strength of the journal's reduced cross-section.

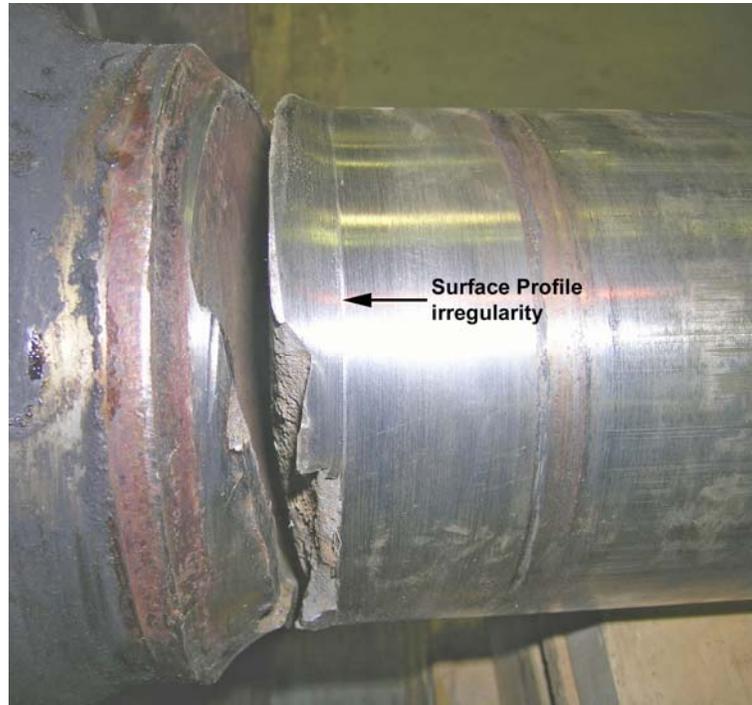
Photo 3. The R-3 (mate) journal fillet radius

- The profile irregularity exhibited a slightly angular transition between the journal fillet radius and the journal surface. The root of the angle coincided with the root of the journal fillet radius. The fracture origin corresponded to the root angle of the profile irregularity.
- The axle material conformed to the requirements of AAR Specification M-101 for Grade F steel. The axle steel was free of any deleterious material and/or metallurgical anomalies. Its microstructure consisted of a mixture of fine-grained pearlite and ferrite, which was consistent with the specified material and heat treatment.

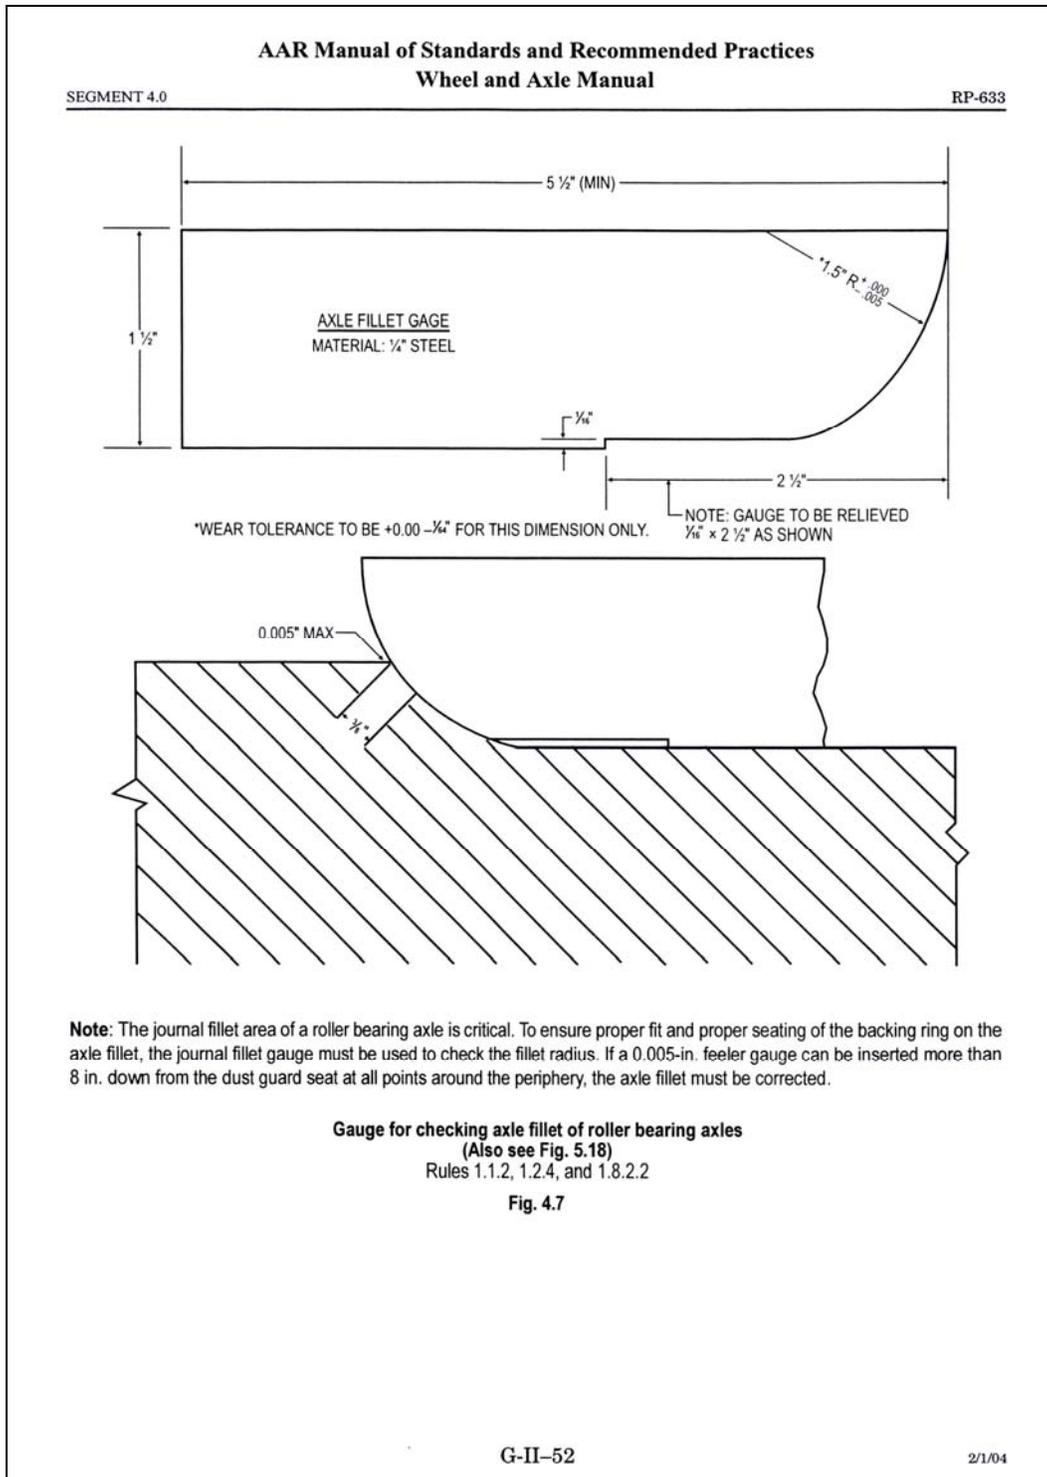
Figure 3. Gauge for checking Axle Fillet of Roller Bearing Axles

Rule 1.1.2 indicates that second-hand (reconditioned) axles must conform to G-II Manual dimensions and specifications, including those shown in Figure 4.7 of the manual. This figure details the journal fillet gauge that must be used for qualifying the journal fillet radius profiles of reconditioned axles. It also contains a note stating that "the journal fillet area of a roller bearing axle is critical. To ensure proper fit and proper seating of the roller bearing backing ring on the axle fillet, the journal fillet gauge must be used to check the fillet radius." The journal fillet gauge contains a 1/16 inch-deep by 2½ inch-long recess along its base that extends from near the bottom of the journal fillet radius profile, along the journal surface (see Figure 3).

Rule 1.1.2 of the G-II Manual indicates that reconditioned axles must conform to the manual's dimensions and specifications. It notes that a journal fillet gauge must be used to check the profile of the journal fillet radius to ensure proper fit and seating of the roller bearing backing ring on the journal fillet radius. However, the journal fillet gauge, used to check radius profiles, contains a 1/16-inch deep by 2½-inch long recess along its base that does not come into contact with the root of the journal fillet radius (see Figure 3). Consequently, as demonstrated by this occurrence, it is possible for a profile with an irregularity, such as a slightly angular transition at the root of the journal fillet radius, to appear to conform to the gauge profile. Therefore, the journal fillet gauge does not provide for adequate inspection for compliance-to-profile at the root of the journal fillet radius.

1. The journal fillet gauge, used to check radius profiles (see Figure 3) is not adequate to ensure that the root of the journal fillet radius complies with the required radius profile.
2. When Rule 1.2.5 of the AAR *Manual of Standards and Recommended Practices* (MSRP) Section G-II Wheel and Axle Shop Manual is considered in conjunction with the shortcoming of the journal fillet gauge, the current standard may permit reconditioned axles with journal fillet radius profile irregularities, located at the root of the journal fillet, to return to service with a commensurate risk of premature journal failure.
