**RAILWAY INVESTIGATION REPORT**  
**R05C0116**

**DERAILMENT AND COLLISION**

**CANADIAN NATIONAL**  
**FREIGHT TRAIN A443-51-06**

**0700 LCS (BELTPACK) YARD ASSIGNMENT**  
**MILE 0.30, GTP INDUSTRIAL BRANCH**  
**HEAD BLOCK MILEAGE 125.69**  
**THREE HILLS SUBDIVISION**  
**SARCEE YARD**  
**CALGARY, ALBERTA**  
**13 JULY 2005**

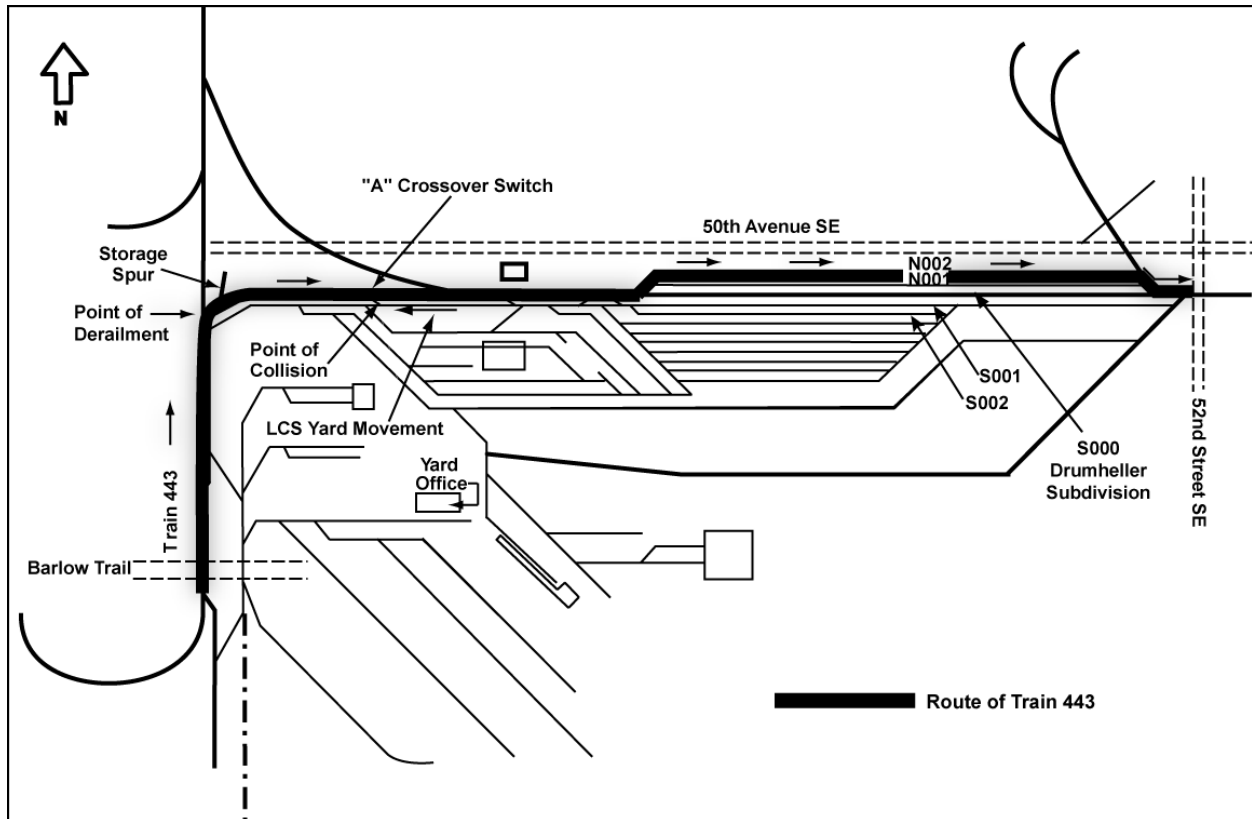
Figure 3. Route of train 443 in Sarcee Yard

When the westward movement of the locomotives and cars from N001 came to a stop clear of the switch to track N002, the locomotives were west of the Barlow Trail public level crossing. The crossing was blocked and traffic quickly backed up. The locomotive engineer was instructed by the conductor to back the movement eastward to couple the cars from track N001 onto the cars in track N002. According to event recorder data, the eastward movement started at 1041:57 and the movement was stopped at 1043:19 when the coupling was made, followed by the connection of the train air brake system.

The locomotive independent air brake was applied to hold the train on the eastward ascending grade. At 1044:18, the selector lever was placed in reverse, independent brake pressure reduced and the throttle opened to gather the slack. The independent brake was released at 1044:25 and at 1044:28 the speed registered 1 mph. The throttle was increased to position No. 4 at 1044:47 and speed increased to 3 mph at 1044:49. When the speed dropped to 1 mph at 1044:51, the throttle was rapidly increased to position No. 7 then reduced to position No. 5 at 1044:52. Between 1044:52 and 1045:31, when the speed increased to 5 mph, the throttle was manipulated between positions 6, 5, 3, and 4. Between 1045:45 and 1046:18, the throttle was manipulated between positions 3, 2, and 1. The speed dropped to 4 mph at 1046:31 and to 3 mph at 1047:03. At this time, there was a train-initiated emergency brake application. The movement came to a stop at 1047:06.
