## **RAILWAY INVESTIGATION REPORT**

**R05Q0033**

### **MAIN-TRACK DERAILMENT**

**CANADIAN NATIONAL**

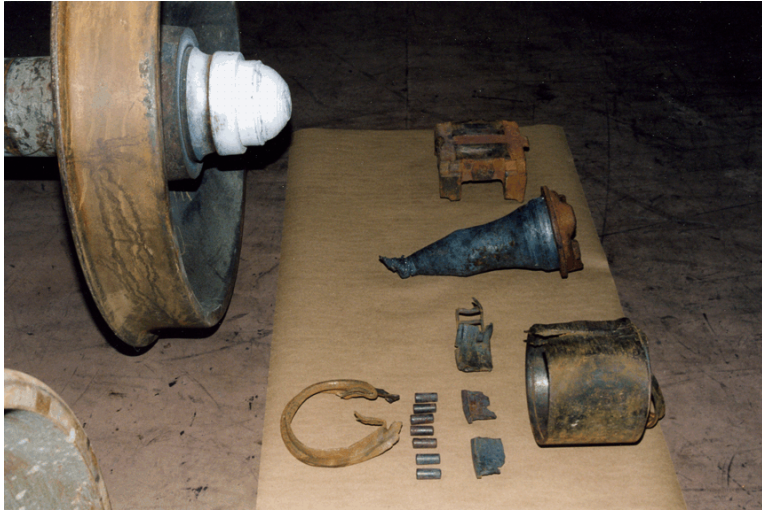
Derailed bulkhead flat car JRDX 490038,<sup>2</sup> the fifth car behind the locomotives, was missing a portion of an axle (position R-2). The axle journal along with the associated bearing was discoloured and had completely separated from the rest of its wheel set, a condition commonly described as a burnt-off journal, or BOJ. The truck side had marks indicating a recent impact on the bottom and on the trailing end of the side frame. There were no indications of impending bearing failure, such as grease spatter on the floor underframe immediately above the failed roller bearing location. The missing axle journal stub, with the bearing end cap still attached, was located on the south side of the main track at Mile 20.15.

The recovered pieces of the roller bearing (see Photo 1) and the adjacent wheel sets (No. 1 and No. 2 positions) were forwarded to the TSB Engineering Laboratory in Ottawa, Ontario, for further examination and analysis (report LP 093/2005).

**Photo 1.** Wheel and axle journal (R-2) with some of the recovered pieces

Visual examination of the bearing components of the R-2 wheel on car JRDX 490038 revealed deformation and discolouration consistent with severe overheating and bearing seizure identified in other roller bearing failures and axle burn-offs. Just before the derailment, the roller bearing overheated and seized. The axle then extruded, resulting in a reduction in cross-sectional thickness. After sufficient thinning, the overheated axle could no longer support the weight of the car, leading to a complete axle fracture.

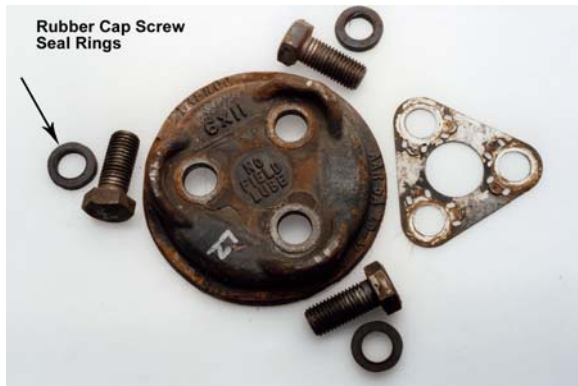
Roller bearings consist of an outer race, two tapered roller bearings with inner races separated by a spacer, and two (inner and outer) grease seals with wear rings. This assembly is pressed on an axle against a backing ring and then retained by the end cap, which attaches to the end of the axle via three cap screws and a locking plate (see Photo 2 and Appendix A).

The bearings on wheel R-2 were Class E Brenco 6 X 11, AAR-5A. When they were assembled, they were equipped with rubber cap screw seal rings between the end cap and the axle. In May 1988, the AAR prohibited the further use of these cap screw seal rings as they were susceptible to reducing the clamping forces on the assembly, which can contribute to premature failure of the bearing. Examination of the end cap and related components from the R-2 position revealed only residues of these seal rings.

**Photo 2.** Rubber cap screw seal rings, with cap screws, end cap, and locking plate, in roller bearing at L-2 and R-2 positions

The bearing was also assembled at a time when seal rings were allowed between the end cap and the axle. These seal rings were later prohibited by the AAR due to the detrimental effect the rubber rings can have on the overall clamping force holding the many integral parts of the roller bearing assembly together. The TSB laboratory examination revealed spalled raceways due to rolling contact fatigue caused by overstress resulting from a loose outboard cone. Similarly, the fretting of the threads on the cap screws at both the L-2 and R-2 positions is another indicator of a loose bearing condition. The cumulative effect of wear and stress on each of these components must be considered. Therefore, the age of the bearing, its condition and its type of assembly are considered contributing factors to its failure.

The Association of American Railroads (AAR) issued Circular Letter c-9094, titled *Interchange Prohibition of Roller Bearing Cap Screw Seal Rings Effective January 1, 2007*. This circular letter accelerates the industry removal date, previously shown as 01 January 2014, by seven years, to a new effective date of 01 January 2007. The AAR now prohibits railways from allowing cars with bearings still equipped with cap screw seal rings, similar to the car involved in this accident, from all interchange service beyond this date. The AAR requests car owners to remove cap screw seal rings from their fleets as expeditiously as possible, and repair facilities as well as contract shops are urged to do their part to reduce the cap screw seal ring population (see Appendix B).

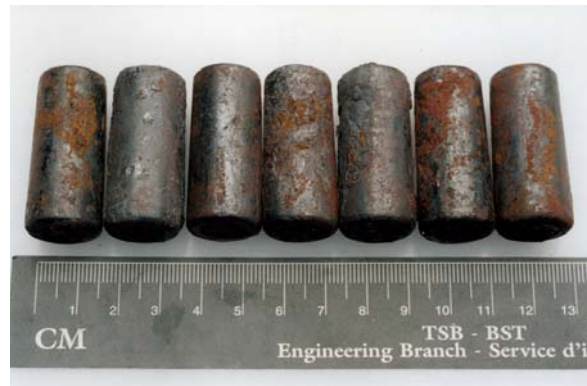
Both grease seals were recovered; the outer fused to the cup and the inner severely damaged. The roller bearings and the outer race were severely deformed and smeared, with some of the rollers fused to the inner race. Portions of the inboard inner race were recovered with rollers and cage sections fused together. Seven of the inboard tapered rollers were recovered, some showing surface spalling (see Photo 3). Closer examination of the inboard raceway of the outer race showed a significant spall on the outboard edge. Fretting wear was observed on the threads of the cap screws in the vicinity of their interaction with the end cap (see Photo 4).

**Photo 3.** Inner rollers from R-2 bearing

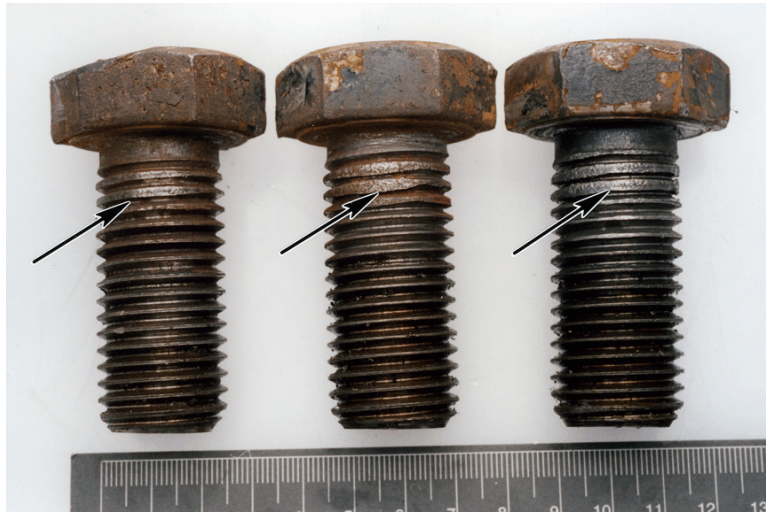
**Photo 4.** Fretting wear on threads of cap screws

- The bearing had been in service for 25 years and its internal parts had wear consistent with its age.
- The bearing failed as a result of overheating, most likely initiated as a result of loose components.
- Fretting wear observed on the cap screw threads and lock plate suggests that the end cap pre-load was less than required.
- Loss of bearing clamp force, due to the presence of rubber washers (seal rings) under the end cap and outboard cone growth, may have contributed to a loose bearing condition.
- Spalling of the inboard raceway of the outer race (cup), due to rolling contact fatigue, was considered indicative of overstress resulting from a loose outboard cone.
