## **RAILWAY INVESTIGATION REPORT**

**R08C0164**

### **MAIN-TRACK TRAIN DERAILMENT**

**CANADIAN PACIFIC RAILWAY  
FREIGHT TRAIN 356-196  
MILE 45.62, TABER SUBDIVISION  
NEAR BURDETT, ALBERTA  
30 NOVEMBER 2008**

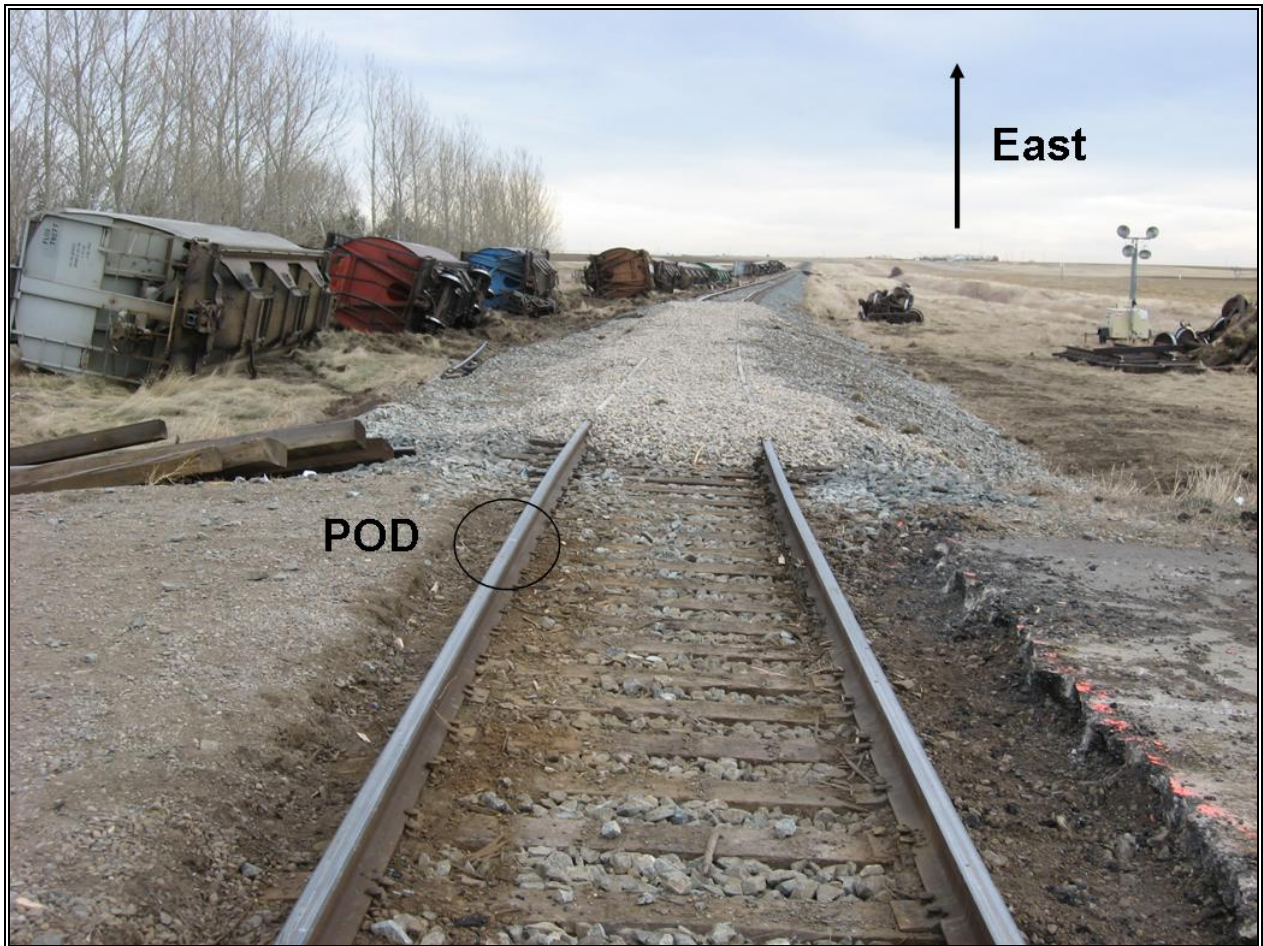
After making the necessary emergency broadcast and notifying the rail traffic controller (RTC), the conductor performed an inspection and discovered a total of 18 cars derailed; the 93<sup>rd</sup> through the 110<sup>th</sup> inclusive. Five cars were upright and 13 were on their sides, all on the north side of the track (see Photo 1).

**Photo 1.** Derailment site looking east from point of derailment (after track restoration)

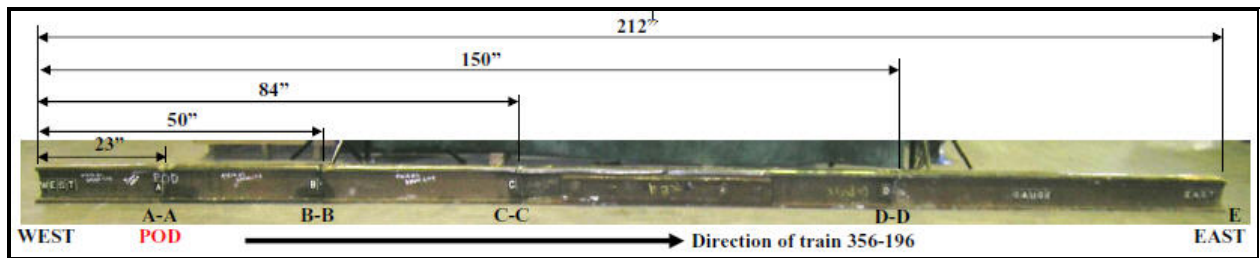
Arrangements were made with CP to examine five mating pieces of a 17-foot, 8-inch long section of the north rail, including the POD at its Test Department Laboratory in Winnipeg (see Photo 2). The west end was cut and the east end had a break. From west to east, in the direction of travel, the breaks occurred at 23 inches, 50 inches, 84 inches, 150 inches, and 212 inches (the east end). The fourth piece from the west end, between the third and fourth breaks, contained a four-hole temporary joint. The analysis revealed three of the five breaks displayed pre-existing detail fractures (DFs) extending from the gauge corner on the fracture faces with the largest at the first break from the west end. Photo 3 (break A-A) shows a DF of approximately 20 per cent of the rail head's cross-section area. This pre-existing defect initiated in an area of head checking and flaking that acted as a stress raiser. This led to a brittle transverse fracture and failure of the rail under the train. The east side of the break exhibited impact marks. Based on the size of the DFs and the severity of the impact facets, break A-A was identified as the primary fracture and the POD.

The four other breaks also displayed impact damage, but to a much lesser degree.

**Photo 2.** Gauge side view of the north rail showing breaks. C-C is a four-hole joint.

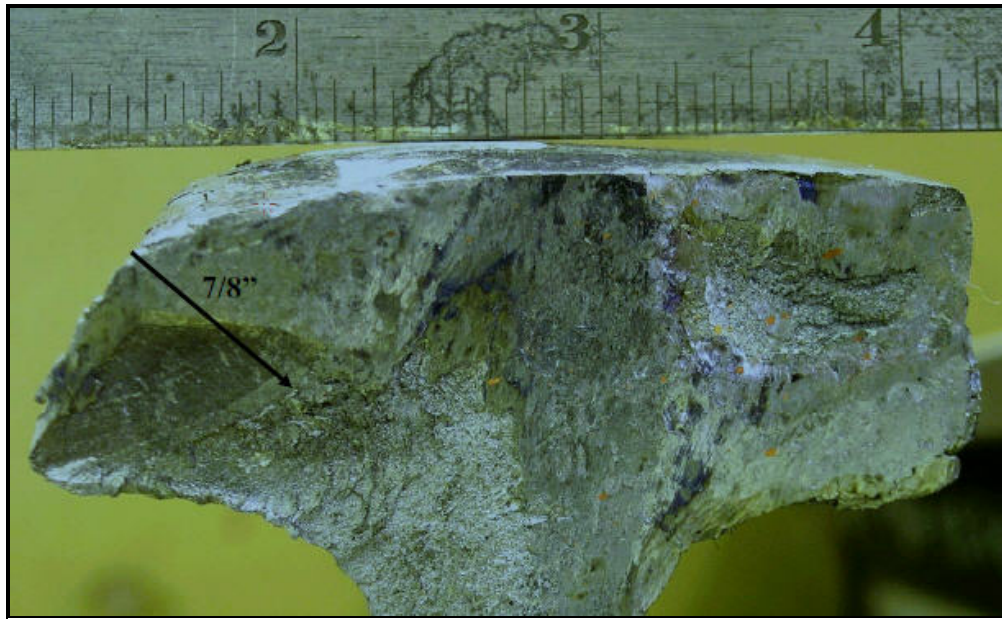
**Photo 3.** Close-up of fracture face on the west side of break A-A showing gauge face detail fracture (DF) defect

The size of a detail fracture is commonly recorded as the percentage of head area of a new or unworn rail. Of the rail recovered from the derailment, the largest detail fracture was 20 per cent of new head area.

Pre-existing fatigue defects identified as DFs were found on three fracture surfaces of the recovered pieces of rail. The largest one, at 20 per cent of the rail head's cross section head area, was observed in the gauge corner of the rail in the west fracture face of break A-A. With batter displayed on the east fracture face, break A-A was identified as the POD. Once initiated, the detail fracture continued to grow with the passage of trains, in turn decreasing the rail's ability to withstand wheel loads. The expanding defect reduced the load-carrying capacity of the rail until it could no longer support the weight of the train, causing the rail to break, resulting in the train derailment and additional fracturing of the rail.

Because the rail surface head had not been ground, the October 17 induction/ultrasonic test was ineffective. Consequently, had the DF defects existed at that time, they would not likely have been detected.

The poor rail surface condition likely led to the ultrasonic signal being reflected away from the transducer, thus preventing detection of the DF defects. Ultrasonic rail testing through crossings can be unreliable if the rail surface condition is poor or if the rail is contaminated with road debris such as oil, salt, mud, ice, or grit, thereby increasing the risk of defects going undetected.

Canadian Pacific Railway has directed more vigilant track and rail inspections through crossings. Grinding of rail at crossings is to be scheduled at locations where rails exhibit surface conditions that interfere with rail flaw detector response.
