**RAILWAY INVESTIGATION REPORT
R08M0015**

MAIN-TRACK DERAILMENT

VIA RAIL CANADA INC.

MILE 23.32, MONT-JOLI SUBDIVISION

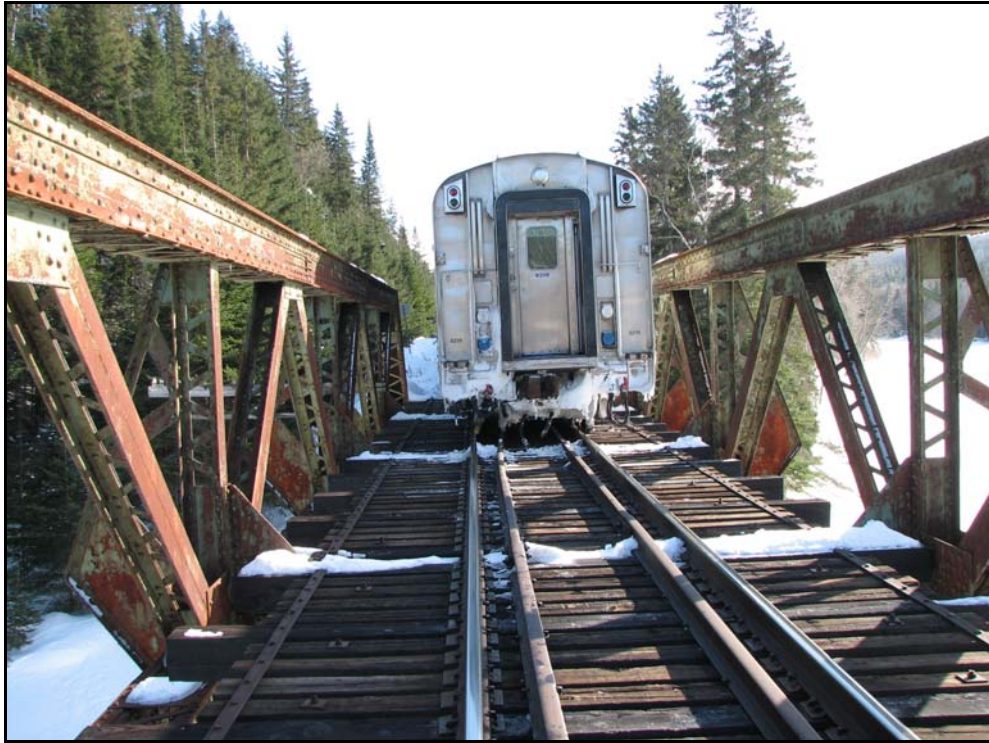
The air temperature was -3°C. The ground was covered with compacted snow and only the top of the rail was visible. The derailed cars stopped on the subgrade at the east entrance of the bridge, which is 440 feet long and spans the Matapédia River. They stayed upright and coupled to the front of the train (see Photo 1).

Photo 1. Derailed car on the bridge spanning the Matapédia River

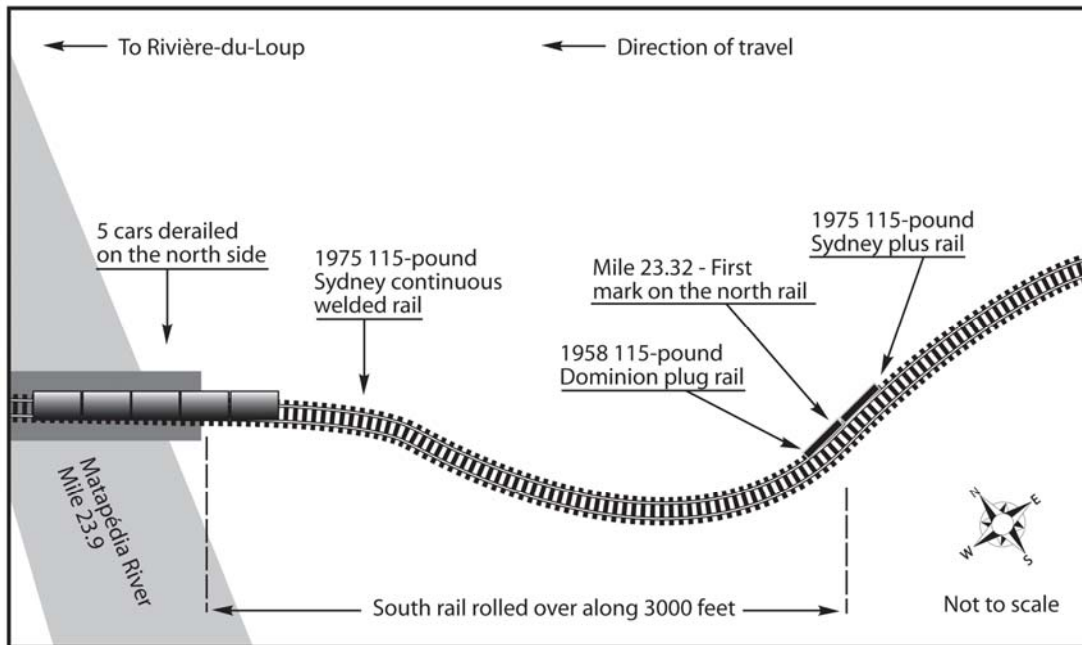
The wheels of the cars sustained minor damage. The damage to the track started immediately in way of the derailed cars and continued into the curve to the Dominion plug rail located on the low rail (north) about 3000 feet east of the bridge. The head on the interior side of the plug rail was broken and fragments had come off. The 27-foot plug rail was made of 115-pound rail. It had been made in 1958, but its origin and installation date are unknown. On the west end, it had been flash-welded to the rest of the rail in the curve, which consisted of 115-pound RE Sydney continuous welded rail (CWR) from 1975. On the east end, it was bolted to another Sydney plug rail from 1975, which had been laid after a 26-inch-long vertical split head (VSH) defect was detected during rail testing on 10 April 2007 (see Figure 2). The track gauge 30 feet to the east was 57 ¼ inches, within the allowable limits set out in the Transport Canada-approved *Railway Track Safety Rules* (TSR).

Figure 2. Diagram showing the area where the derailment occurred

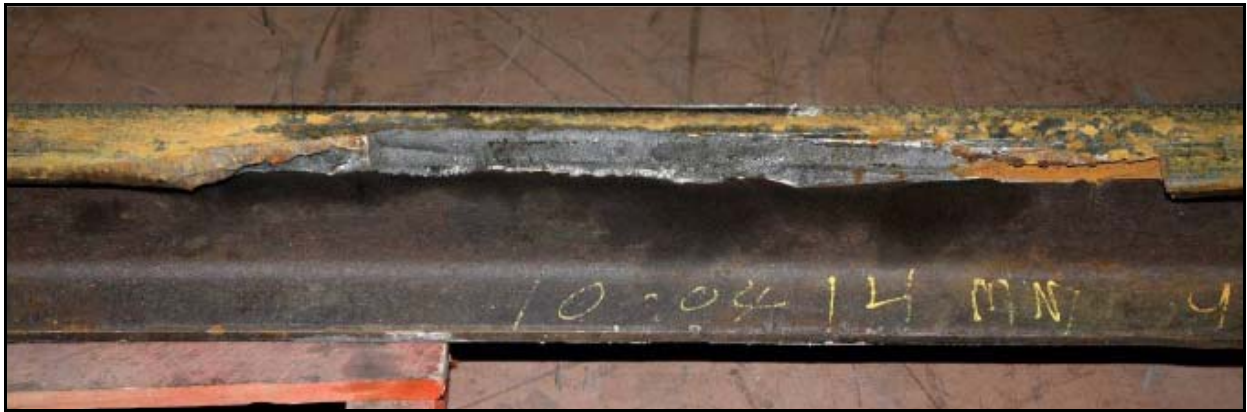
The detached fragments from the head and a segment including the Dominion plug rail and two feet of Sydney rail were recovered and sent to the TSB Engineering Laboratory for analysis (report LP 058/2008). The plug rail had a VSH defect 28 inches long on the interior side of the rail (see Photo 2) that started about 22 inches from the bolted end of the rail. A localized surface collapse (LSC) defect 26 inches long and 3/8 inch deep was observed 14 inches from the VSH defect.

Photo 2. Vertical split in the rail head of the Dominion plug rail

Examination of the rail fragments affected by the VSH defect revealed the presence of rough fracture surfaces with chevron markings pointing to the point of origin of the fracture located in the largest fragment. At this point of origin of the fracture, several progressive crack markings oriented at about 45 degrees to the running surface and about halfway between the running surface and the gauge corner were observed. Inclusions of manganese sulphide and slight fatigue striations were identified.

Examination of the Dominion rail revealed the presence of a VSH and an LSC. The fracture surfaces showed inclusions of manganese sulphide and adjacent slight fatigue striations, which confirm that the rail was affected by pre-existing fatigue cracks at the location of the VSH and LSC. The cracks started in the inclusions of manganese sulphide and spread as fatigue defects in a 45-degree direction in relation to the running surface. As soon as the cracks reached a critical size, they spread in the vertical direction. Under the loads from the wheels, the interior part of the rail head detached, causing the cars to derail.

The flattening and widening of the head observed along most of the length of the Dominion rail suggest that the VSH had spread longitudinally beyond the sections of rail containing the VSH and LSC. In addition, the presence of rust and damage caused by friction in the fatigue cracks suggests that these defects had existed for some time.

In 2007, because of resource constraints encountered by the rail testing company, testing was performed only three times, with the last one carried out almost 25 weeks before the accident. The cracks observed on the plug rail were rusted and must have been present for some time. More frequent testing would have created a better opportunity to detect the defect.

The acquisition of CFMG by Canadian National (CN) will allow rail testing to be conducted under CN's much larger service contracts. CN expects to conduct from six to eight rail flaw detection tests over this territory during 2009. Historical rail defects for the past two years will be integrated into CN's Rail Defect Index and Rail Severity Index systems, which use rail defect data to assign a severity level to a section of track. The joints connecting worn rails were identified, ground down, and painted blue to monitor them during inspections.

Shortly after acquiring the territory, CN's rail safety programs were extended and the track was examined by CN's test car on 11 November 2008. Rail locations exceeding the wear limits were protected pending replacement of the rails, while those approaching the limits were included on CN's Capital Program for 2009.
