RAILWAY INVESTIGATION REPORT
R09H0006

MAIN-TRACK DERAILMENT
OTTAWA VALLEY RAILWAY
FREIGHT TRAIN, *COBDEN TURN*
MILE 60.1, NORTH BAY SUBDIVISION
HODGSON, ONTARIO
03 JUNE 2009

Report Number R09H0006

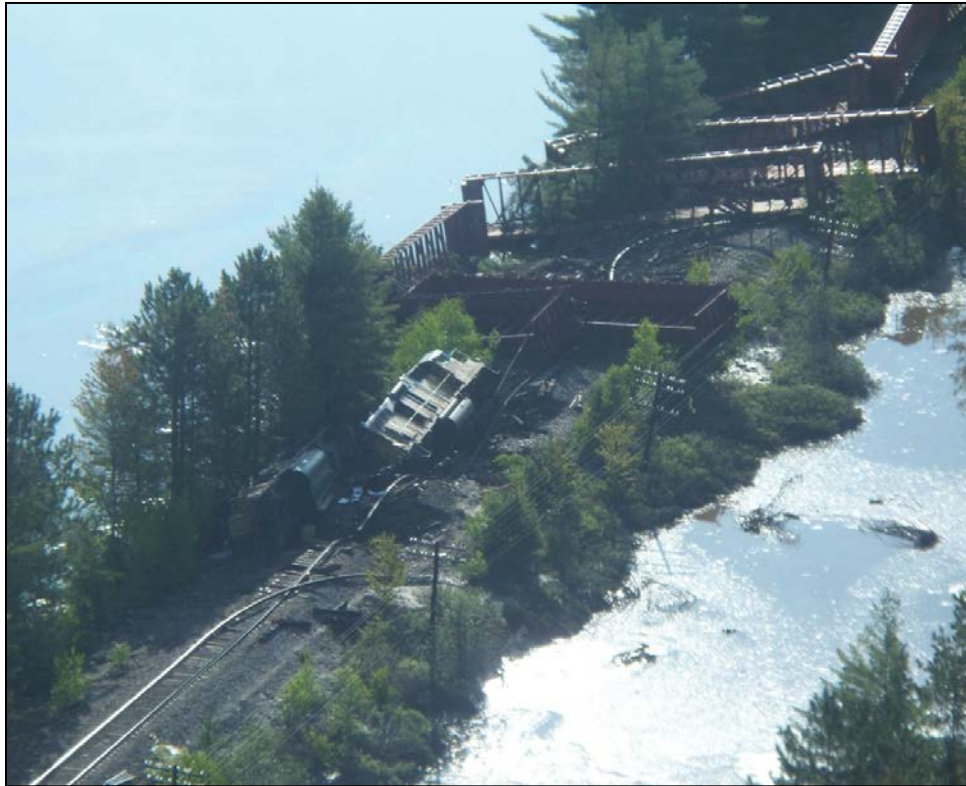
Photo 1. Aerial view of derailment site

The track was damaged for approximately 460 feet. There were five locations where the track subgrade had washed away, ranging in length from about 6 feet to about 20 feet long. The two locomotives had dropped into two of these washed-out sections of track and sustained extensive damage. The seven derailed cars were jackknifed across the track with four cars positioned on the river bank and partially overhanging the Ottawa River.

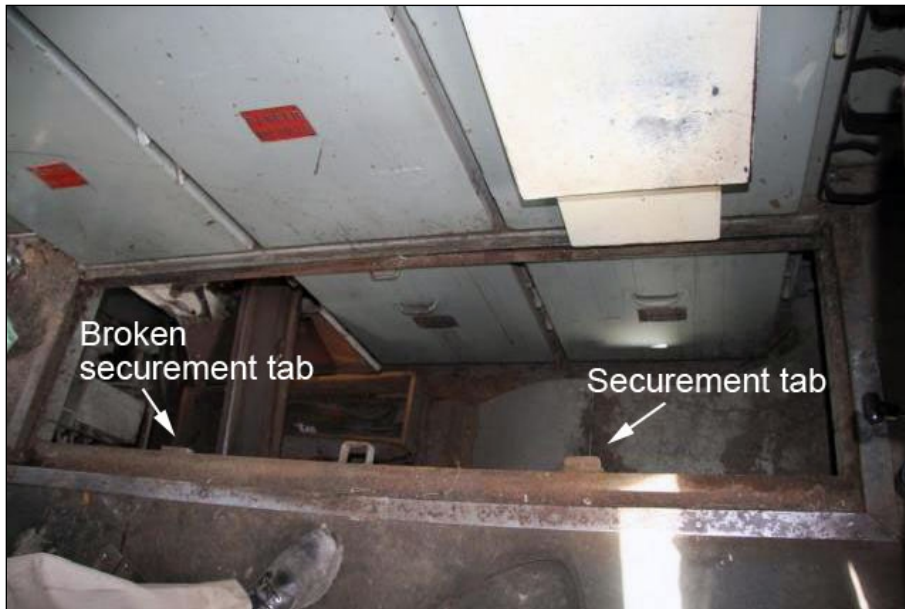
Inspection of the locomotive cab revealed that one of the floor panels had been dislodged and had broken free from the floor. The anchor for the securement mechanism of this panel had broken away (see Photo 2). The fracture face of the broken anchor had an accumulation of dirt from exposure to the interior subfloor and did not have the luster of a fresh break.

Photo 2. Floor panel cavity

A broken anchor for a floor panel latch had not been identified for repair during the previous periodic maintenance inspection, allowing the floor panel to dislodge inside the locomotive cab. When locomotive panel securement mechanisms are not thoroughly inspected and maintained, there is an increased risk that unsecured panels can cause injury or block egress in the event of a locomotive rollover.

The TSB issued Rail Safety Information Letter (RSI) 03-09 concerning broken securement mechanisms on locomotives. In response, Transport Canada completed a survey of federally regulated railways having locomotives with removable floor panels and is satisfied with its instructions for inspecting securement mechanisms. During inspection activities, Rail Safety inspectors will review the condition of floor panels and verify that railway inspections are being performed as required. In addition, the Ottawa Valley Railway (OVR) holds regular meetings to remind employees of the importance of a thorough and exacting inspection and to report equipment defects or issues as they become known.

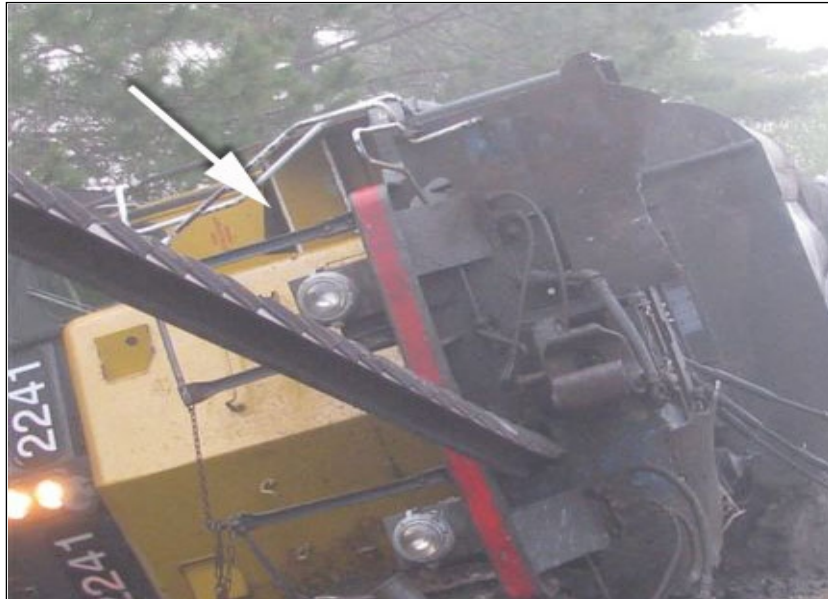
Inspection of the locomotive cab exit points revealed that the battery box lid had fallen open and was preventing the nose door from opening (see Photo 3). The rear exit door was buried in the mud. The cab was not equipped with an emergency exit hatch, nor emergency exit windshields.

Photo 3. Battery box lid blocking the cab door

The locomotive was derailed on its side and the normal points of egress (that is, locomotive doors) were blocked. Consequently, the only available egress from the locomotive cab was one of the windows above the crew members' heads, requiring them to climb upwards to exit. This delayed their egress by up to 10 minutes following the derailment. Although there were no adverse consequences from this delay, egress would have been difficult in situations involving injured crew members or in the presence of immediate hazards (for example, fire or chemical spills). Despite the occurrence locomotives meeting current egress requirements for locomotive cabs, as prescribed in AAR Standard S-580, the orientation of the derailed locomotive and the blocked doors resulted in significant delays for the crew members to exit the cab.

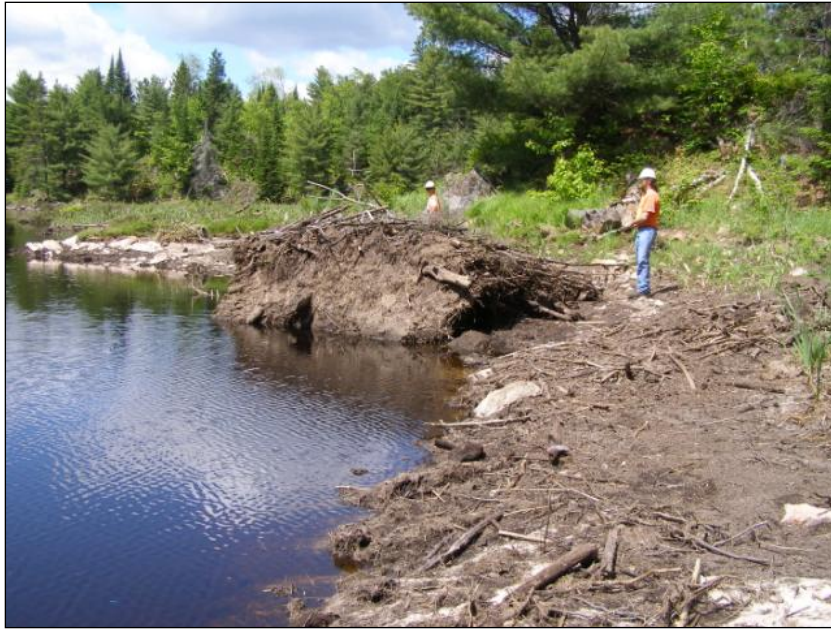
A nearby creek drained through a culvert in the track subgrade. The culvert was clear of debris and the water flow was unimpeded. A pond had formed bordering on the upstream side of the track subgrade. Water marks were discovered on the ballast, ties and rails approximately 10 feet above the water level that was observed after the accident. It was determined that the high water was due to the catastrophic failure of three beaver dams, up to 1.6 km upstream of the track; these dams were not visible from the OVR right-of-way. A large section of a beaver dam, measuring approximately 15 feet long, had been displaced from its location on a smooth bald rock (see Photo 4).

Photo 4. Displaced portion of beaver dam

There were no signs that the beaver dam had failed by anything other than natural forces. Water markings showed that the water level in the beaver dam ponds had dropped by several feet, indicating that a large volume of water had been released recently (see Photo 5). The water course from the furthest beaver pond to the derailment site dropped in elevation by about 100 feet.

A sudden release of a large quantity of water can quickly damage a track bed, resulting in a track washout. In this occurrence, a beaver dam located approximately 1.6 km upstream failed, leading to the accident. OVR's track inspection procedures identify the potential consequences of a beaver dam failure and the need for more frequent inspections. In comparison, CPR's Standard Practice Circular provides guidance on the type of inspection, the need to maintain records of beaver dam locations and the need to be aware of certain times during the year when there is an elevated risk of beaver dam failures. The requirements prescribed in CPR's policy are much more comprehensive and will help identify high-risk locations where water has accumulated upstream from the track. Without a comprehensive strategy to identify high-risk

The TSB issued Rail Safety Advisory (RSA) 06-09 concerning the adequacy of beaver dam inspection practices on RailAmerica. In response, RailAmerica revised its 2010 Safety Management System Safety Action Plan to include a commitment to conduct aerial inspections to assess beaver dams off the OVR right-of-way once a year, aimed at identifying high-risk areas beyond the range of conventional right-of-way and culvert inspections. Once the areas are identified, OVR will coordinate with the Ontario Ministry of Natural Resources to cause breakage of, or release from, the dams consistent with the relevant conservation legislation and protection of property.

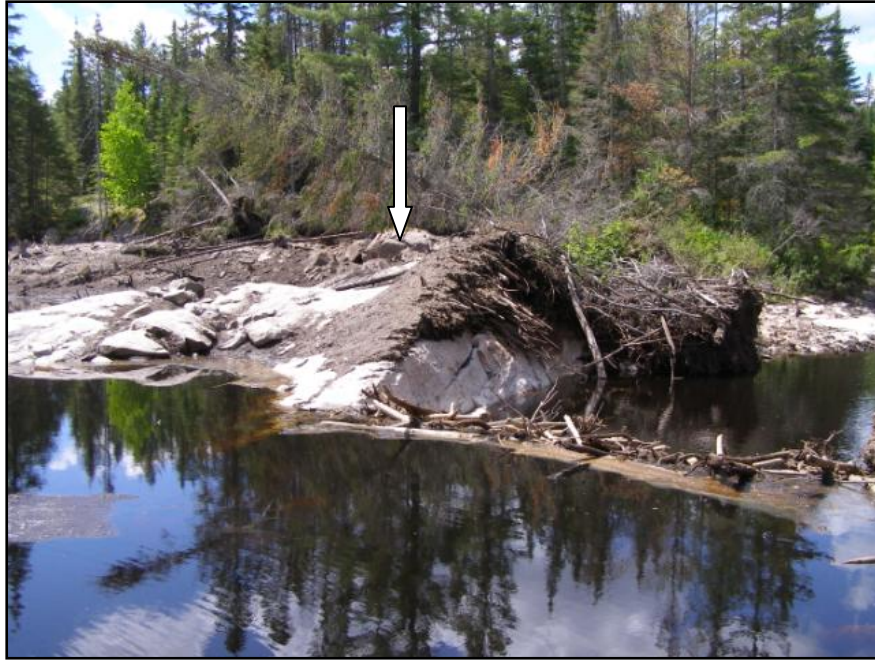
Photo 5. High water mark
