## **RAILWAY INVESTIGATION REPORT**

**R09W0033**

### **MAIN TRACK TRAIN DERAILMENT**

**CANADIAN NATIONAL RAILWAY**  
**MILE 108.23, ALLANWATER SUBDIVISION**  
**ROBINSON, ONTARIO**  
**13 FEBRUARY 2009**

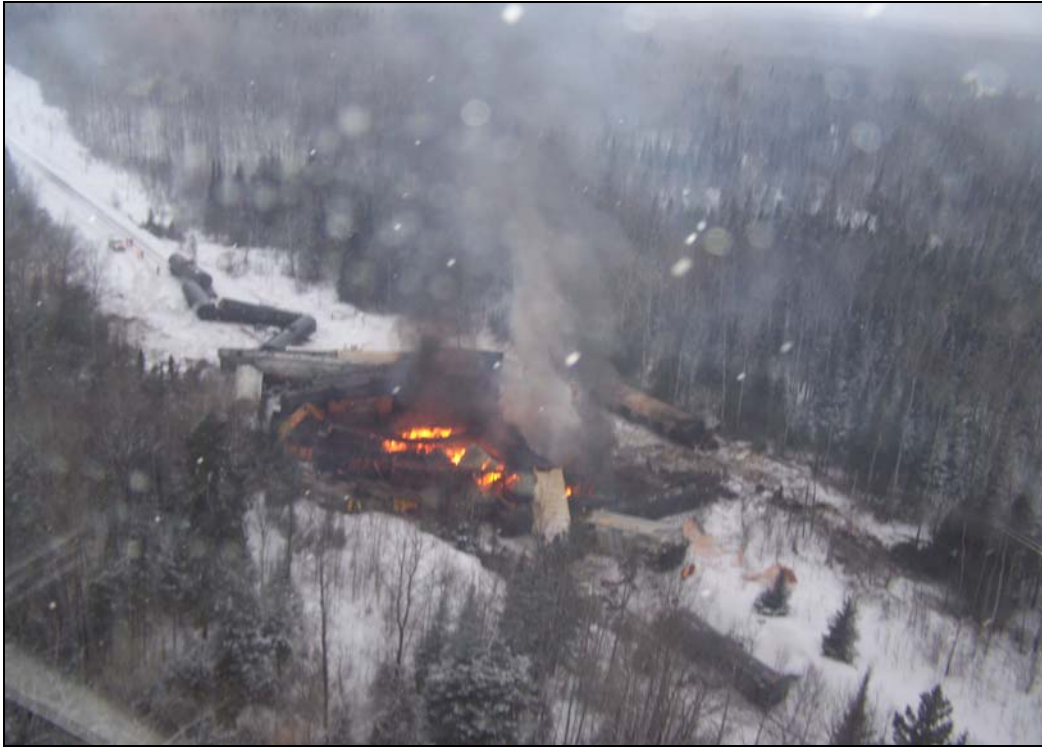
An 800-gallon wayside propane tank, which was used to fuel the Robinson east power switch heater, was located on the railway right of way about 50 feet north of the switch (see Figure 2). During the derailment, rolling stock struck and breached the tank, which resulted in an explosion and a fire. The fire engulfed most of the derailment site, including approximately

15 of the 29 derailed cars. Two tank cars of lard and a carload of lumber were consumed in the fire (see Photo 1). Several bulldozers and large backhoes were brought to the accident site to contain the fire and to work on restoring the rail line. The heavy equipment spread the damaged rolling stock about the site and covered it in snow in an effort to extinguish the fire, which burned for about 24 hours. Once the fire was under control, site remediation continued.

**Photo 1.** Derailement site and fire

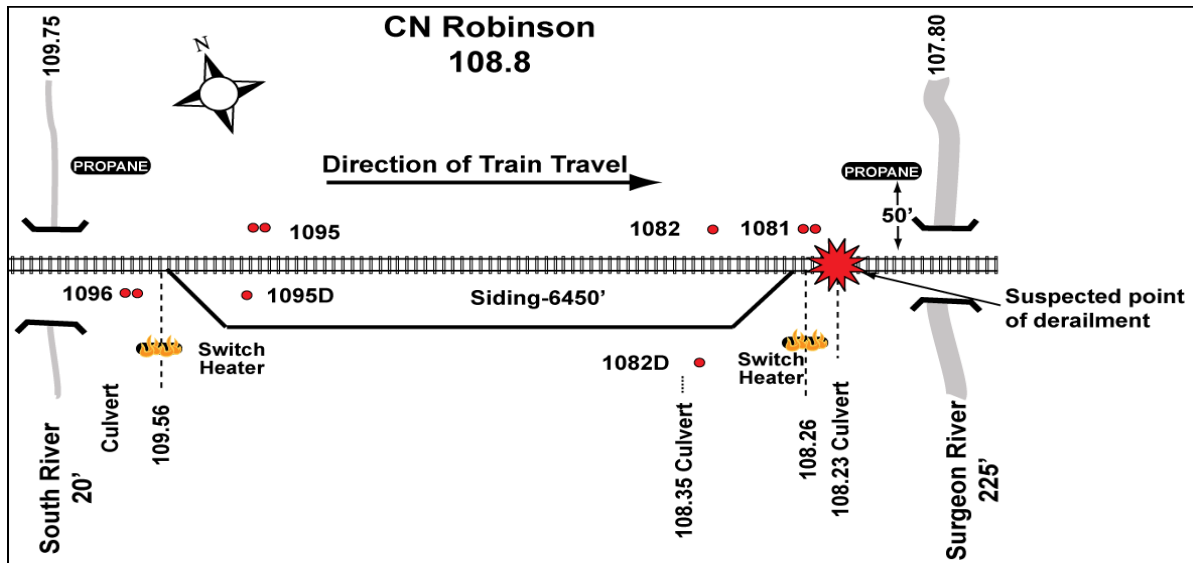
Figure 2. Track layout in area of the accident.

In the vicinity of the derailment, the track was tangent and oriented in an east-west direction with a 0.10 per cent eastward ascending grade. Just south of the main track, a 6450-foot long siding runs parallel, between Mile 108.26 and Mile 109.56 (See Figure 2). A temporary slow order (TSO), which restricted speed to 40mph, was placed in the area of the Robinson east switch on 10 February 2009. Maintenance surfacing of the track at this location was planned for 13 February 2009, the day of the derailment.
