RAILWAY INVESTIGATION REPORT R09W0252

MAIN-TRACK TRAIN DERAILMENT

**CANADIAN NATIONAL
FREIGHT TRAIN Q11459-03
MILE 222.90, RIVERS SUBDIVISION
SPY HILL, SASKATCHEWAN
05 DECEMBER 2009**

Report Number R09W0252

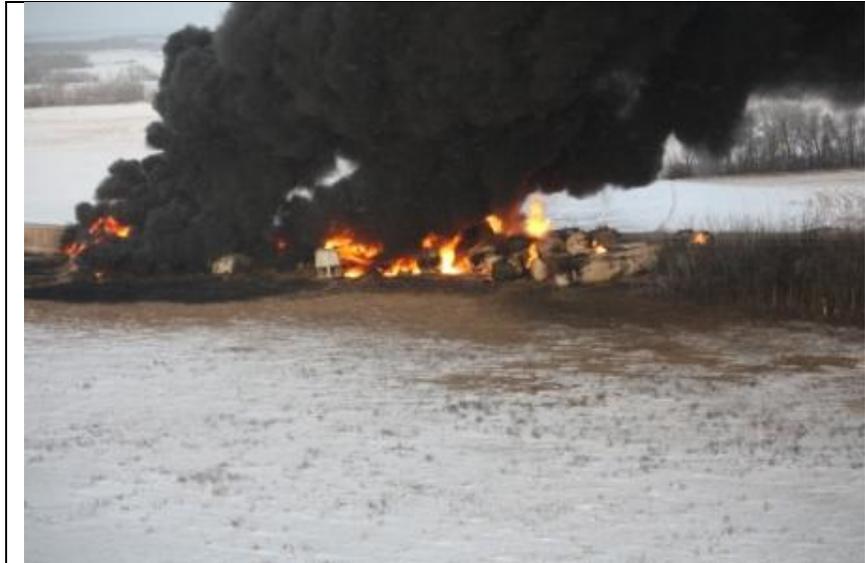
A large fire involving the various DG and plastic pellets burned throughout the derailment site. There were large clouds of black smoke and heat could be felt from a distance of approximately a half kilometre away (see Photo 1).

Photo 1. Derailment site and fire looking north

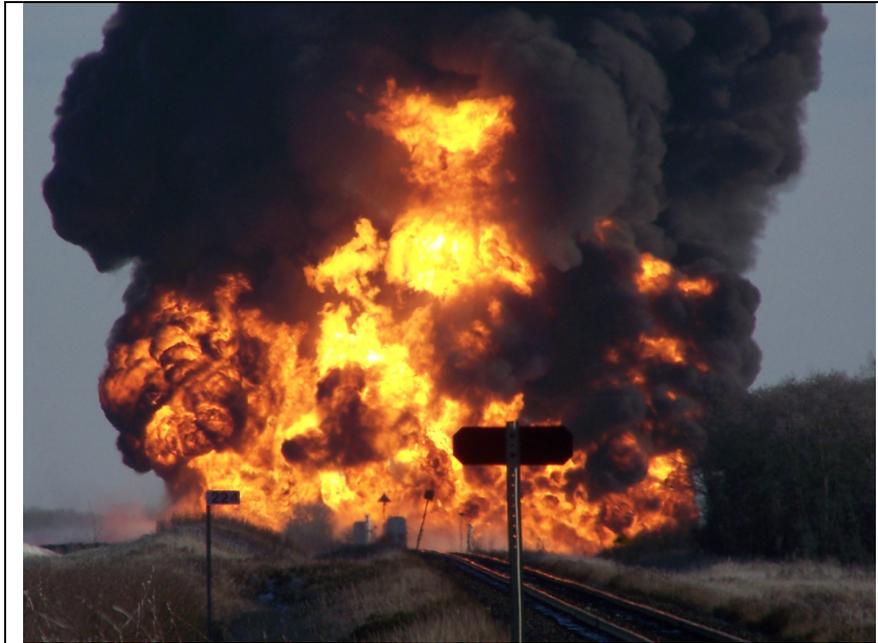
Photo 2. Second vent and burn operation

Shortly thereafter, the TSB advised that 1 tank car continued to hold pressure and vent product, which ignited upon release. A subsequent site assessment was conducted at 2300. It was confirmed that on 1 car, the charge had only penetrated the tank jacket and had not breached the tank shell, so the car remained under pressure.

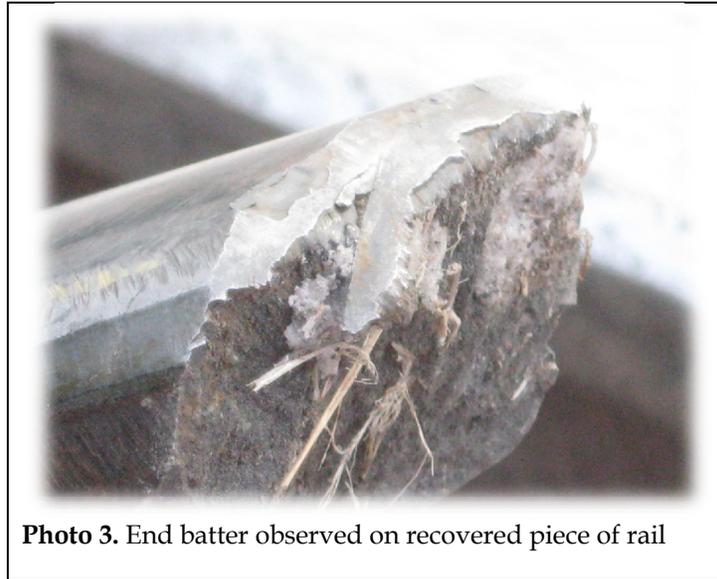
During site remediation, following the derailment, CN recovered approximately 153 feet of rail, identified as being from the south rail by grinding marks and wear profile. One of the pieces exhibited minor rail batter on its west end (see Photo 3). The recovered rail pieces containing fractures were forwarded to the TSB Laboratory for analysis, which determined that all fractures were a result of overstress and no single rail piece had a pre-existing defect that could be positively identified as causal to the accident.

Photo 3. End batter observed on recovered piece of rail

There was a bump under the lead locomotive just prior to the emergency brake application. The south rail was canted out of the tie plates and bent to the south, while the north rail remained straight up to the body of the derailment. TSB Laboratory analysis determined that all recovered rail fractures were a result of overstress and no single rail piece had a pre-existing defect that could be positively identified as causal. The minor rail batter observed on 1 piece suggests that it failed in service and briefly remained in place before breaking away. The majority of derailed cars came to rest on the south side of the main track. The distribution of the derailed cars, the position of the remaining south rail east of the derailment area and the absence of any pre-existing defects in the recovered rail pieces all suggest that the derailment likely occurred due to a sudden, catastrophic failure of the south rail under the train.
