**RAILWAY INVESTIGATION REPORT  
R10Q0011**

**MAIN-TRACK DERAILMENT**

**VIA RAIL CANADA INC.  
PASSENGER TRAIN No. 15  
MILE 100.78, CANADIAN NATIONAL MONTMAGNY  
SUBDIVISION  
SAINT-CHARLES-DE-BELLECHASSE, QUEBEC  
25 FEBRUARY 2010**

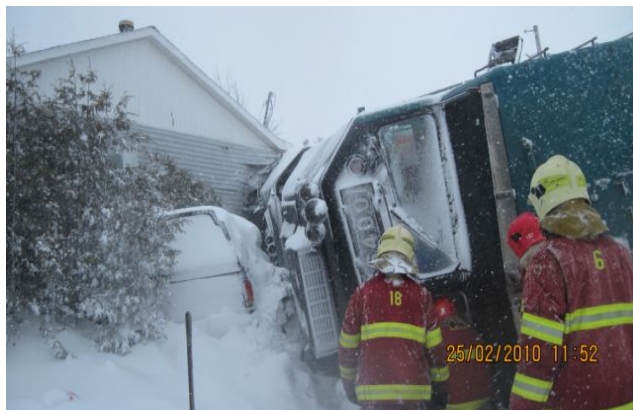
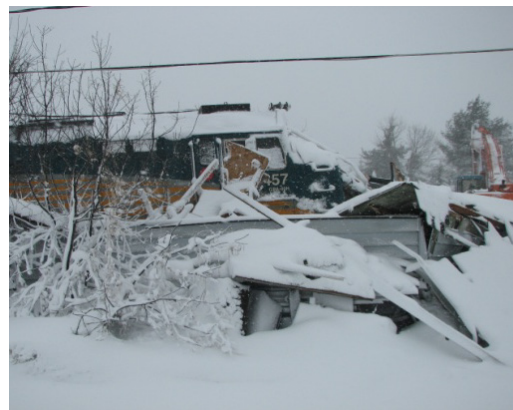
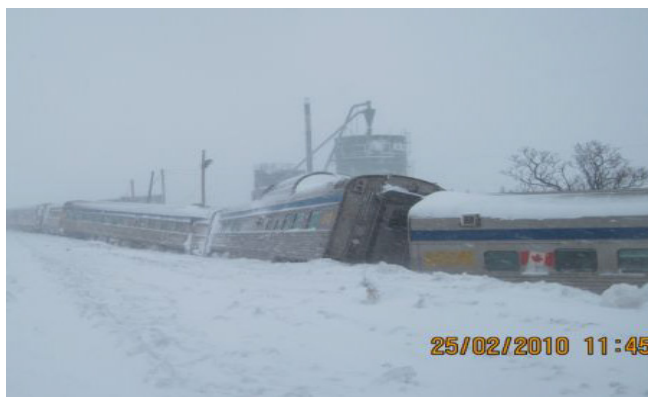
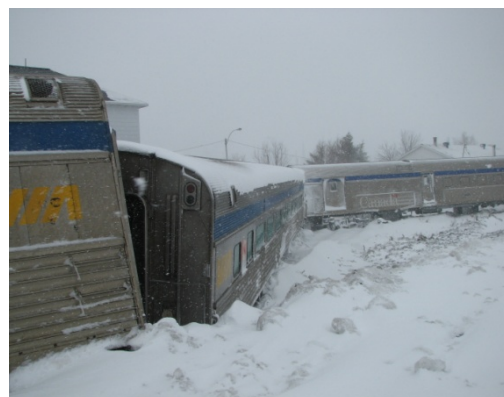
On 25 February 2010, at approximately 0425, <sup>1</sup> VIA 15, travelling at approximately 64 mph, entered a siding at Mile 100.78 of the Canadian National (CN) Montmagny Subdivision in the municipality of Saint-Charles-de-Bellechasse, Quebec, and 2 locomotives and 6 passenger cars of the train derailed. The derailing train downed adjacent hydro lines and struck 2 houses and a garage before coming to a stop (see Photo 1).

**Photo 1.** Derailed equipment and damage to residential properties

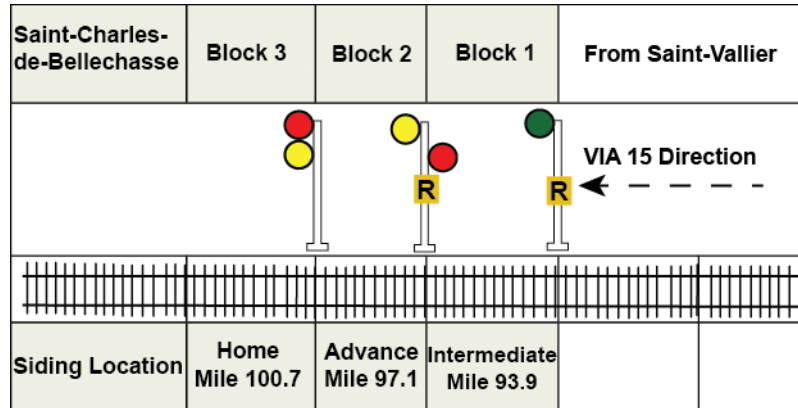
- intermediate signal 939 would display a clear signal (green aspect);
- advance signal 971 would display a clear-to-stop indication (2-aspect signal displaying a yellow over red, which means proceed, prepare to stop at next signal); and
- home signal 1007 would display a restricting signal (red over yellow, which means proceed at restricted speed <sup>5</sup>).

Figure 2. Signal indications when lined for Saint-Charles-de-Bellechasse siding

Since both clear and clear-to-stop signal indications have a lower red aspect, it is likely that the crew correctly perceived only the lower lens of advance signal 971. With the poor weather conditions, it is likely that the crew misperceived the top lens and interpreted the signal as clear. This would be consistent with the principle of closure or confirmation bias (that is, the tendency to fill in parts that are missing to conform to an overall impression). The crew members continued to operate the train in a manner suggesting that, according to their mental model, they were not meeting CN 308 at Saint-Charles-de-Bellechasse.

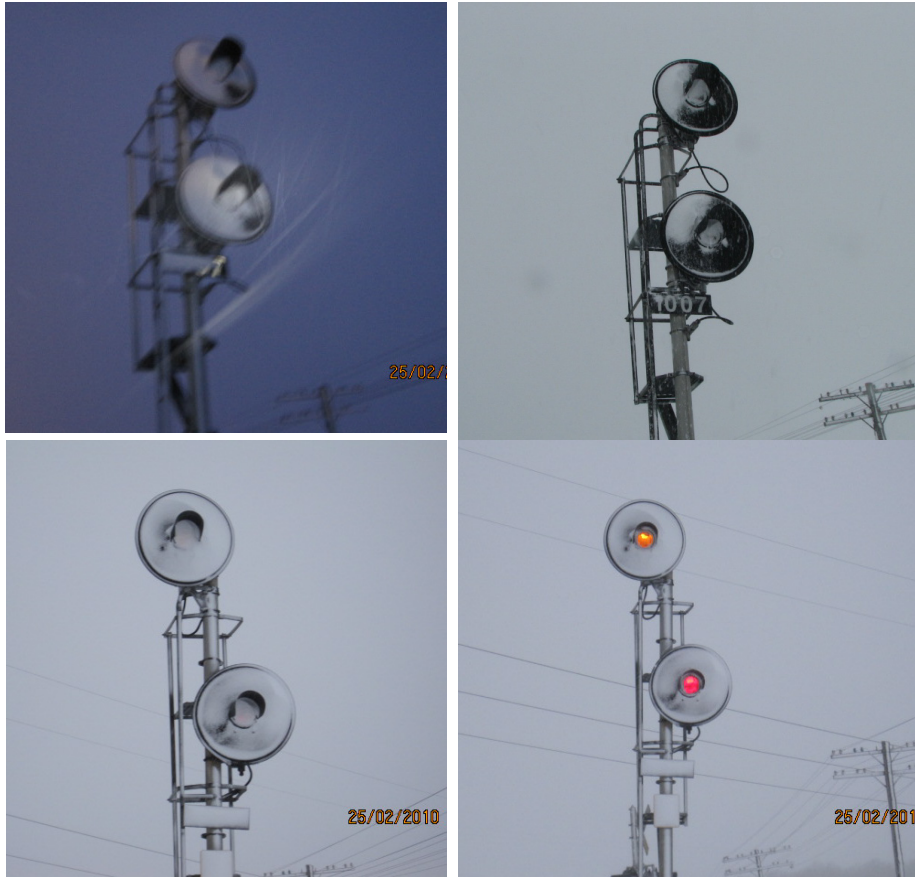
Shortly after the accident (at 0700 and again at 1130 on the day of the accident), the signal lenses on the advance signal and the home signal were either partially blocked or completely blocked by wet opaque snow (see Photo 2). A review of railway records for the previous year showed that, in this area, there were 6 reports of signals being obscured due to winter conditions. In each case, Signals and Communications technicians responded and cleaned the signal lenses. There were no reports of signal malfunctions at this location.

**Photo 2.** Top: Snow on signal lenses at home signal 1007 (25 February 2010 at 0700 and 1130). Bottom: Advance signal 971 before and after cleaning lenses (Source: TSB and CN)

Railway signal lenses are relatively small in size and are viewed from remote distances. It can be difficult for crews to appreciate that a signal is becoming obscured due to snow accumulation. The reduced visibility of a signal lens in these circumstances is not as apparent to crews as the more obvious conditions such as fog, heavy rain or blowing snow.

The accumulation of snow on signals is particularly an issue for faster moving passenger trains given the shorter length of time for crews to identify a signal indication, as compared to slower moving freight trains. Field testing confirmed that a single thin layer of obscurant over the signal lens greatly reduced the distance from which the signal colour could be distinguished and the indication perceived. As the train was moving into the frontal edge of the storm, the strong winds and blowing snow were reducing visibility. Because the temperature was within 1° of freezing, it caused snow to accumulate on the signals. The deteriorating weather conditions and snow affected the crew's ability to accurately perceive advance signal 971 and home signal 1007 from the usual distance.

On 03 August 2010, the TSB issued Rail Safety Advisory (RSA) 02/10 (Reduced Visibility and Signals Obscured due to Poor Weather Conditions). The advisory addressed the application of *Canadian Rail Operating Rules* (CROR) Rule 27, which requires train crews to consider an imperfectly displayed signal as the most restrictive indication that can be displayed and then to report the condition to the rail traffic controller (RTC). Although the RTC must communicate immediately with the Signals and Communications Department so that technicians can take corrective action, the advisory noted that the RTC is not required to issue a warning or a speed restriction. Furthermore, train crews are expected to operate as close as safely possible to track speed unless they are issued a formal speed restriction. The advisory concluded that "Given the serious consequences of this occurrence, Transport Canada may wish to review operating procedures when there are known visibility restrictions due to inclement weather."
