**RAILWAY INVESTIGATION REPORT
R11Q0050**

**MAIN-TRACK DERAILMENT
QUEBEC NORTH SHORE AND LABRADOR RAILWAY
FREIGHT TRAIN PL 485
MILE 56.33, WACOUNA SUBDIVISION
NEAR TIKA, QUEBEC
26 SEPTEMBER 2011**

Report Number R11Q0050

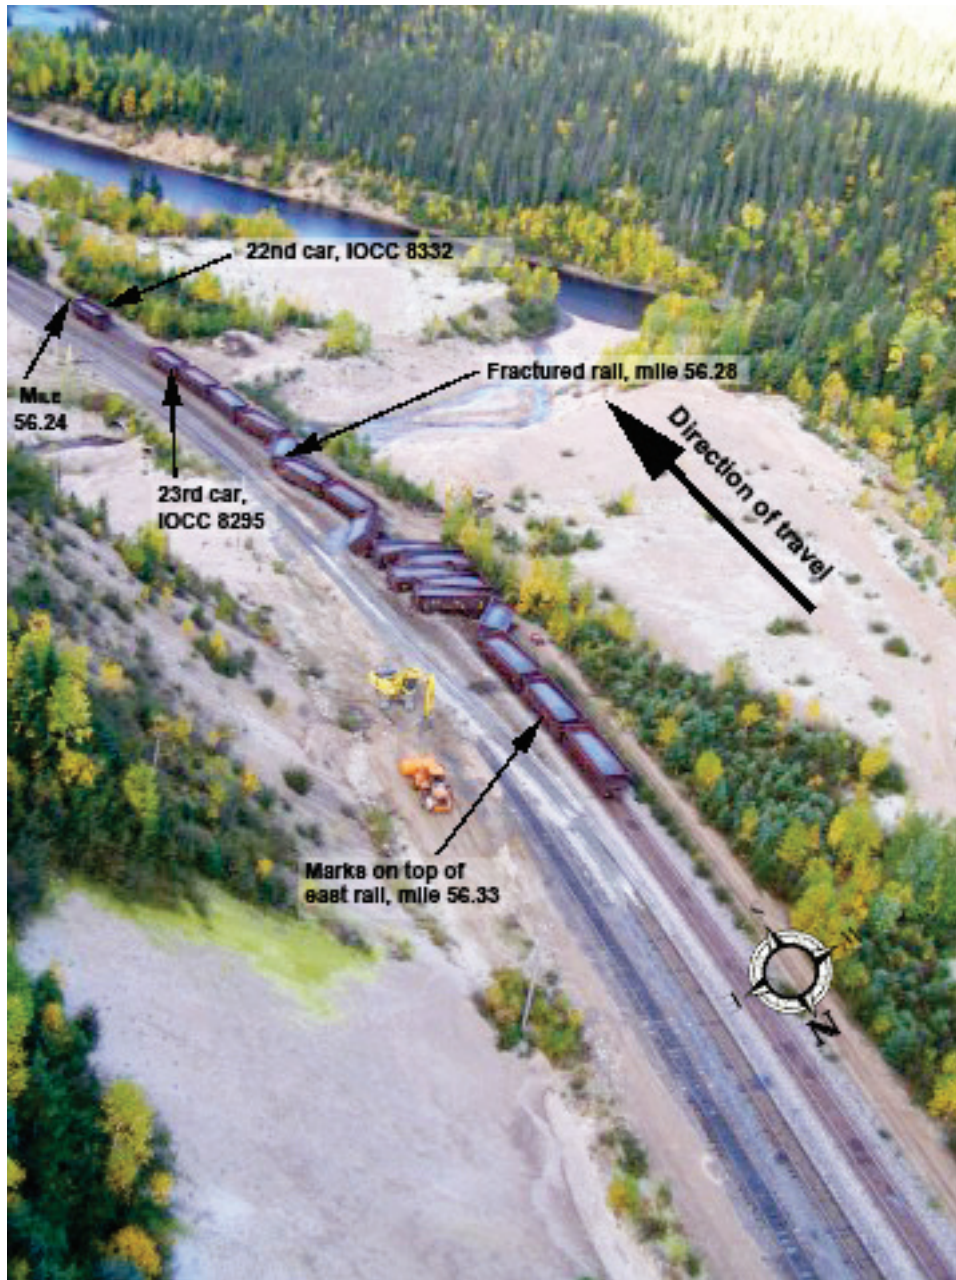
The derailment area covered about 450 feet (Photo 1). Derailed equipment included 17 gondola cars loaded with iron ore.

Photo 1. Overview of accident site

The 22nd car from the head end, IOCC 8332, was the first to derail. It remained coupled to the head end of the train while the other derailed cars separated from the train and came to rest about 250 feet north. All cars remained upright except for the 30th car, which came to rest at a 45° angle on the east side of the track. The 22nd car derailed its trailing truck. The next 7 cars, from the 23rd to the 29th, derailed parallel to the track while the next 6 cars, from the 31st to the 36th, jackknifed. The 38th car derailed its lead truck only.

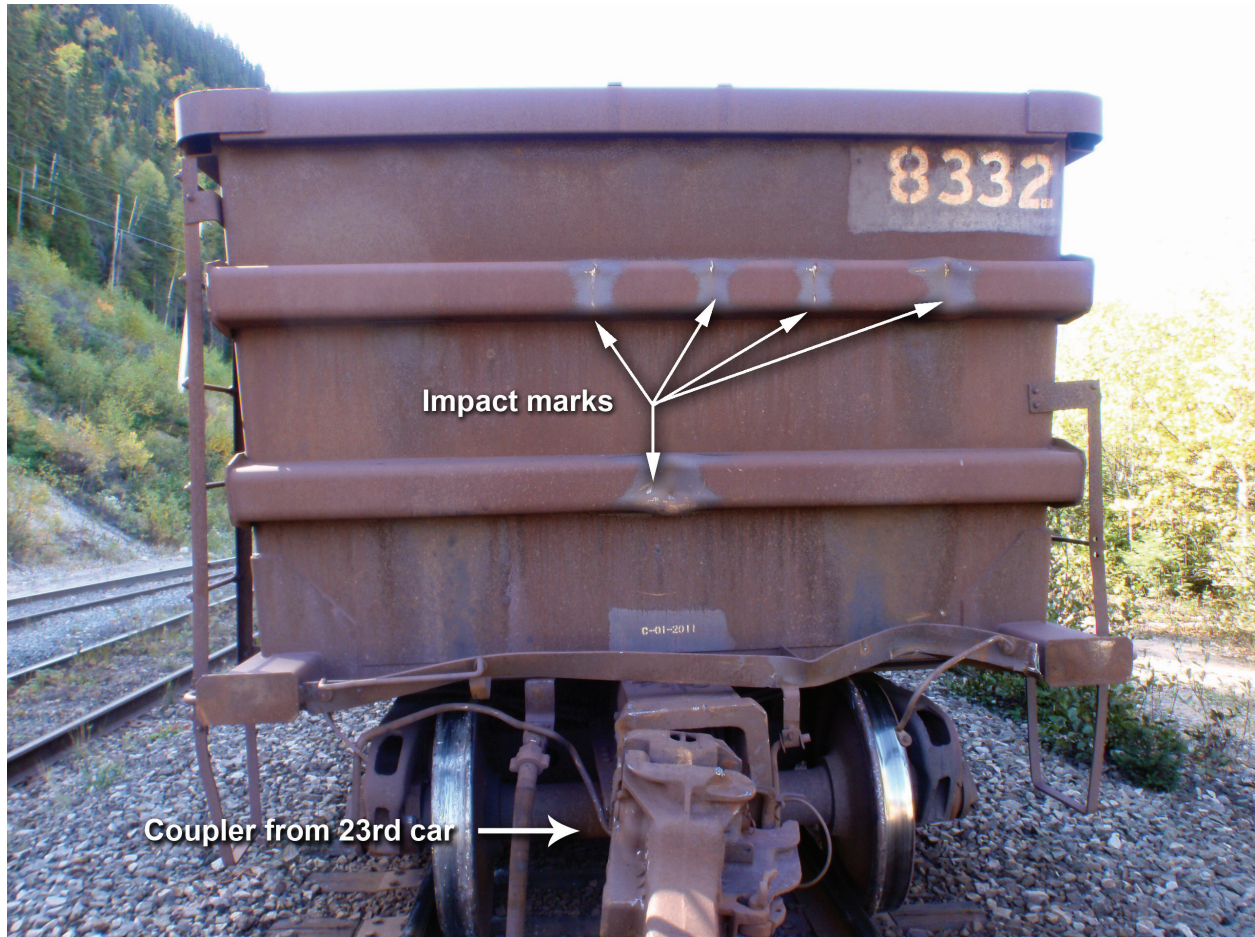
All derailed equipment was examined. The coupler on the 23rd car (IOCC 8295) detached and remained coupled to the 22nd car. The coupler pin and coupling lever were found between the rails at Mile 57.06 and Mile 56.40 respectively. There were impact marks at the ends of these 2 cars and on the west side of the trailing axle and frame of the 23rd car (photos 2 and 3).

Photo 2. North end (A end) of car IOCC 8332 (22nd car)

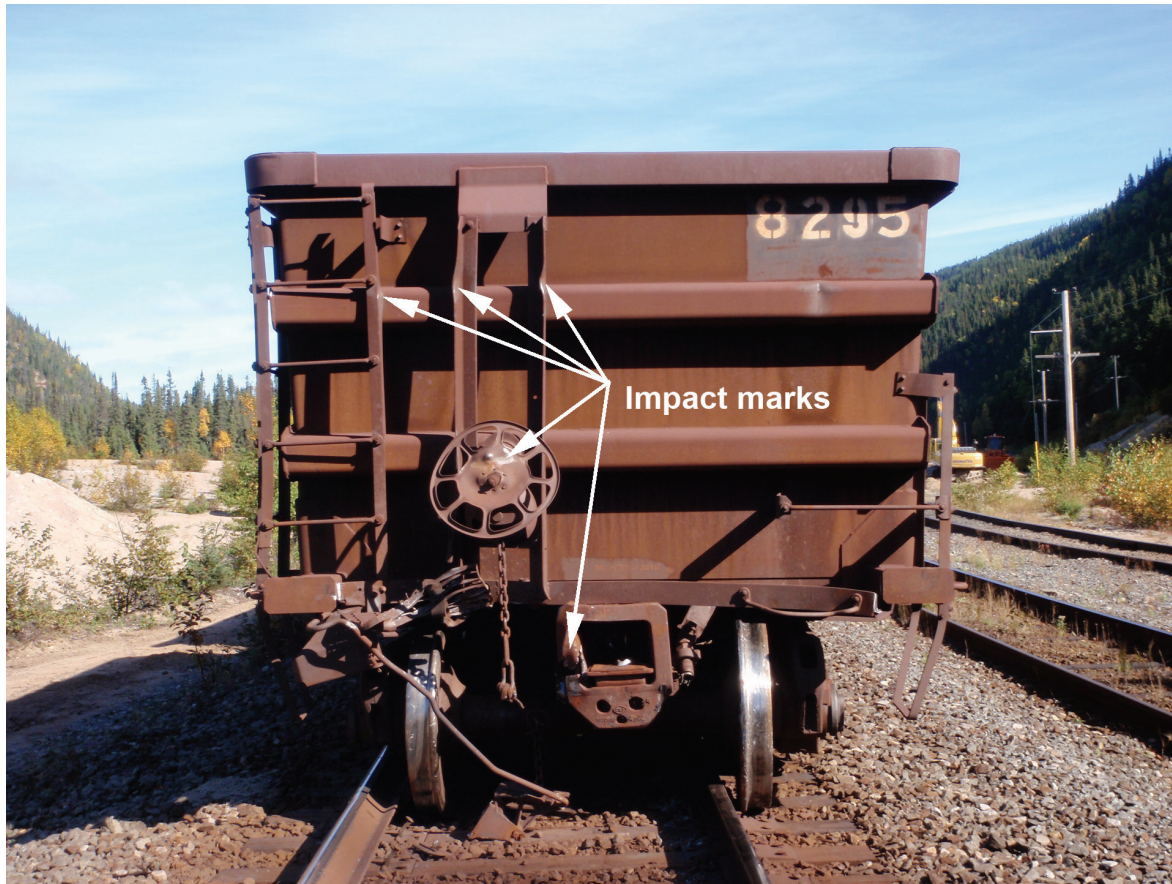
Photo 3. South end (B end) of car IOCC 8295 (23rd car)

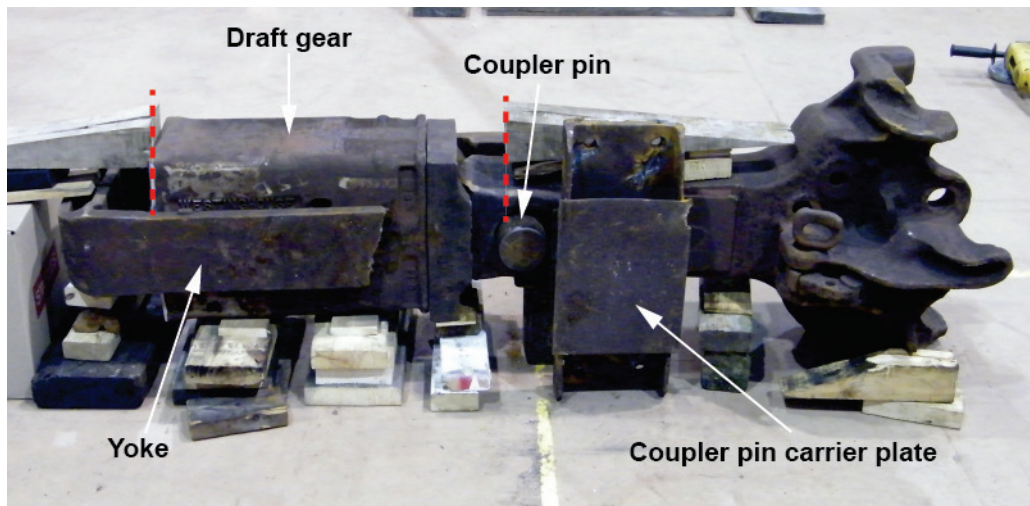
The coupling device at the B end of car IOCC 8295 had a type F coupler (code F70CE) attached to the yoke with a vertical coupler pin supported by a horizontal carrier plate (Photo 4). TSB Laboratory examination of the coupling device (report LP 135/2011) revealed wear on the contact surfaces of the components.

Photo 4. Overview of coupling device

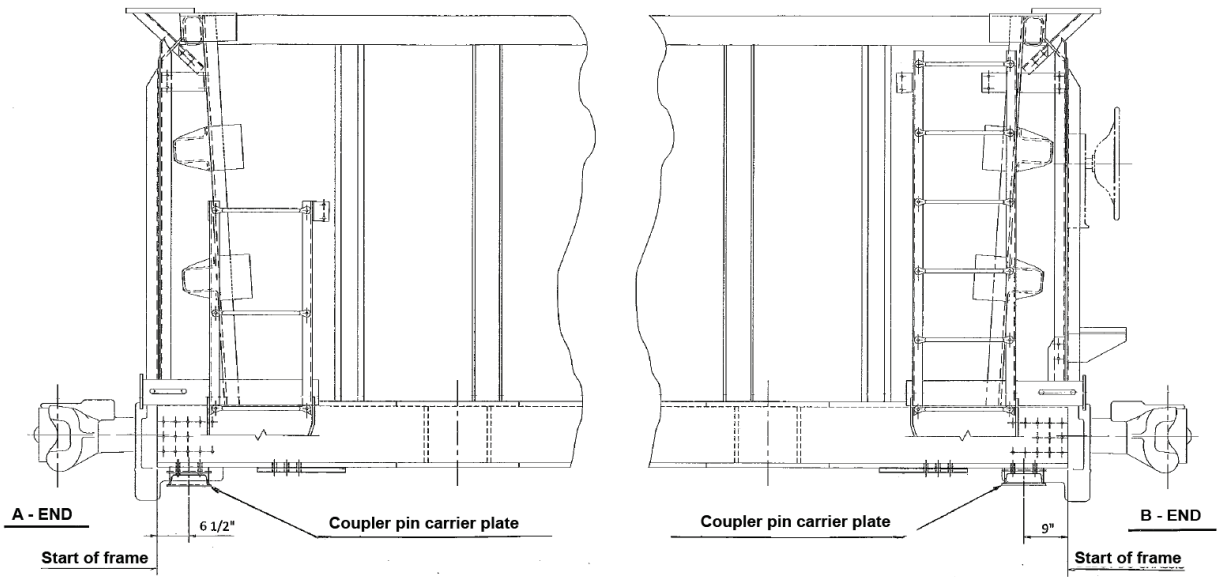
According to the new design, the coupler pins are positioned differently at either end of the cars because the coupler at the B end is a standard, fixed coupler whereas the one at the A end is a rotary coupler, which allows cars to be turned for unloading while they are still attached to the train. The coupler pin carrier plate at the B end ² must be placed 9 inches from the end of the car, and the one for the A end, 6 ½ inches (Figure 2) to compensate for the coupler movements.

Figure 2. Car diagram showing the positioning of the coupler pin carrier plates

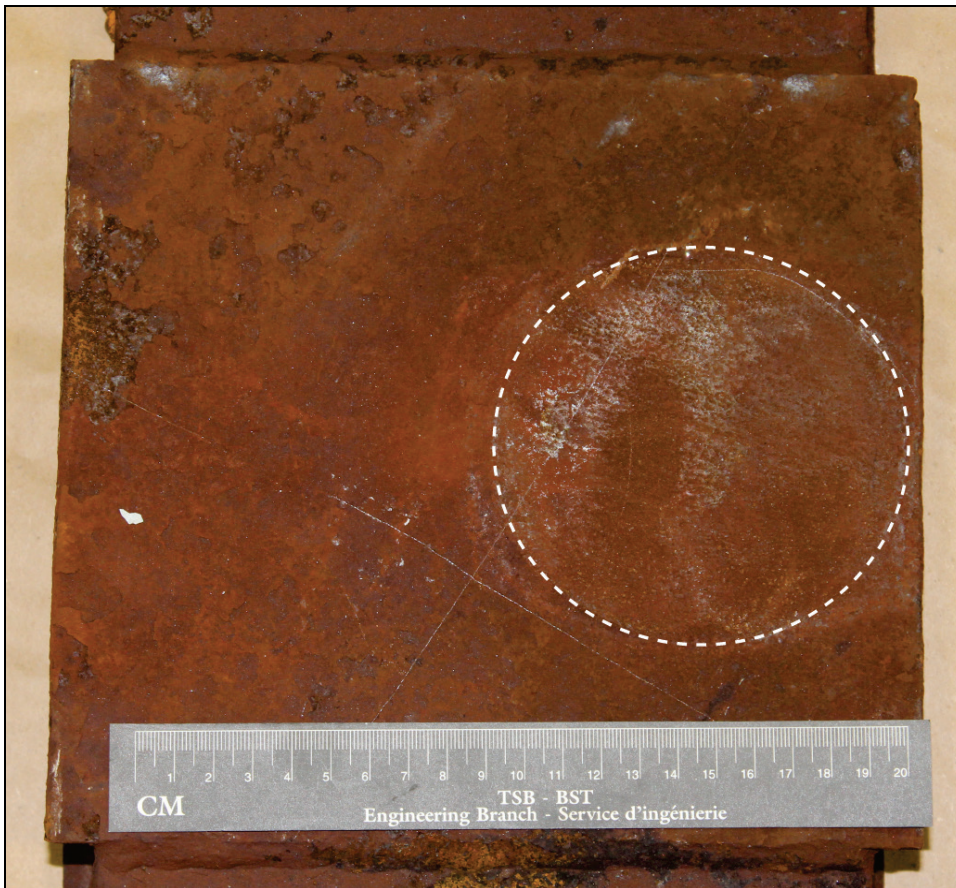
When car IOCC 8295 was examined, the carrier plates were not well positioned. The B end carrier plate had friction marks (Photo 5) horizontally off-centred by about 63.5 mm (2.5 inches) and was positioned 6 ½ inches from the end of the car while the coupler pin was at 9 inches. Conversely, at the A end, the plate was positioned 9 inches while the pin was at 6 ½ inches.

Photo 5. Coupler pin carrier plate showing eccentricity of wear marks

The coupler pin did not fall out immediately after the modified plates were installed because it was still partially supported when the coupler was in compression. However, because of the traction and compression generated in the train over time, wear accumulated on the various coupling device components and reached a combined level that was sufficient to allow the coupler pin to dislodge from the carrier plate when the device was in compression. When the train went into traction mode, the coupling device, which was no longer supported, detached and caused the train separation.

1. The train derailed after the 2 portions that had separated collided following the dislodging of the coupling device from the 23rd car.
2. Because the coupling pin carrier plate from the 23rd car was ill-positioned and wear had accumulated on the various components of the coupling device, the coupler pin fell, causing the train separation.
3. Despite the quality control conducted after the work and subsequent periodical inspections, the ill-positioned carrier plates were never identified because a stringent comparison with the drawings was not part of the inspection and quality-control procedures.

Transport Canada indicated that a special inspection was conducted by its Quebec Region inspectors and that it had been noted that 24 other cars had ill-positioned carrier plates. Further to that inspection, QNS&L implemented new car inspection and repair procedures that now include a verification of the carrier-plate positioning.
