**RAILWAY INVESTIGATION REPORT
R11T0034**

**DAMAGE TO ROLLING STOCK WITHOUT
DERAILMENT OR COLLISION
VIA RAIL INCORPORATED
PASSENGER TRAIN 70
MILE 21.40, OAKVILLE SUBDIVISION
OAKVILLE, ONTARIO
06 FEBRUARY 2011**

Report Number R11T0034

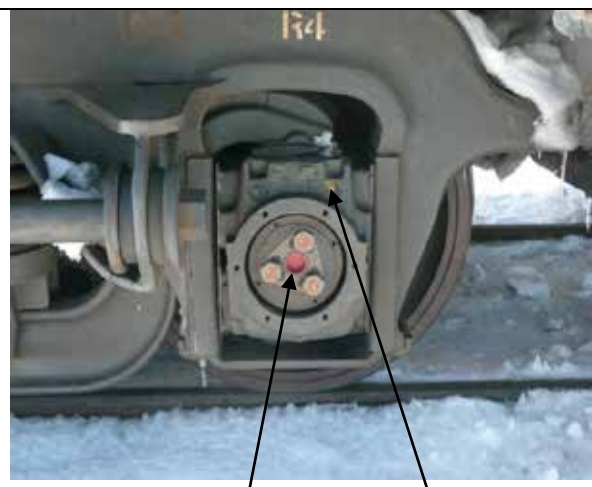
Photo 2. HEP arrangement

Note: plastic cap and stench bomb

HEP journal boxes are equipped with a heat-activated stench bomb that emits a slight odor and dye to aid with detection of overheated roller bearings during routine inspections. In addition, the truck side has long pedestal legs secured by a 4-inch wide pedestal tie strap at the bottom.

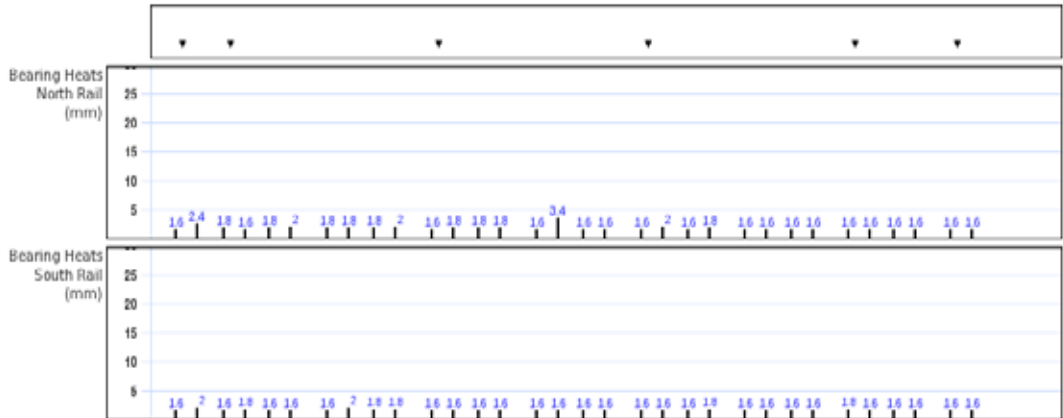
The R-4 position of VIA 4009 (Train 70) recorded a reading of 3.4 mm and the R-4 position of VIA 4000 (Train 60) recorded a reading of 4.0 mm just prior to stopping. While the readings were below established CN HBD warm alarm thresholds, they were at least twice as high as the average reading for the passenger trains. The HEP coach roller bearings were likely heating up and beginning to fail without triggering an HBD alarm.

Site: ASH2
 Fullname: Aldershot Track 2
 Subdivision: Oakville
 Mile: 33
 Territory: 3AC
 WIS type: DHP2000
 Circuit Number: LLL_325
 Branch or Main: main
 Backup Power:

Date: 2011-02-06
 Arrival Time: 09:30:18
 Speed In: 62 mph
 Direction: E
 Number of Cars: 6
 Number of Axles: 32
 North Rail Bearing Avg 1.8 mm
 South Rail Bearing Avg 1.7 mm
 North Rail Wheel Avg 20°F
 South Rail Wheel Avg 24°F
 Integrity Alarms
 No integrity alarms present

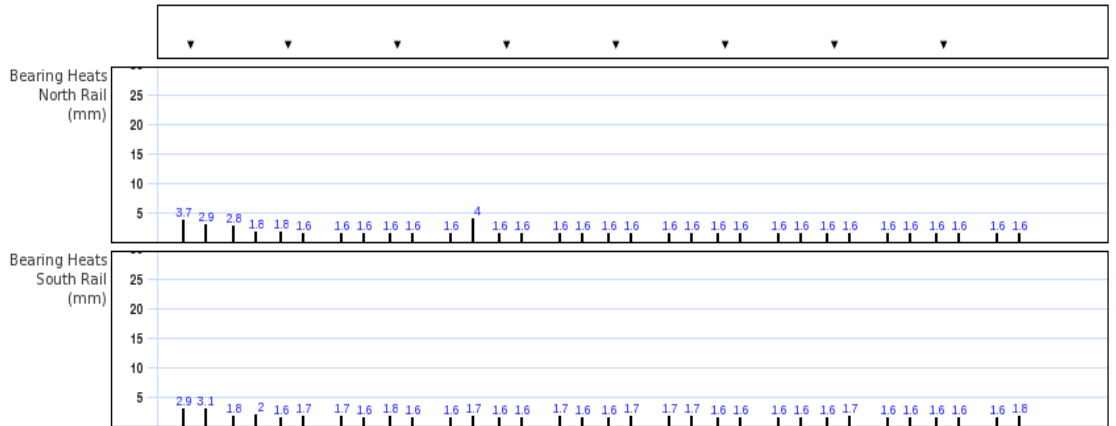
VIA Train 60 HBD Readings – Mile 4.8 Montreal Subdivision. – 12 February 2011

Site: HENS
 Fullname: St. Henri South
 Subdivision: Montreal
 Mile: 4.8
 Territory: 2AE
 WIS type: STC_Sentry
 Circuit Number: CSHBD0103
 Branch or Main: main
 Backup Power: Yes

Date: 2011-02-12
 Arrival Time: 17:20:58
 Speed In: 66 mph
 Direction: E
 Number of Cars: 8
 Number of Axles: 32
 North Rail Bearing Avg 1.8 mm
 South Rail Bearing Avg 1.7 mm
 North Rail Wheel Avg Unavailable
 South Rail Wheel Avg Unavailable
 Integrity Alarms
 No integrity alarms present
