**RAILWAY INVESTIGATION REPORT  
R11T0175**

**CROSSING COLLISION  
VIA RAIL CANADA INC.  
TRAIN NUMBER 71  
MILE 30.62, CHATHAM SUBDIVISION  
GLENCOE, ONTARIO  
29 JULY 2011**

Report Number R11T0175

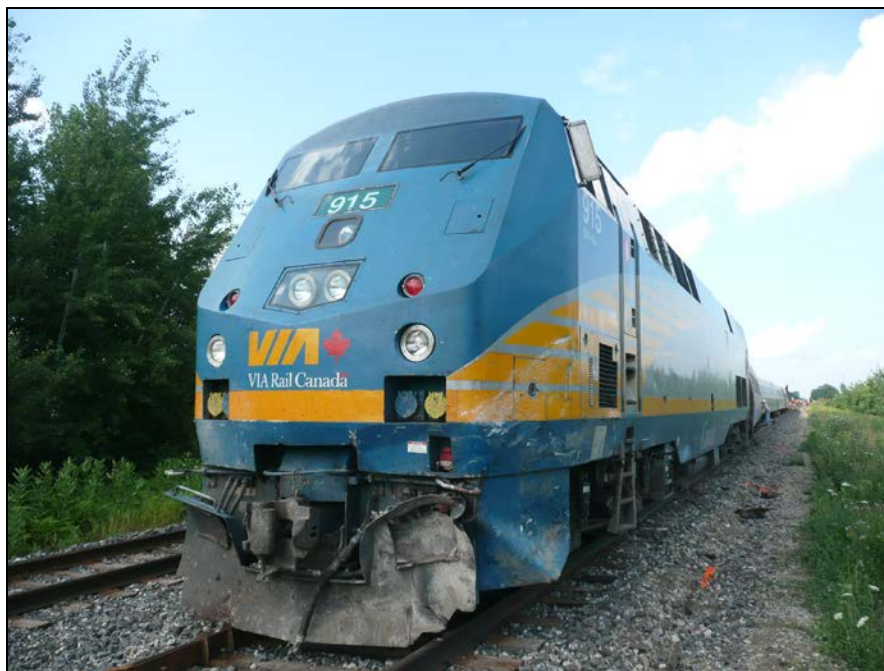
The locomotive and 4 coaches had derailed, but had remained upright, fouling the north main track. The locomotive came to rest about 1135 feet west of the crossing. The north wheels of the leading truck on the locomotive were resting on the web of the north rail. The south wheels were situated between the rails. The locomotive pilot was damaged on the left side, likely when debris from the vehicle lodged underneath (Photo 1).

**Photo 1.** VIA 71 locomotive with damaged pilot

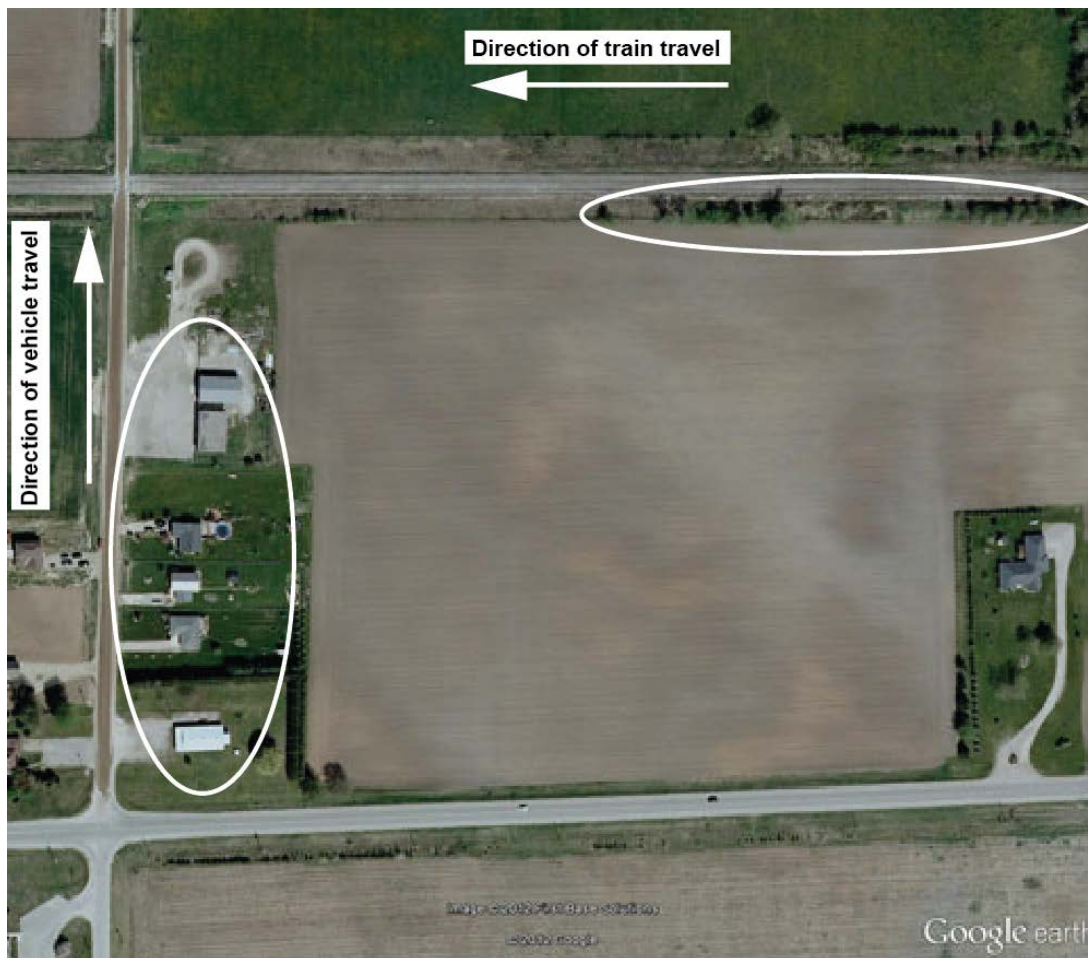
The SRCS and stop sign were visible from at least 1000 feet for both northbound and southbound vehicles. The track towards the east was concealed to northbound vehicles by buildings adjacent to the road and by vegetation along the track and in the fields (Photo 2). The sightlines at the stop sign of the south crossing approach were more than 2500 feet.

**Photo 2.** South east quadrant at Pratt Siding Road Crossing (Note: buildings along the road and vegetation along the tracks)

The stop sign was visible to northbound vehicles and the sightlines at the stop sign met the draft standards as detailed in RTD 10. However, the buildings located along the east side of Pratt Siding Road and the vegetation along the track and in the fields prevented the vehicle driver and the train crew from noticing each other well in advance of the crossing. The vehicle came into view of the train crew only after it passed the buildings. By that time, there were only a few seconds remaining before the train and the vehicle reached the crossing.

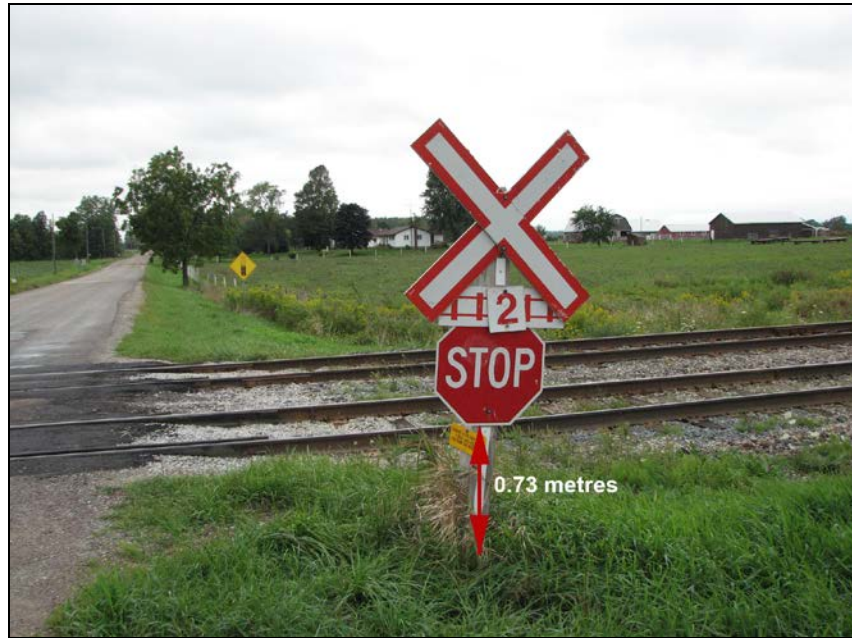
The lower edge of the stop sign was approximately 2.4 feet (0.73 m) from the ground. The sign post was slightly angled to the east. The sign indicating 2 tracks, which was situated under the SRCS, overlapped slightly onto the stop sign (Photo 3).

**Photo 2.** Signage at the South Approach (Pratt Siding Road Crossing)

The signage marking the Pratt Siding Road crossing was visible to the approaching drivers and properly informed them of the hazards present. However, some of the signs were not installed at the recommended height and were not well maintained as outlined in the proposed draft standards (Section 9 of RTD 10) and in the MUTCDC. Furthermore, there were no markings on the roadway to indicate where vehicles should stop. Such factors are known to adversely affect the level of compliance accorded to railway crossing signs by vehicle drivers, increasing the risk of a vehicle-train collision.

- CN submitted an application for funding under the Grade Crossing Improvement Program (GCIP) to upgrade the Pratt Siding Road crossing protection to flashing lights, bells and gates.

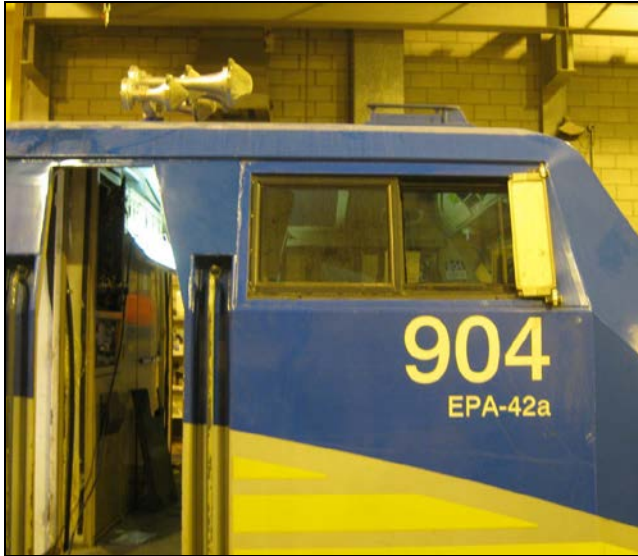
**Photo 3.** VIA locomotive 904 with retrofitted horn mounted near the head-end of the locomotive

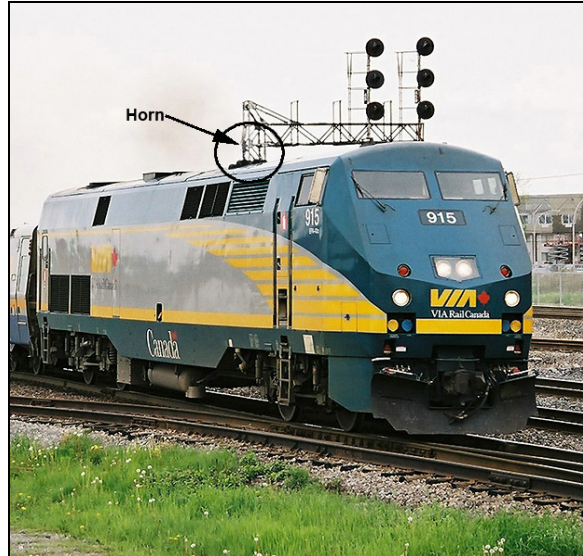
At the time of the occurrence, the locomotive on VIA 71 had not yet been retrofitted with the new, more powerful, 2-stage horn (Photo 4). Instead, the horn was positioned on the locomotive roof close to the mid-section of the locomotive (Photo 5).

**Photo 4.** VIA 71 locomotive with horn mounted midway along the locomotive roof

4. With the train travelling at approximately 80 mph and the horn placed near the mid-point of the locomotive, the forward sound pressure propagation of the horn and its resulting auditory warning was reduced.
