**RAILWAY INVESTIGATION REPORT
R12C0051**

MAIN-TRACK DERAILMENT AND COLLISION

**CANADIAN PACIFIC RAILWAY
FREIGHT TRAINS 200-19 AND 465-19
MILE 71.30, RED DEER SUBDIVISION
CAMPAIGN, ALBERTA
21 APRIL 2012**

Report Number R12C0051

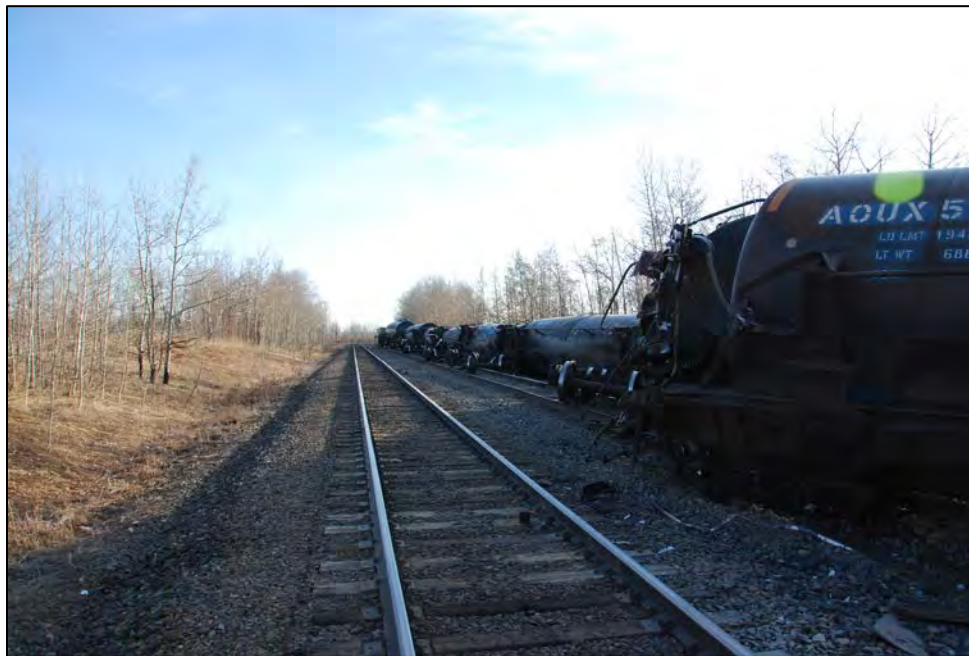
- The 3 locomotives and first 11 cars on train 200 had passed through the south siding switch.
- The 6th to the 11th cars were derailed on their sides to the east (see Photo 1). These cars had remained connected through their double shelf couplers ⁴ (see Photo 2).

Photo 1. Looking north, derailed cars on their sides

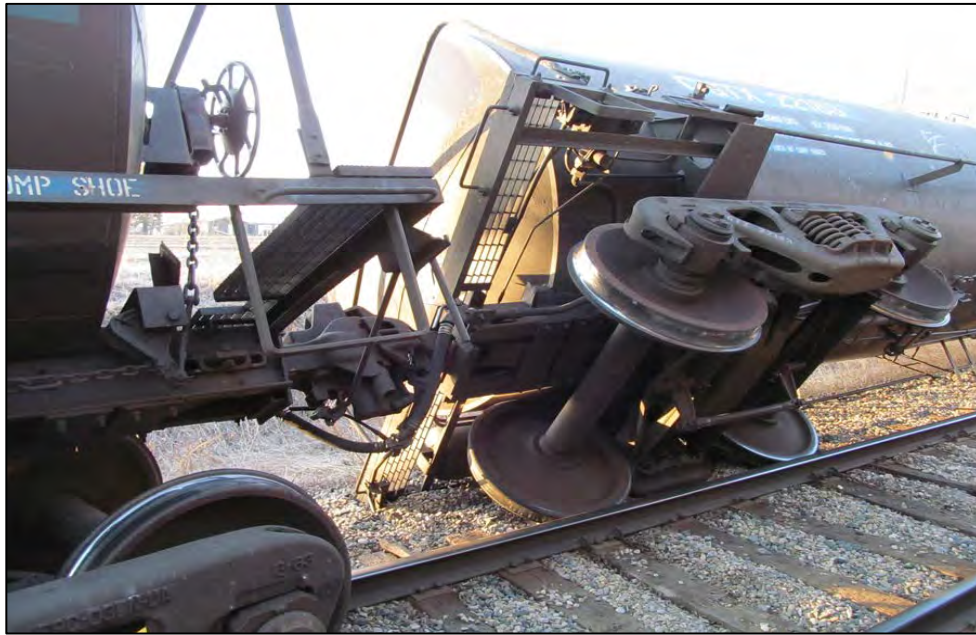
Photo 2. Double shelf couplers

Double shelf couplers are designed to prevent unintended detachment of coupled cars. They are used primarily on tank cars to reduce the likelihood of disconnected couplers puncturing tank heads in the aftermath of a derailment. In this occurrence, 6 empty tank cars, the 6th through 11th, were dragged off the rails by the derailed 12th car due to their double shelf couplers.

1. Six empty tank cars, the 6th through the 11th, were dragged off the rails by the derailed 12th car due to their double shelf couplers.

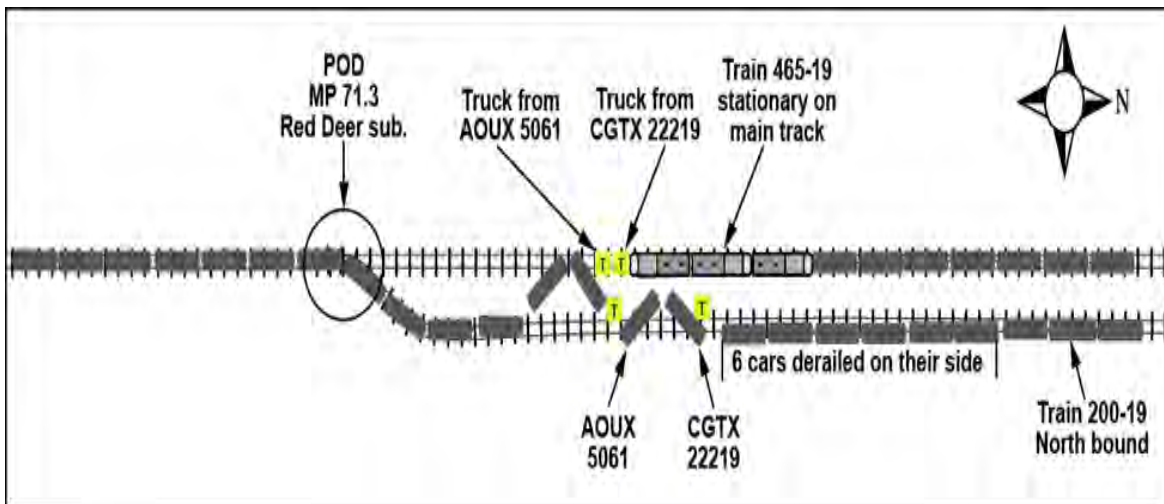
- The leading truck of the 12th car, CGTX 22219, had separated and came to rest beside the tank car. The trailing truck of this car had travelled down the main track and came to rest after striking the lead locomotive on train 465 (see Figure 2).

Figure 2. Derailment sketch (Note: "T" denotes "truck")

- The leading truck of the 13th car, AOUX 5061, had separated and came to rest beside the leading truck of the 12th car. The trailing truck of AOUX 5061 had separated, but continued along the siding and came to rest beside the tank car.
- The 12th and 13th cars came to rest in a jackknifed position on the siding track.
- The 14th and 15th cars came to rest in a jackknifed position.

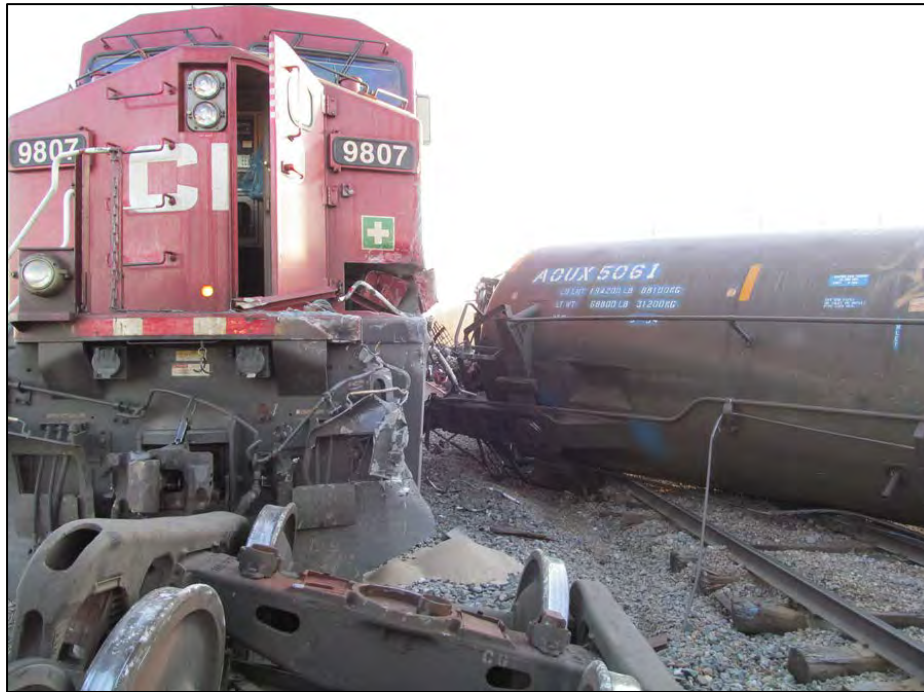
- There was minor damage on the front of the lead locomotive of train 465 (see Photo 3).

Photo 3. Damaged stationary locomotive and jackknifed AOUX 5061

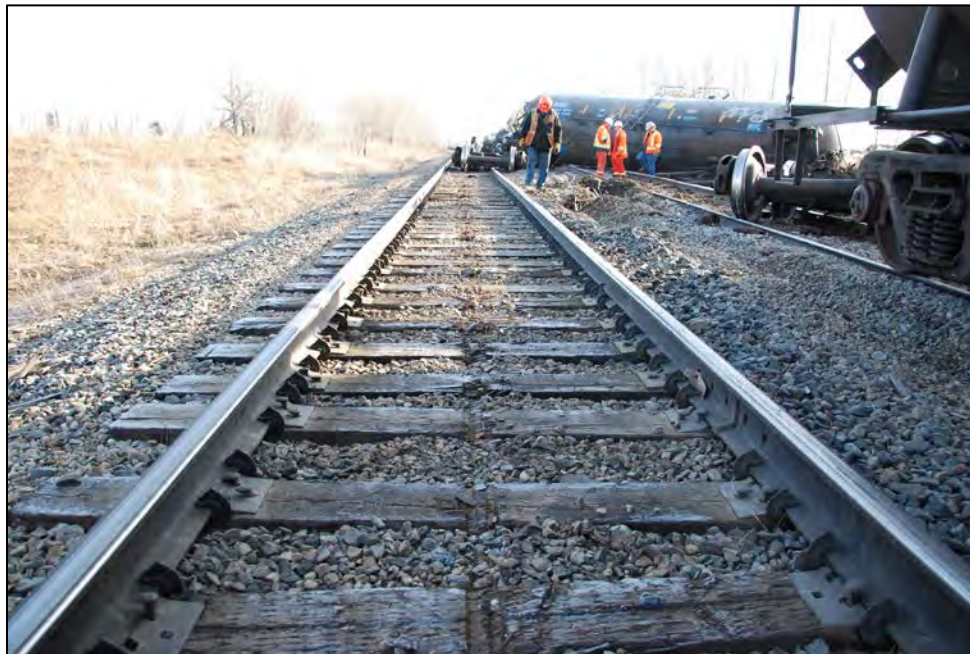
- Wheel marks were present on main-track ties, starting immediately north of the south siding switch (see Photo 4).

Photo 4. Looking north, wheel marks on main-track ties north of the switch

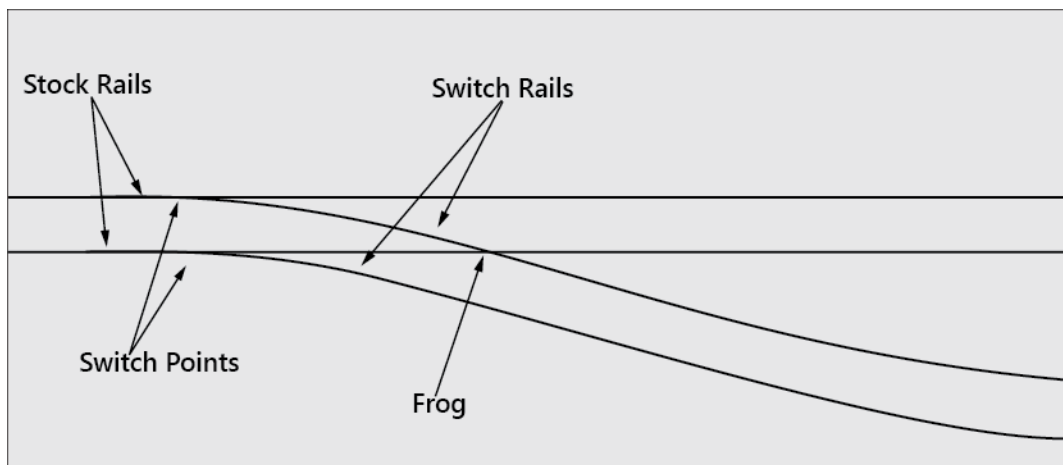
- There was no damage to the switch points (see Figure 3 for schematic of switch and turnout components). However, the No. 3 rod was bent. There were wheel climb marks on the west face of the west switch point. Contact marks and shavings were present on the south face of the west switch heel block.
- There were 3 wheel marks at the west heel block that crossed over the point to the gauge side but did not continue to the ground. A 4th wheel mark travelled approximately 7 feet before dropping between the east point and stock rail.
- Approximately 31 feet north of the switch point, wheel drop marks were observed to the field side of the curve closure rail and between the east point and stock rail.
- There were also wheel drop marks to the gauge side of the main-line rail and to the field side of the curve closure rail approximately 82 feet and 87 feet further northward respectively.

Figure 3. Turnout with relevant components

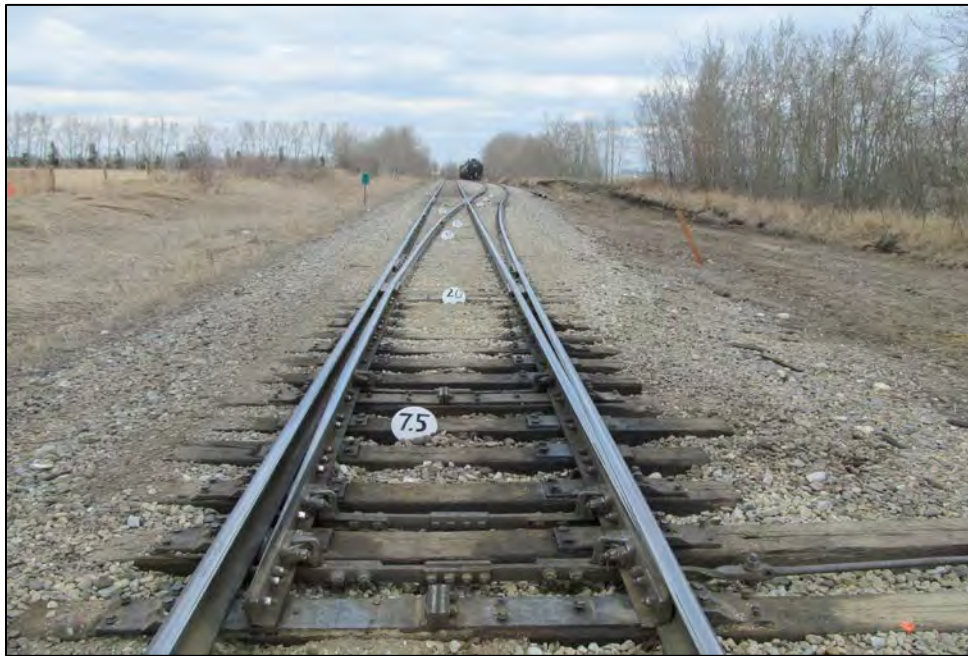
The switch was a No. 13, 115-pound turnout with a high mast. It had 22-foot switch points, bolted guard rails (8 feet 3 inches in length) and adjustable braces. The frog⁵ had been replaced on 02 April 2012 and had not received any welding or repairs since its installation. The turnout included a 4.3° right-hand curve reversing to a left-hand curve onto the siding. The siding track at Campaign was situated slightly lower than the adjacent main track. The transition from the main track to the lower siding track occurs in the vicinity of the turnout (see Photo 5).

Photo 5. Looking north, south siding turnout at Campaign

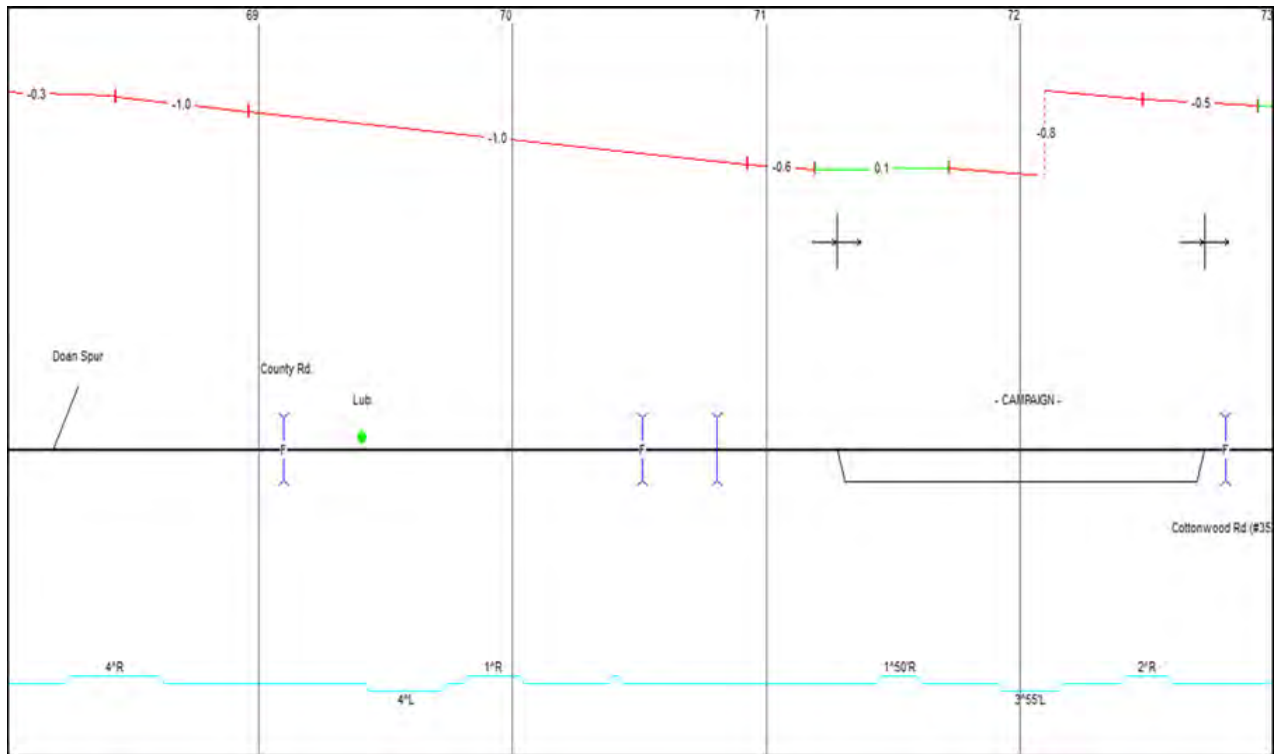
The track leading up to the south siding switch at Campaign is on a long descending grade (see Figure 4). The steepest portion of the grade (that is, approximately 1.0%) occurs between Mile 68.43 and Mile 70.93. The south siding switch is located on tangent track at Mile 71.3, just north of the steepest part of the grade. In the vicinity of the switch, the grade changes from 0.6% (descending) to 0.1% (ascending) and then to 0.8% (descending).

Figure 4. Track profile of Red Deer Subdivision, Mile 68 to Mile 73 (source: CPR track profile)

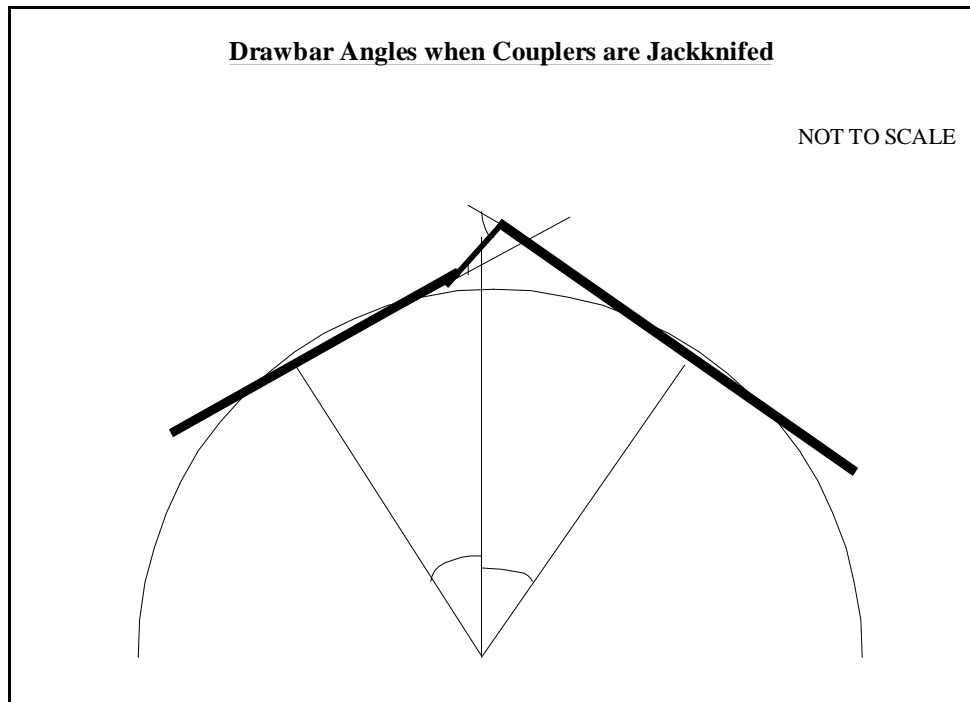
- The west wheels of the trailing truck of the 12th car, CGTX 22219, and the leading truck of the 13th car, AOUX 5061, climbed over the west point rail of the south switch at the Campaign Siding and started the accident.
- The wheel climb over the west point rail was likely caused by a combination of factors, including in-train buff force, jackknifing position of the cars and couplers (see Figure 6), track geometry conditions, car conditions, point rail profile and coupler height difference. Each of these factors alone would not have led to the derailment.

Figure 6. Drawbar angles when cars are in a jackknife position

- A medium longitudinal in-train force (that is, approximately 95 kips) was produced while the head end of the train transitioned from the descending grade to the slight ascending grade in the vicinity of the south siding switch.
- Although non-condemnable, low and different coupler heights between the first derailed cars may have created a vertical loading/unloading effect in transmitting the longitudinal force.
- The jackknifing position of the first 2 derailed tank cars (that is, CGTX 22219 and AOUX 5061) transformed the in-train buff force laterally, resulting in a higher L/V ratio.

With the train navigating the turnout, the cars were in the jackknifing position, which transformed the in-train buff force laterally against the rail, resulting in a higher L/V ratio. The track geometry irregularities in the vicinity of the turnout and the mechanical condition of the 12th and 13th cars (that is, side bearing clearance and dry centre plate conditions) also contributed to the higher L/V ratio.
