**RAILWAY INVESTIGATION REPORT
R12E0008**

MAIN-TRACK DERAILMENT

**CANADIAN NATIONAL RAILWAY
FREIGHT TRAIN M30141-20
MILE 149.21, WAINWRIGHT SUBDIVISION
FABYAN, ALBERTA
21 JANUARY 2012**

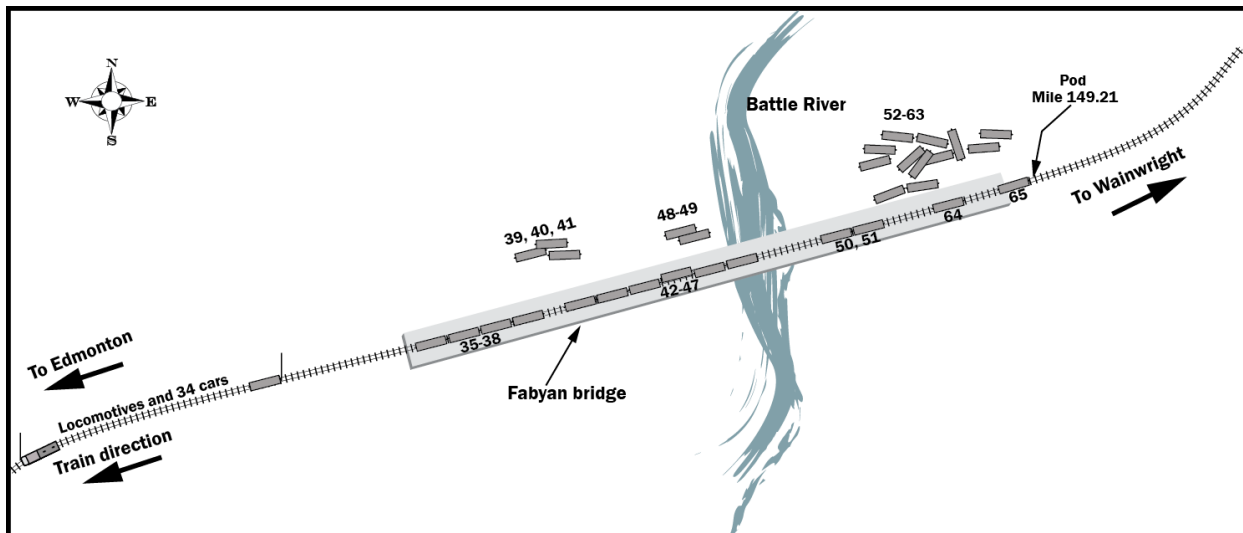
Of the 31 derailed cars, 13 remained on the bridge (Figure 2). The first 4 derailed cars on the bridge were the 35th to the 38th cars:

Figure 2. Derailment site

All other derailed cars that remained on the bridge derailed in the same manner as the 37th and 38th cars. Table 1 provides a summary of the location of the derailed cars.

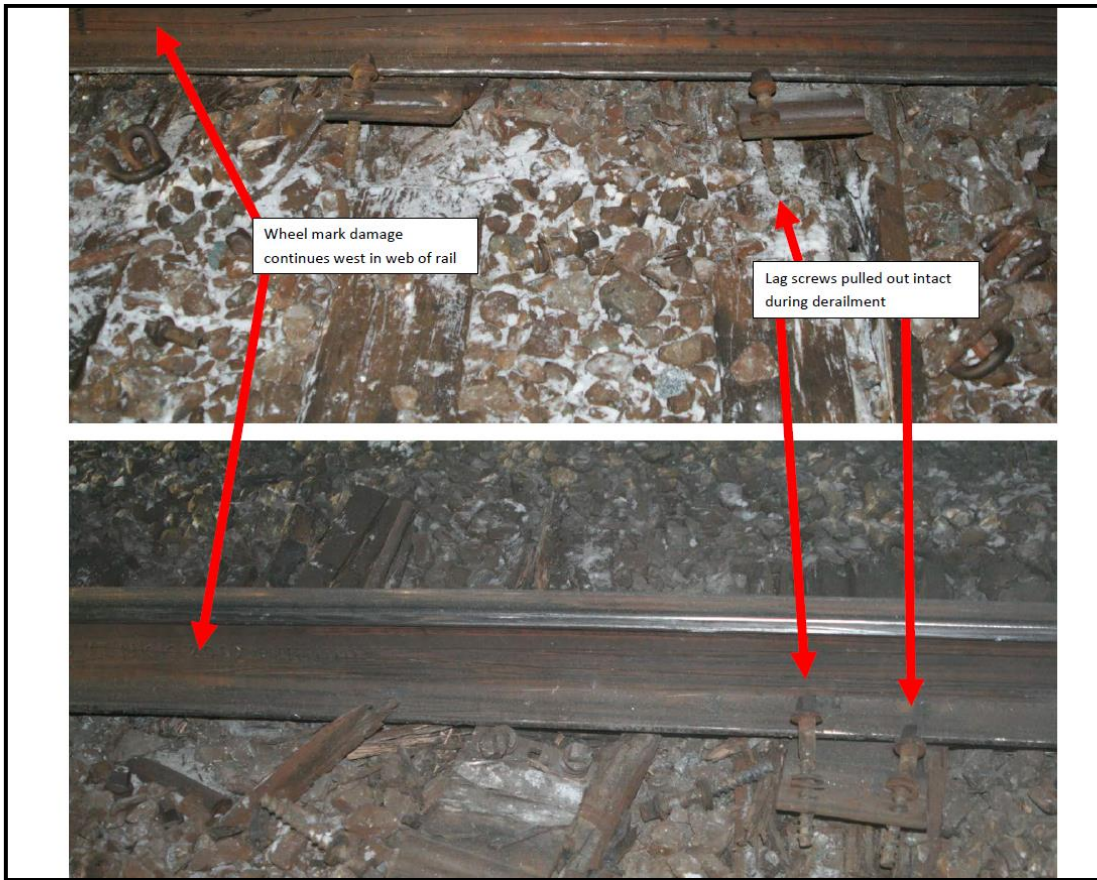
- Lag screw fasteners had been pulled out of a number of ties on the high rail (Photo 1).
- The high rail had rolled over at this location.
- Wheel marks observed on the flange and web of the high rail indicate that the point of derailment (POD) was approximately 67 feet east of the east bridge abutment (Photo 1).
- Plate-cut ties ⁴ were observed, along with many missing and broken screws, as well as bent and broken plates.
- Some clips were missing, and not all fastener holes appeared to be filled where the rail was not rolled.
- Many “missing” lag screws had broken off in the ties.
- There were some cracked and broken tie plates.

Photo 1. Track damage on high rail

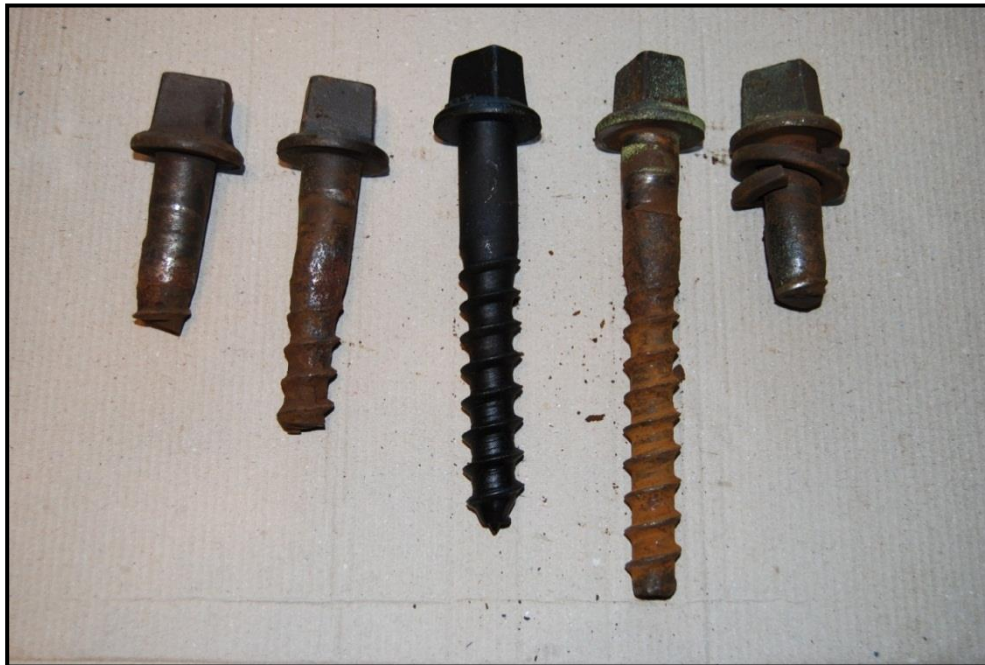
Seventy-four broken and damaged lag screws were collected and sent to the TSB Laboratory for analysis (Photo 2).

Photo 2. Broken 8.5-inch lag screws, new 7.5-inch lag screw (middle) and old 8.5-inch lag screw (2nd from right)

The 74 failed lag screws submitted for examination were produced from 4 different batches and supplied by 3 different manufacturers. The presence of several batches and manufacturers was due to the ongoing replacement of broken screws with newer stocks. The laboratory analysis determined that:

- The strength of the lag screw steel met specifications in effect at the time of manufacture.
- The fatigue cracks in the lag screw started in the upper portion of the threaded shanks.
- There were multiple fatigue origins, suggesting that fatigue initiation was caused by a general stress condition rather than any material defect.
- The age of fatigue cracks in different screws varied from many years to shortly before the occurrence.

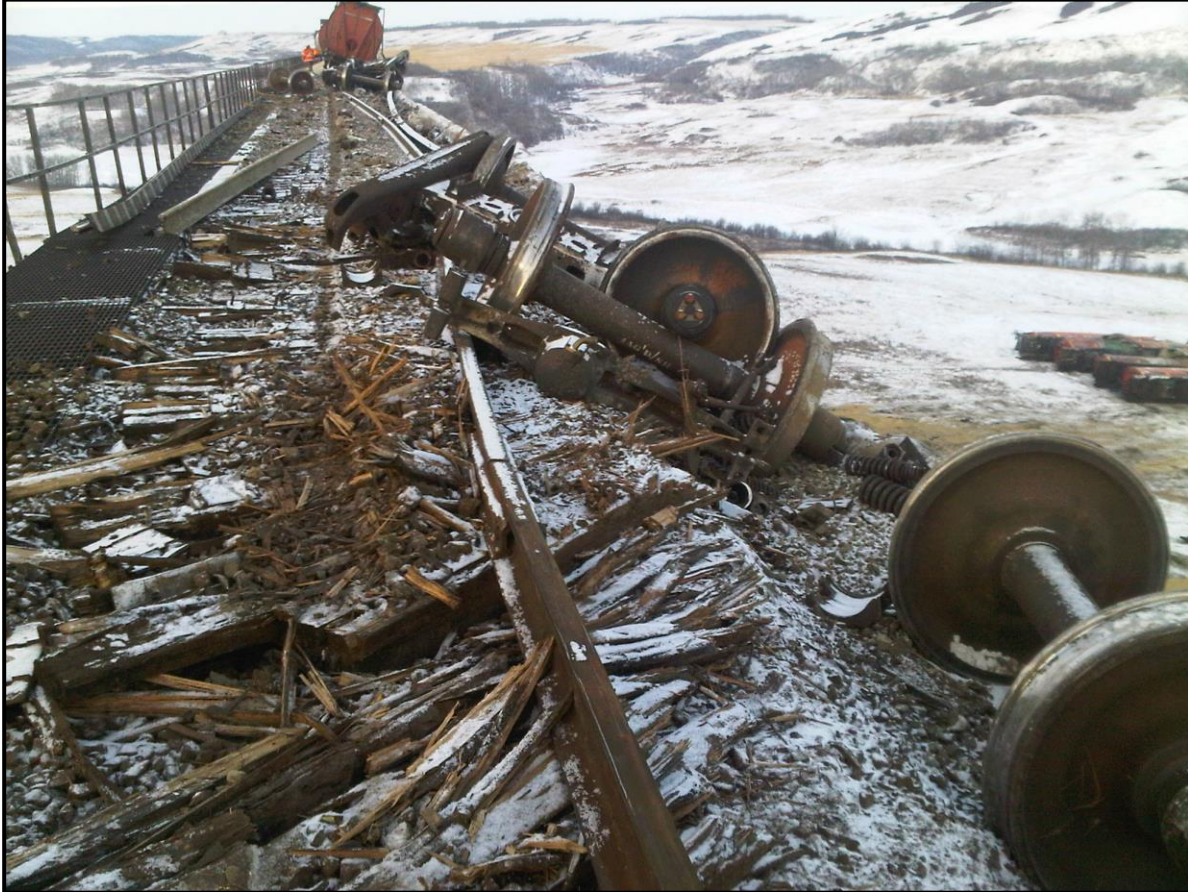
Approximately 1760 feet of track was destroyed during the accident (Photo 3). There was also damage to various components of the bridge, which included the north top section of the east wing wall that detached and fell to the ground; walkway gratings; north side concrete curbs between spans 2 and 31; north tower legs and bracing of bents 1, 2, 5, 15 and 16; bent stiffeners on the north girders of spans 5, 6 and 8; and various other structural members.

Photo 3. East end of bridge

Track restoration required the installation of 45 new track panels. Bridge repairs took longer than the track restoration work. During the repairs, rail traffic was rerouted over CN's Prairie North Line. The track was reopened on 26 January 2012, 5 days after the occurrence.

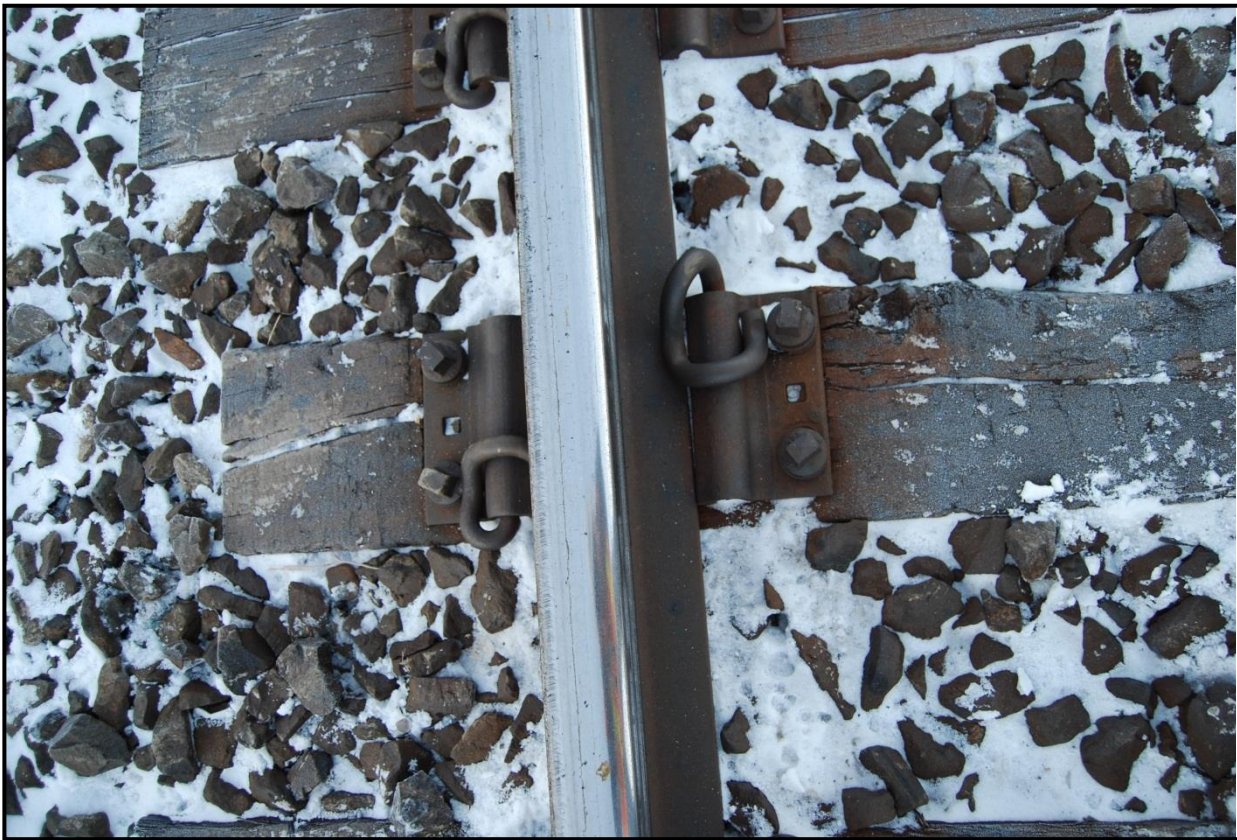
The derailment occurred at Mile 149.2, which is located in a 4° right-hand curve at the east approach to Fabyan Bridge. The curve had an average of 3.6 inches of superelevation, which was balanced for the 40 mph posted track speed. The rail through the curve was 2002 NKK 136-pound fully head-hardened (FHH) continuous welded rail (CWR). Within the curve, the rail was secured onto 16-inch rolled tie plates with elastic fasteners. The tie plates were attached to hardwood ties with 4 screws per plate (Photo 4). The rail was box-anchored every tie. The

Photo 4. Rolled plate fastener system

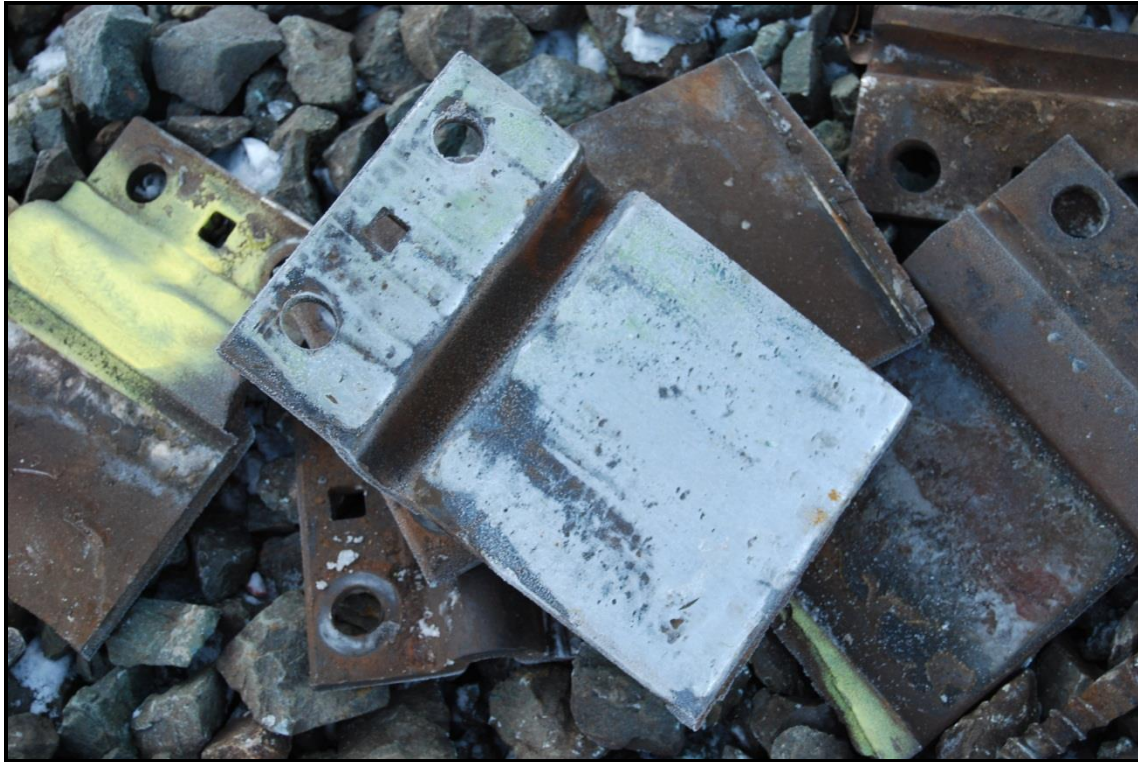
If the screws are tight on the rolled plates, the clamping force produces friction between the plate and the tie, providing lateral resistance to gauge-widening forces in the curve. If the screws are loose, they act as pins, providing the sole lateral resistance. When this happens, the flat bottom rolled plates move under load and can break (Photo 8). Failure of the screws is usually due to a combination of shear and bending, as all screws do not receive even loading.

Photo 8. Shiny bottom of broken rolled plate

In this occurrence, a number of lag screws in the vicinity of the POD broke off in the tie. The breaks, which occurred over a considerable period of time, were due to fatigue at the transition point between the shank and the threads, where the cross-sectional area is reduced. Even with broken lag screws, there was little indication that the curve was under stress, as track gauge was maintained by the lag screws that did not break. The remaining intact lag screws experienced much higher lateral curving forces. The derailment occurred when the remaining screw fasteners were insufficient to resist the lateral curving forces; the high rail then rolled under the train, resulting in wheels falling into gauge at the east end of Fabyan Bridge.
