RAILWAY INVESTIGATION REPORT R13Q0001

COLLISION AND DERAILMENT QUEBEC NORTH SHORE AND LABRADOR RAILWAY FREIGHT TRAIN FCN-05 AND IRON ORE TRAIN BNL-005 AT MILE 124.2, WACOUNA SUBDIVISION, NEAR MAI, QUEBEC 11 JANUARY 2013

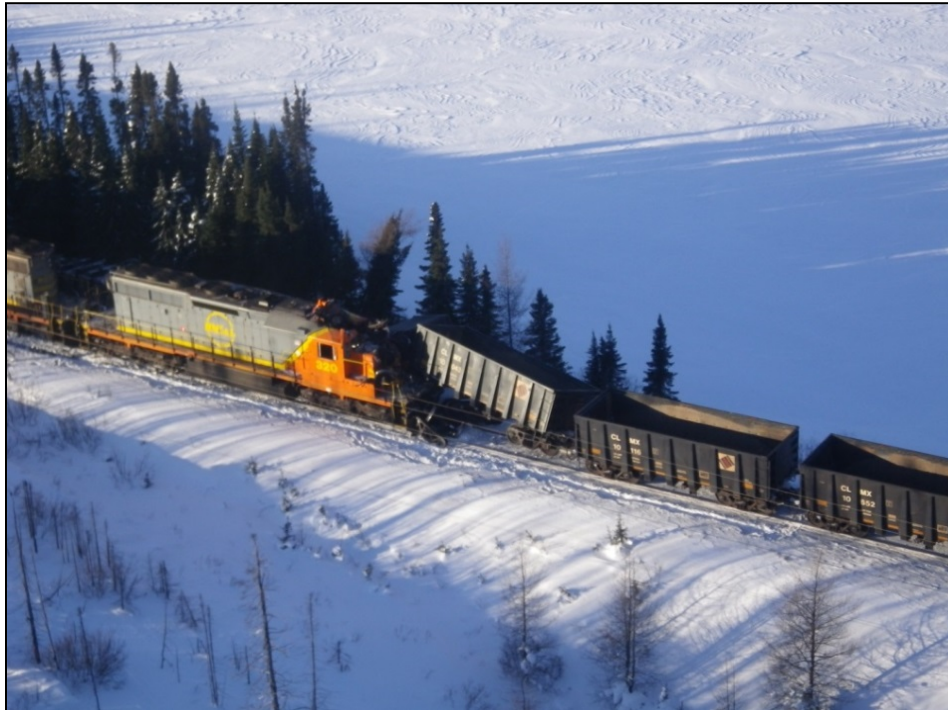
Photo 1. Train FCN-05 in collision with the tail end of train BNL-005 (source: QNS&L)

The crew members of train FCN-05 sustained minor injuries. Just prior to the collision, the engineer instructor got up from his seat and moved next to the engineer trainee. The engineer instructor braced himself behind the engineer trainee's seat, while the latter bent forward in his seat awaiting the impending collision. The cabin of the lead locomotive on train FCN (locomotive 320) was destroyed by the impact. The second locomotive on train FCN (locomotive 318) and 8 cars from train BNL derailed and sustained varying degrees of damage. Approximately 40 feet of track was damaged.

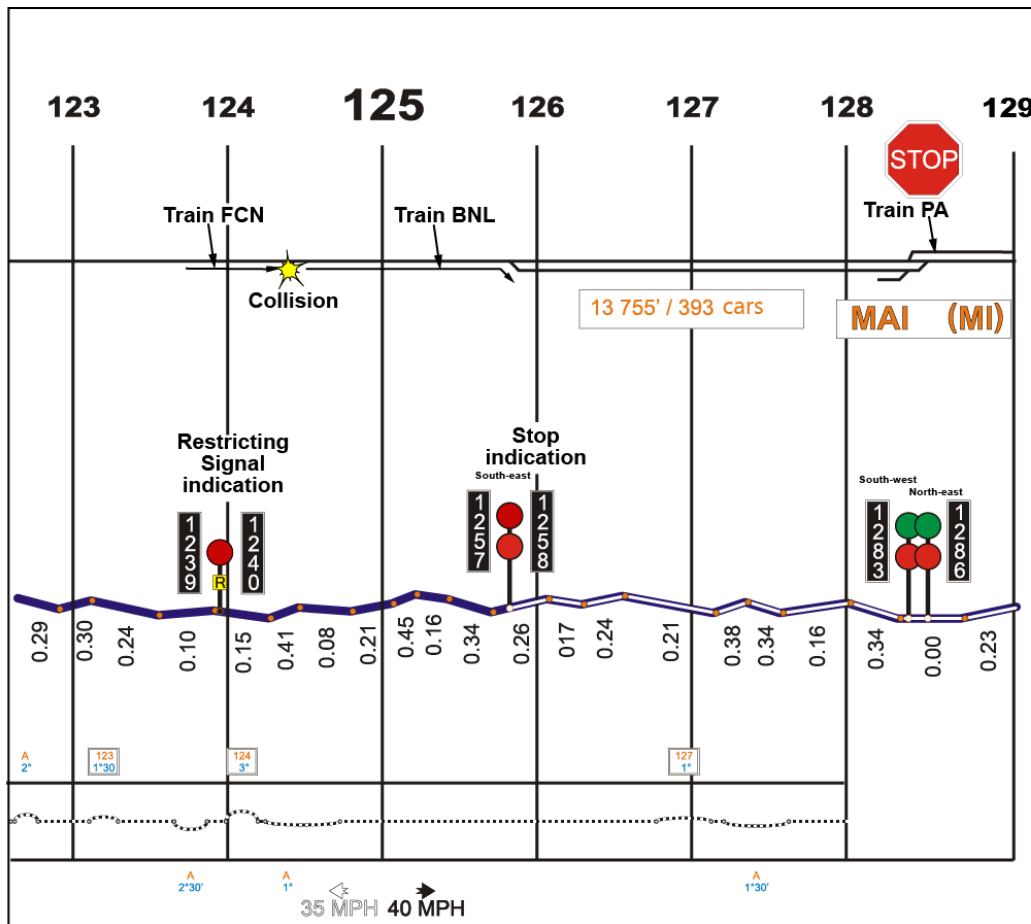
The first locomotive on train FCN came to rest at Mile 124.2, at the exit of a 3° left-hand curve. This curve, located right after signal 1239, is preceded by a 2°30' right-hand curve. The cabin on this locomotive was destroyed. Two truck side frames from derailed cars on train BNL were projected into the cabin. The rear truck on the second locomotive of train FCN derailed.

Figure 2. Track profile, signal layout and trains in the vicinity of Mai

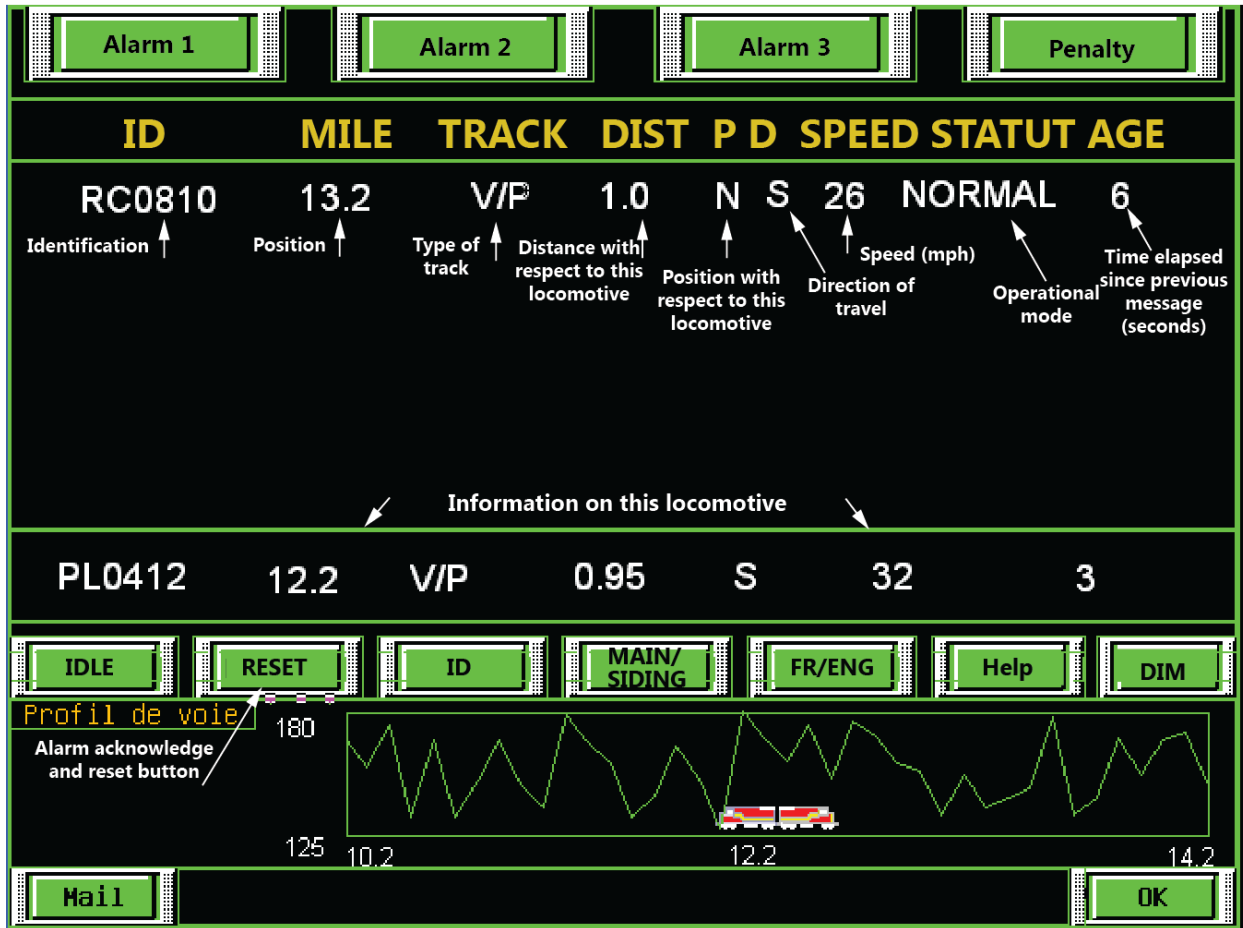
Figure 3. Standard screen for a proximity detection device (source: QNS&L)

The PDD displays the distance between rail vehicles along with the other positions received. This distance calculation does not take into account the length of a train and only provides the distance between vehicles that have an onboard PDD. The distance must be interpreted by the engineer. When the separation between locomotives is less than 8, 5 or 3 miles, a visual warning indicating the alarm level (1, 2 or 3) is displayed on the screen and an audible warning is sounded (identical for all 3 alarm levels). To acknowledge receipt of type 1 and 2 alarms, the engineer must press the button on the crew alertness device located near the PDD screen or click on the "REARMER" button on the PDD screen itself. For type 3 alarms, the engineer must first press the button on the crew alertness device within 10 seconds of the alarm, and then click on the "REARMER" button in the next 5 seconds. If an engineer fails to acknowledge receipt of a type 2 or 3 alarm within 10 seconds, the system triggers automatic braking of the rail vehicle.

The audible warnings sounded by the PDD force the operator to refocus his visual concentration on the screen. The operator acknowledges each alarm by clicking on the "REARMER" button located at the bottom left of the screen. However, this does not prompt the operator to take note of such critical parameters such as separation distance, and the speed and location of the nearest rail vehicle. A visual warning signal associated to these parameters would draw the operator's attention to this critical information. Moreover, the distance given for a train preceding another train in the same direction indicates the distance between the 2 locomotives and not the actual separation distance between the 2 trains. The operator must extrapolate the distance from the identification code of the trains to determine the actual distance. Therefore, when the type 3 alarm sounded, the actual separation between the 2 trains was approximately 1 mile whereas the screen indicated 3 miles. Given that the PDD screen does not show the actual separation distance between 2 trains moving in the same direction, the operator did not fully realize that a collision was imminent.

5. Given that the proximity detection device (PDD) screen does not show the actual separation distance between 2 trains moving in the same direction, the operator did not fully realize that a collision was imminent.
