**RAILWAY INVESTIGATION REPORT
R13T0060**

MAIN-TRACK TRAIN DERAILMENT

**CANADIAN PACIFIC RAILWAY
FREIGHT TRAIN 420-02
MILE 9.41 HERON BAY SUBDIVISION
WHITE RIVER, ONTARIO
03 APRIL 2013**

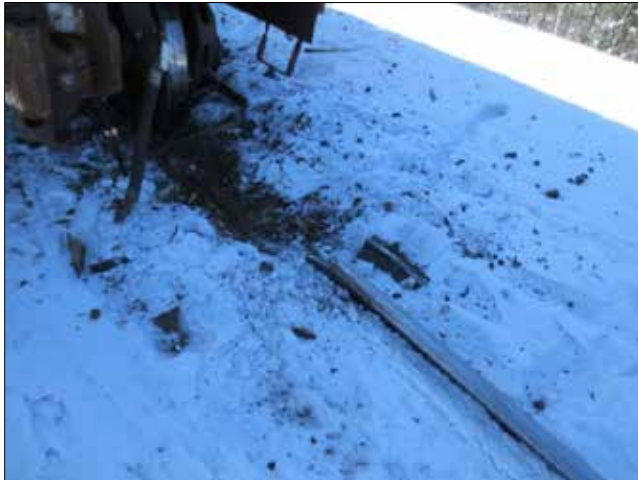
On 04 April 2013, the initial TSB site examination commenced. Minor rail damage was observed on the head of the south rail at about Mile 12.4. The damage continued intermittently, primarily on curves on the south rail up to the derailment area, where a broken rail was observed in the low rail of a 3°, 33-minute, left-hand curve at Mile 9.41 (Photo 1). Several large pieces of a wheel rim were located near the broken rail.

Photo 1. Broken south rail at Mile 9.41 (looking east)

- Rail wear was within the allowable limits.
- The fractures on the south rail were the result of instantaneous overstress, with no indication of progressive cracking.
- There was no indication of previous rail defects.

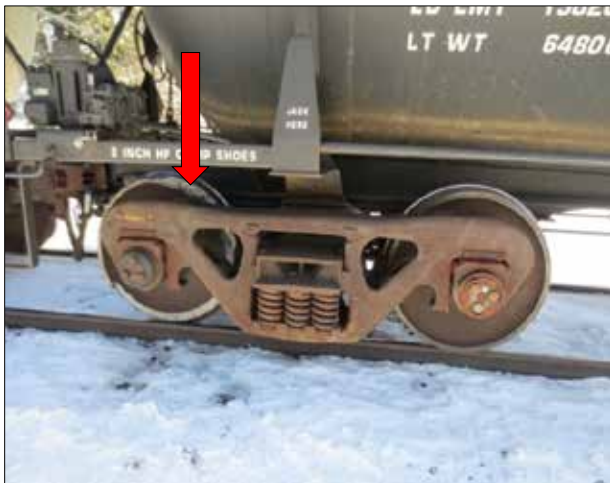
Subsequent examination identified that DG tank car DBUX 302383 (loaded with petroleum crude oil, UN 1267), the 34th car from the head end, sustained a broken R1 wheel (south rail) of the trailing truck. A non-condemnable slid flat was observed on the mate (L1) wheel tread in line with a suspected fracture origin on the R1 wheel. The car was upright, had not derailed, and was located east of the derailment site (Photo 2).

Photo 2. Broken R1 wheel (source: CP Police)

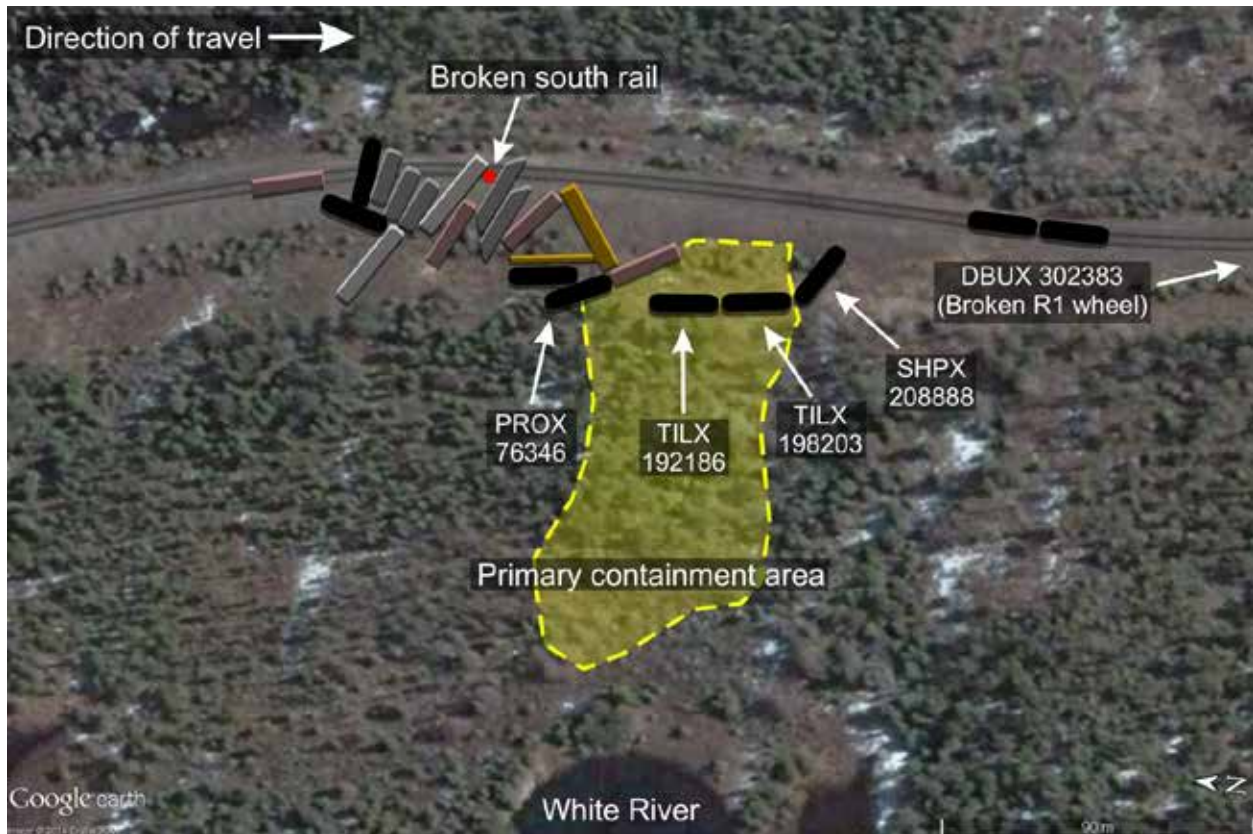
The 35th car did not derail; however, the following 22 cars (lines 36–57) derailed primarily to the low (south) side of the curve. A number of the cars slid down a 90-foot embankment and came to rest in various positions (Figure 2).

Figure 2. Diagram of the derailment site

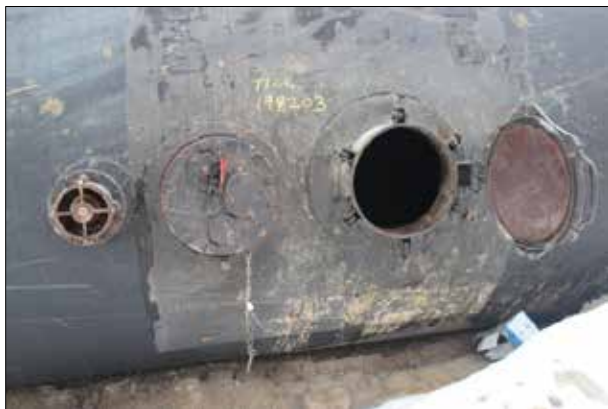
The top of car TILX 198203 sustained impact damage that had deformed and stretched one of the hinged manway hold-down bolts (eyebolts). This damage resulted in small leaks from the manway, which stopped when the hold-downs were tightened by emergency responders. The protective housing was torn off, and a small amount of product leaked from the 1-inch air/vapour valve fitting that had sheared off. The leak was plugged with a wooden dowel. There were no other leaks or damage to the top fittings (Photo 3).

Photo 3. Car TILX 198203 top fittings

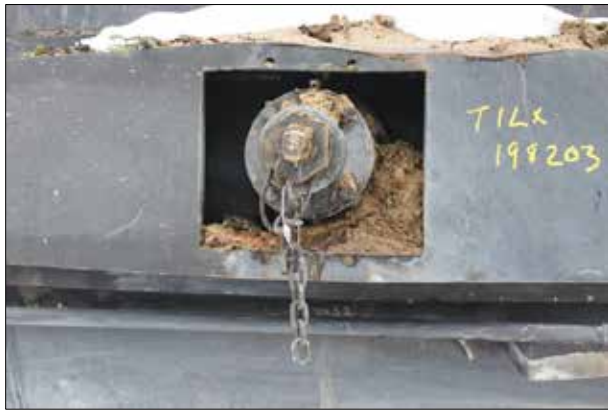
There was no impact damage to the bottom outlet valve (BOV). The BOV nozzle and cap assembly were still intact. The handle for the BOV had separated at the valve as designed, and the skid protection functioned as intended (Photo 4).

Photo 4. Car TILX 198203 bottom outlet valve (BOV) and skid protection

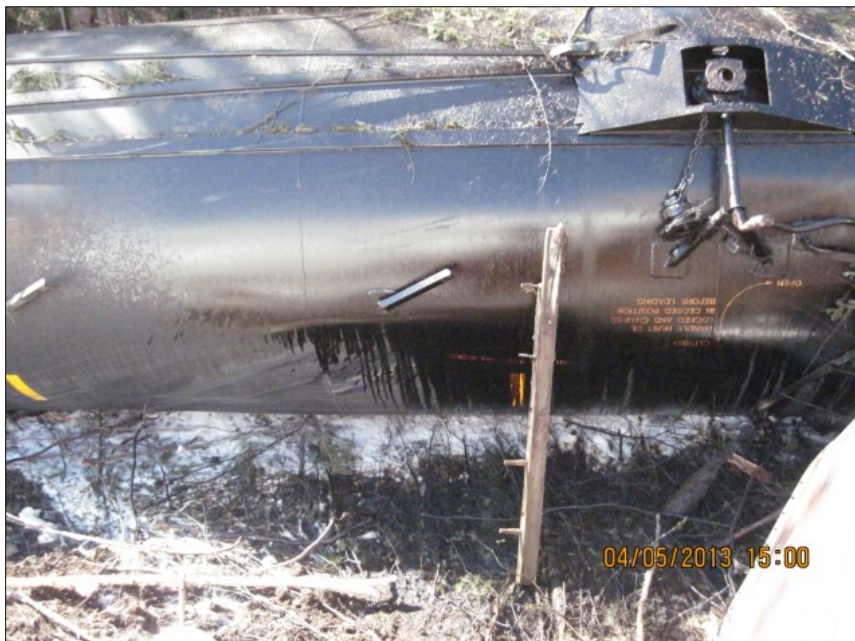
Car TILX 192186 overturned and came to rest with the BOV in the upright position (Photo 5). Impact damage to the top of the car had torn the protective housing for the load/unload arrangement from its hinges. Both the 2-inch-diameter liquid valve fitting and the 1-inch-diameter air/vapour valve fitting had sheared off, resulting in the release of product (Photo 6).

Photo 5. Car TILX 192186, as it came to rest (source: CP Police)

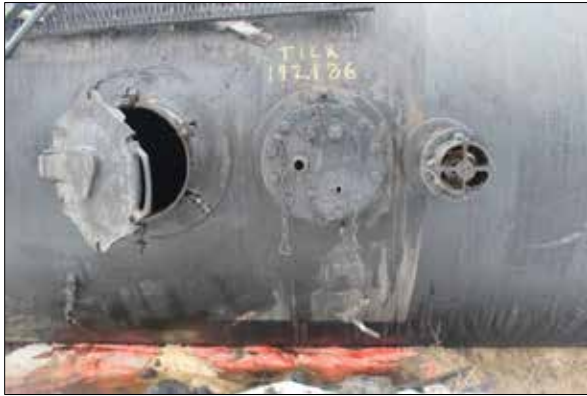
Photo 6. Car TILX 192186 top fittings

- The top fitting protective housings of cars TILX 192186 and TILX 198203 were torn off at the hinges and failed to protect the top fittings from damage. Consequently, the top fittings on both tank cars were sheared off and released product.
- The light steel construction and blunt profile of the top fitting protective housings on cars TILX 192186 and TILX 198203 did not adequately address the dynamics and related impact forces involved in a rollover derailment.
- The BOV skid protection on all 3 derailed tank cars functioned as designed.
- The BOV handles on tank cars TILX 192186 and PROX 76346 remained attached to the BOV throughout the derailment sequence and opened the respective valves. The BOV handle on TILX 192186 was deformed in such a way that it prevented subsequent closure of the valve. Both BOV handle designs met the current AAR standard.

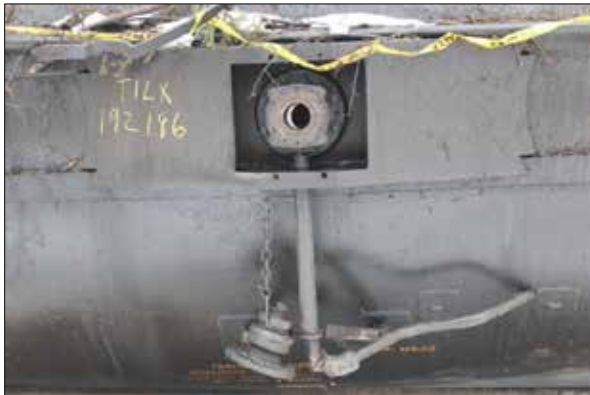
The BOV nozzle and cap had sheared off below the BOV as intended. In this arrangement, the BOV handle was mounted to the valve shaft and was perpendicular to the longitudinal axis of the car. As the car rolled down the embankment, the BOV handle was torn from its retainer, moved to the open position, and bent up against the tank car, such that it could not be closed by emergency responders (Photo 7). Product was released from the open BOV until the car came to rest with the BOV in an upright position. With the car overturned, the open BOV facilitated a more rapid release of product from the damaged top fittings.

Photo 7. Car TILX 192186 BOV and bent handle

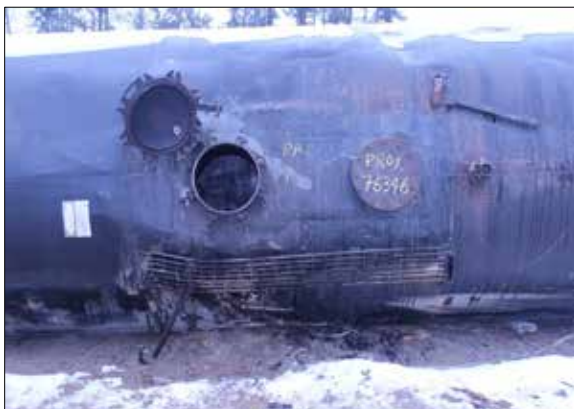
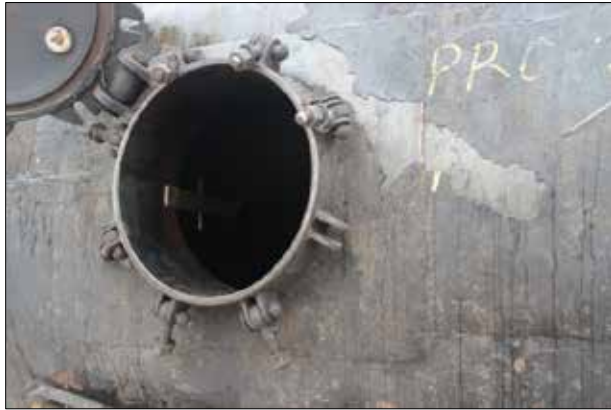
Impact damage sustained by the top of car PROX 76346 had torn away one of the hinged manway eyebolts, which created an air leak (Photos 8 and 9).

Photo 8. Top of car PROX 76346

Photo 9. Missing manway tie-down

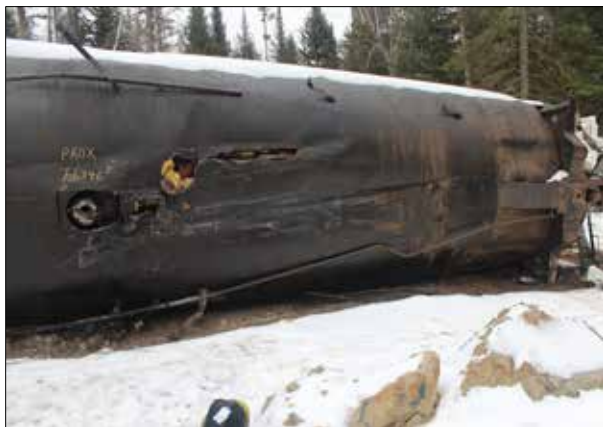
The tank car thermal jacket near the BOV was extensively damaged (Photo 10). The BOV sustained impact damage, and the nozzle and cap assembly had sheared off as designed. The BOV handle was torn from the retainer and bent, but did not break away. As a result, the BOV was partially open and released product (Photo 11), but responders were still able to close the BOV. With the BOV partially open, the manway air leak accelerated the product release.

Photo 10. Car PROX 76346 jacket damage

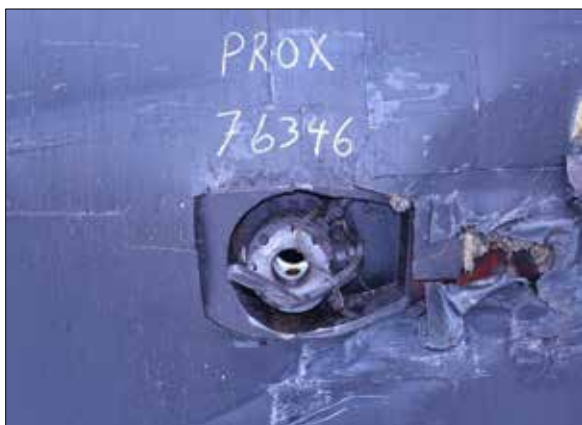
Photo 11. Partially open BOV of car PROX 76346

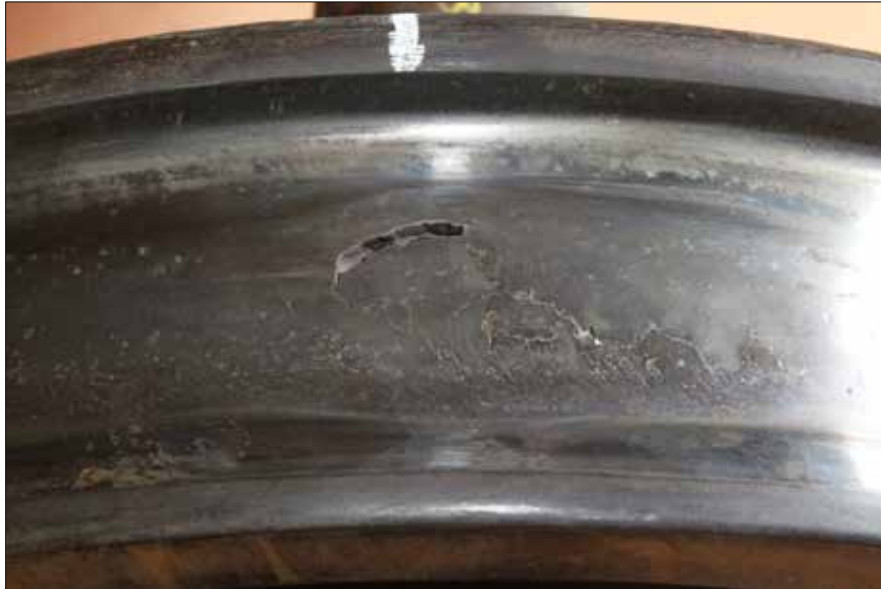
- There was a non-condemnable slid flat on the L1 wheel tread. The slid flat was directly in line with the fracture origin on the R1 wheel. As the wheels and the axle rotate as a unit, a slid flat on the L1 mate wheel means that there was likely a slid flat on the R1 wheel at the same relative location.

- A deep but non-condemnable shell was partially hidden beneath the tread surface of the slid flat area on the L1 mate wheel (Photo 12). The shell was further exposed as material came loose during cutting for metallographic sample preparation, which demonstrates

that subsurface shelling can occur, yet remain undetected, as it is covered by tread surface material.

Photo 12. Shell on L1 mate wheel tread contained within non-condemnable slid flat

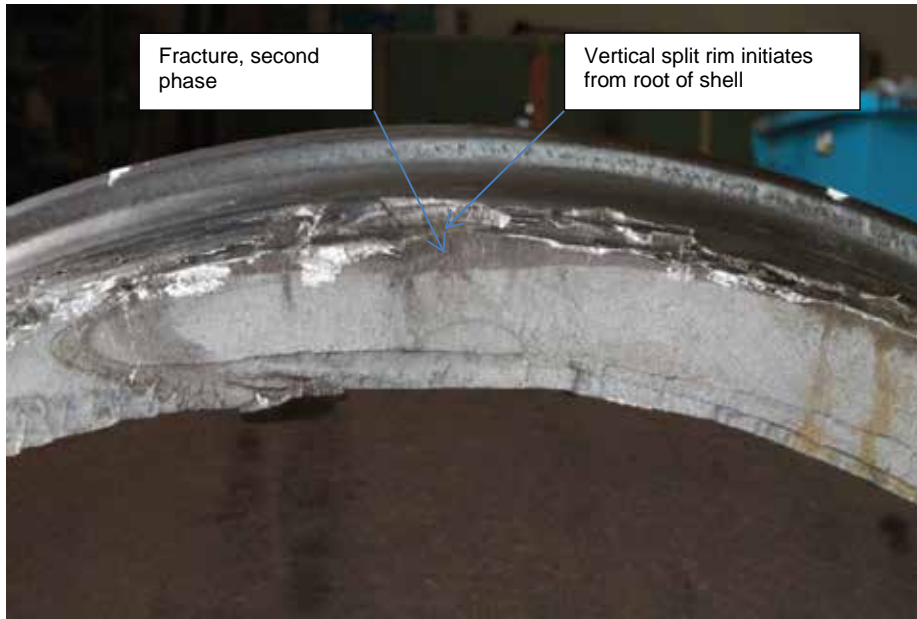
1. During the first phase, a growth of shells occurred subsurface to the wheel tread. The shelling extended about 1/3 of the way around the circumference of the wheel, coincident with the larger separated portions of the wheel rim. Subsurface fatigue cracking was also present. Polishing in these zones indicated that the portions of the shelled tread surface were in situ for an extended period of time before fully separating.
2. The second phase of fracture was the initiation of the vertical split rim (VSR) at the root of a shell (i.e., origin), located about 1/2 inch below the running surface of the wheel tread (Photo 13). The darker surface colouration indicated that this phase of the fracture had been developing for some time, but for less time than the initial subsurface shelling (i.e., first phase).

Photo 13. Vertical split rim (VSR) fracture origin and second phase of failure

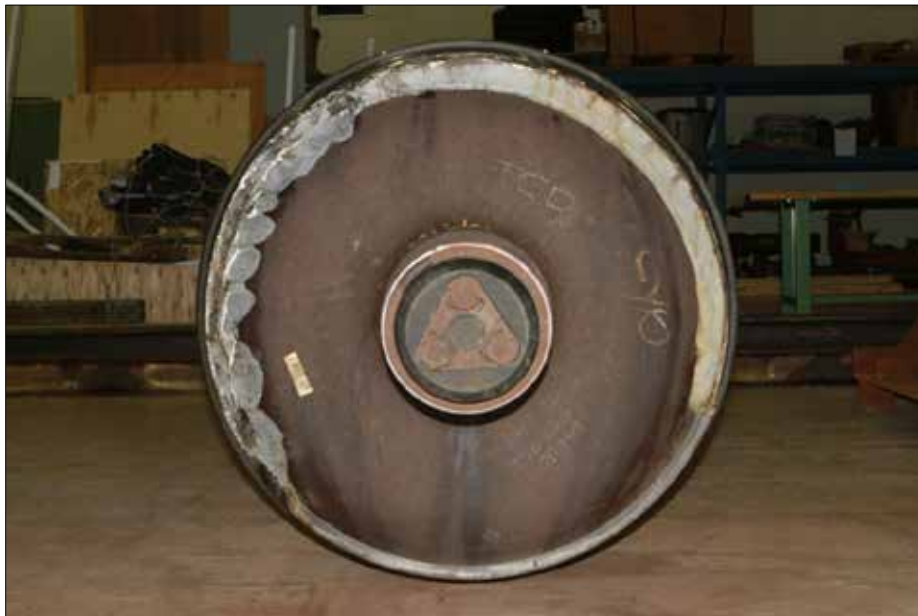
3. The third phase of fracture occurred in the form of a VSR, which progressed about $\frac{3}{4}$ of the way around the wheel circumference and resulted in the separation of approximately 80 inches of the outboard rim (Photo 14). The fracture topography indicated that the final VSR failure was rapid and had propagated circumferentially from the extremities of the second phase of the fracture.

Photo 14. Outboard view depicting the extent of wheel fracture

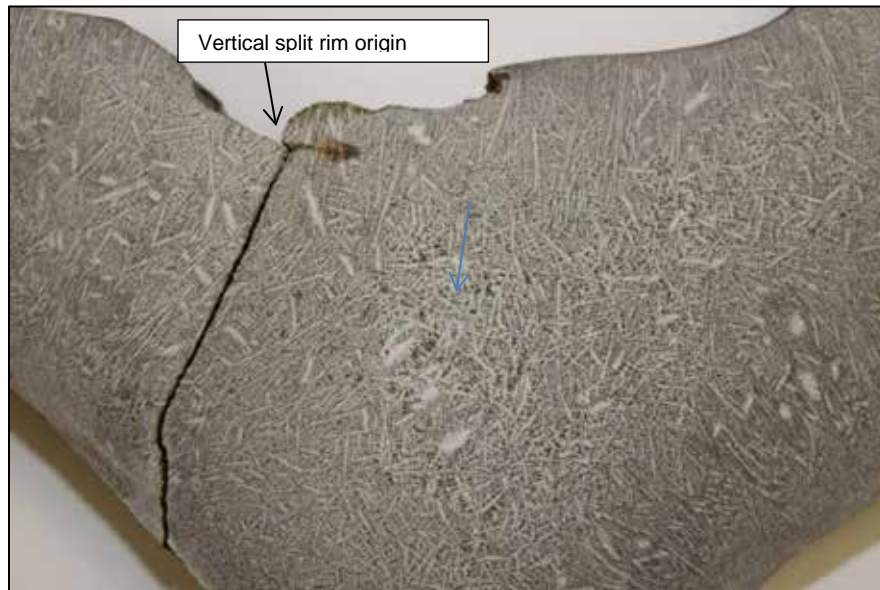
- The macrostructure was composed of a mixture of dendrites. The areas near the tread surface and the outer surface of the wheel displayed smaller dendrites, which became progressively larger (i.e., coarser) toward the centre of the core material (Photo 15).

Photo 15. Cross-section of failed R1 wheel near vertical split rim origin

- This is considered to be normal structure in castings, since the material near the surface of the wheel cools quickly, creating smaller dendrites than in the central portions, where the material cools slower and the dendrites grow larger.
- The fracture origin was close to the coarser dendrite structure near the centre of the rim section. The orientation of the larger dendrites was roughly parallel to the fracture plane. Coarser dendrites facilitate more rapid crack propagation, as there is less resistance to cracking.
