RAILWAY INVESTIGATION REPORT R13T0192

CROSSING COLLISION

**VIA RAIL CANADA INC. PASSENGER TRAIN NO. 51
OC TRANSPOR DOUBLE-DECKER BUS NO. 8017
MILE 3.30, SMITHS FALLS SUBDIVISION
OTTAWA, ONTARIO
18 SEPTEMBER 2013**

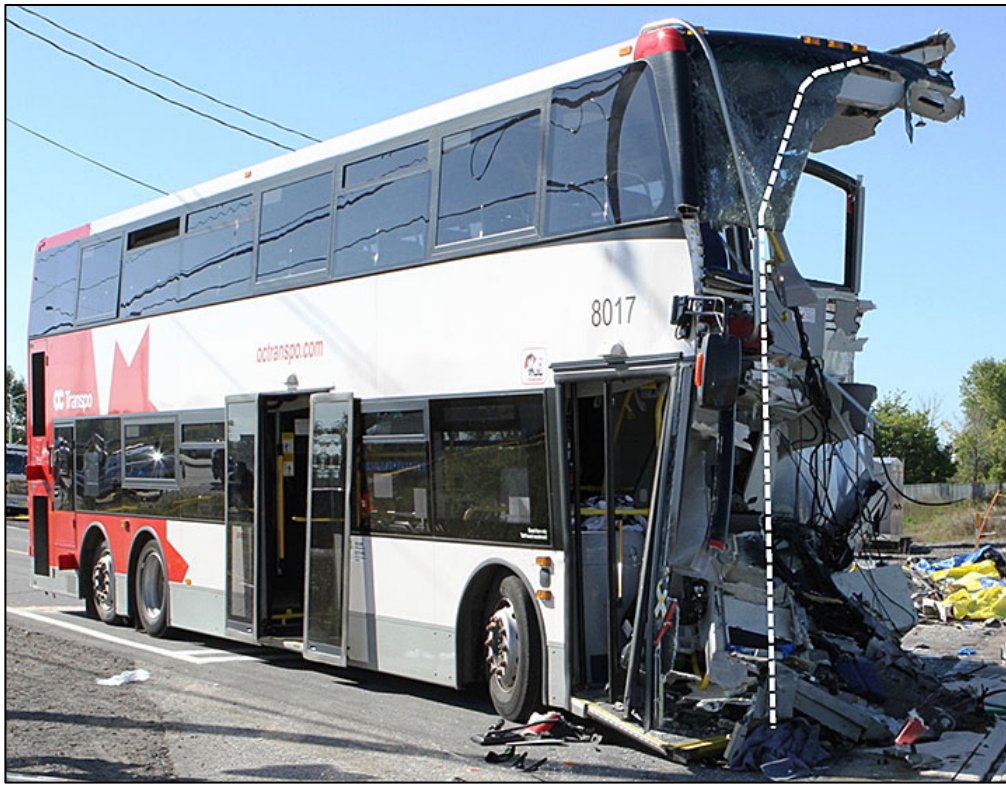
The right side wall of the bus had little damage, except for the panel located above the front door, which was bent to the left, in the direction of train movement. The right front corner pillar, which serves as the foremost vertical beam for the front door frame, was deformed and disconnected from the chassis at its lower end. Most of the front dome glazing (window) was missing, except for a small portion hanging from the right top corner. The remaining glazing was about 30 inches (76 cm) wide at the bottom. The contour of the remaining glazing was consistent with that of VIA 915's bodywork (Photo 1), as this was the last portion of the bus that contacted the train.

Photo 1. Right side view of the bus (the dotted line represents contour of locomotive VIA 915)

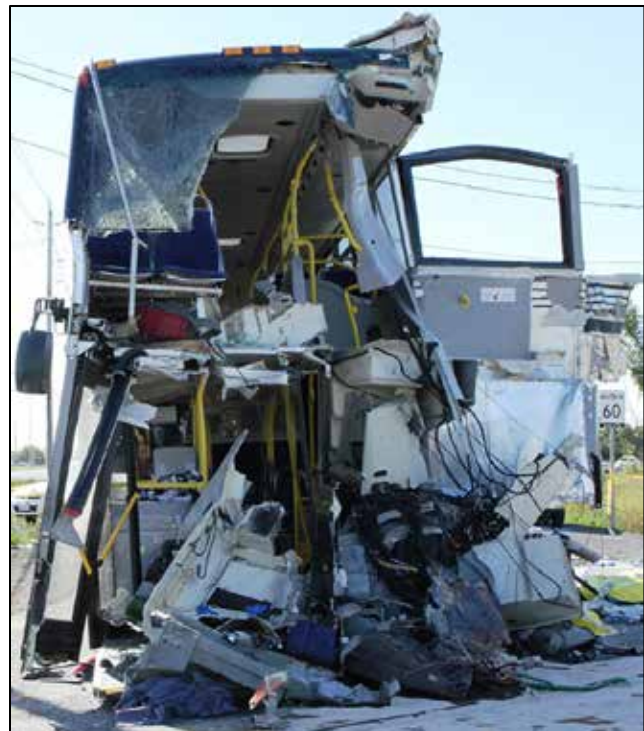
The front portion of the chassis was deformed to the left. The lower and upper front-end framing had separated from the bus and were found adjacent to the main wreckage. The remainder of the separated front structure was extensively broken up (Photo 2).

Photo 2. Front view of the bus

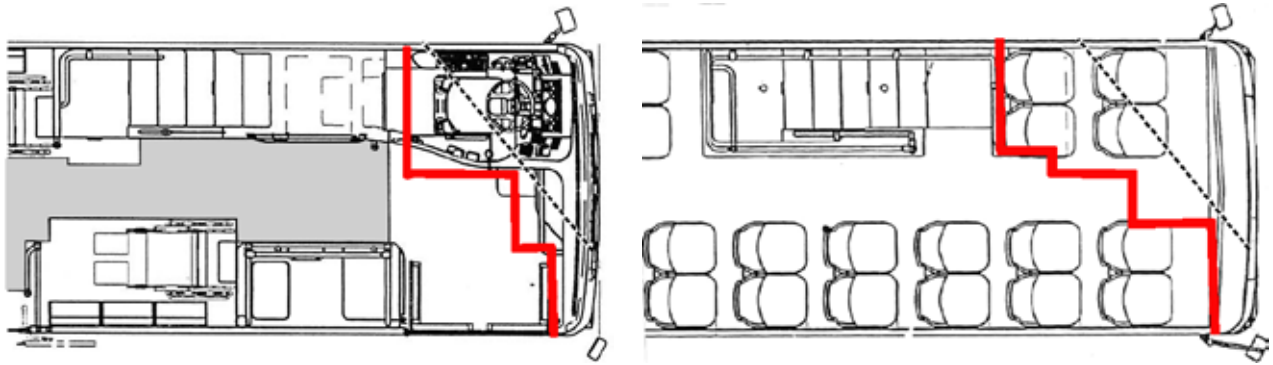
The driver's seat and the 4 seats on the 2 foremost rows of passenger seats on the left side of the upper deck were torn from the bus along with their supporting floor structure (Figure 4), coming to rest on the adjacent roadway west of the bus. The frame of these passenger seats had no significant damage, as the seats had not been directly struck by the train, nor did the impact with the ground exceed the seat design strength.

Figure 4. Schematics illustrating floor separation (lower deck on left; upper deck on right). The solid lines outline the boundary of floor separation. The dotted lines show the estimated line of train movement.

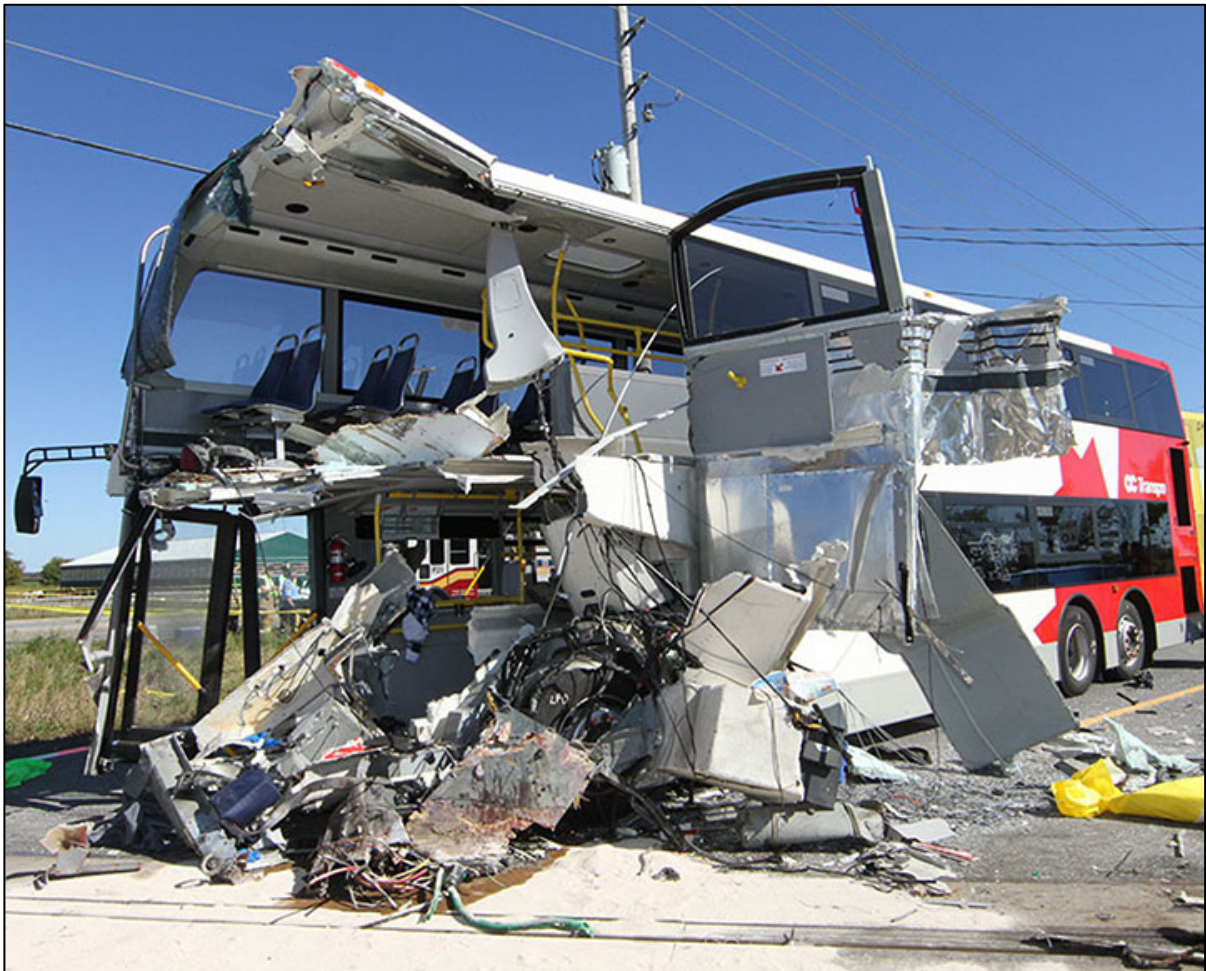
A portion of the left side wall of the bus (approximately 10 feet [3 m] long), containing the 2 foremost panels of the upper and lower decks, had separated from the left front corner of the bus and was bent toward the left (Photo 3). The left front corner pillar was missing. The left front corner of the roof was deformed upward. The foremost left side wall at the lower deck (below the driver's side window) had separated completely.

Photo 3. Left side of OC Transpo double-decker bus 8017

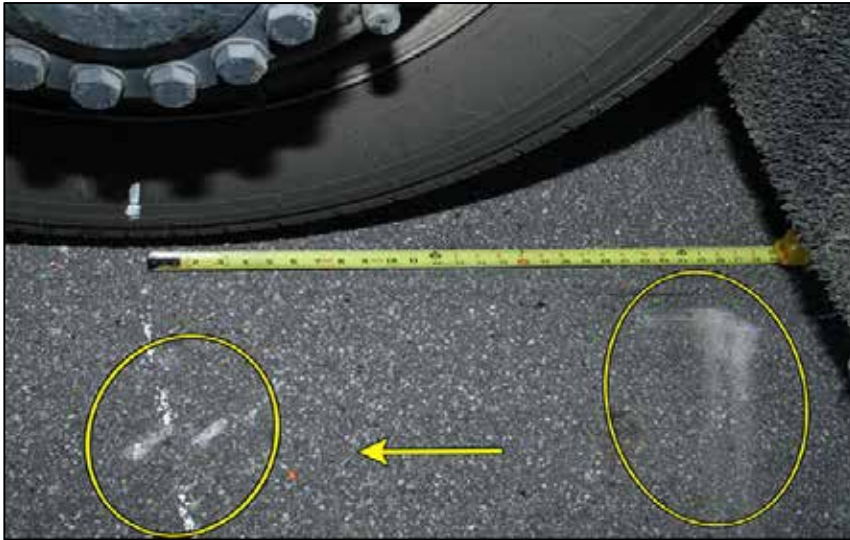
Short skid marks (about 3 inches (7.6 cm) long) were present on the Transitway extending southward under the rear tires of the bus (Photo 4).

Photo 4. Skid marks on Transitway under rear drive tires

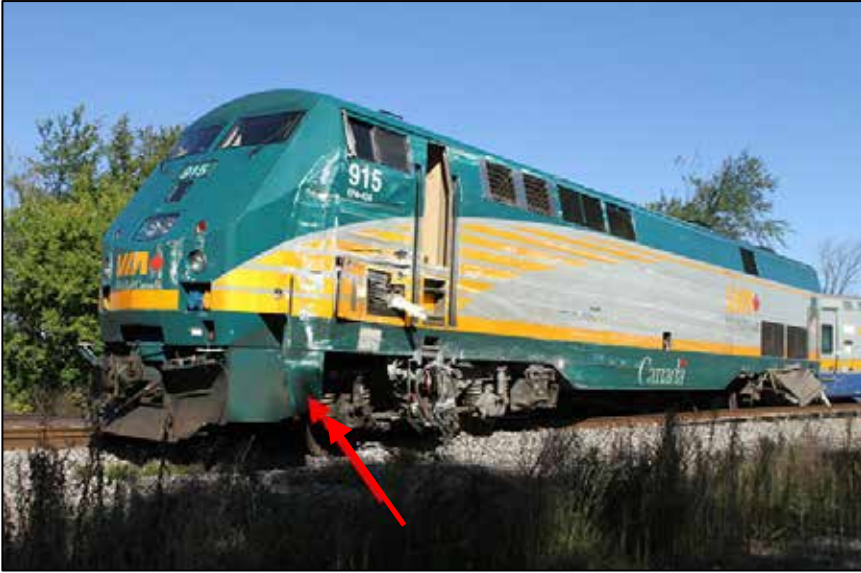
Photo 5. Damage on locomotive VIA 915

Horizontal lines of denting and scoring extended on the left side of VIA 915's bodywork and onto the first 20 feet (6.1 m) of the first passenger car (VIA 3455), as the bus had kept moving forward after the initial impact until it stopped. There was shallow denting along the body side sheets of VIA 915, but the frame of VIA 915 was not deformed.

The bottom portion of the skirt behind the pilot of VIA 915 was 20 inches (51 cm) above the ground level at the point of collision. The side panel was 44 inches (112 cm) above the ground. The chassis of the ADL E500 bus, which was about 17 inches (43 cm) above ground level, had passed beneath the bottom portion of the skirt behind the pilot and side panel of VIA 915.

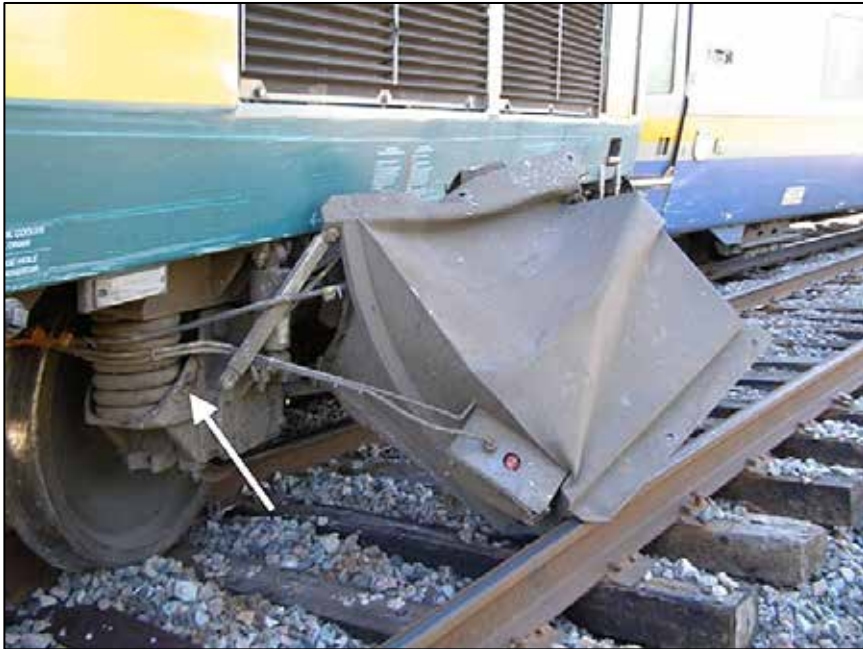
Photo 6. Impact mark on locomotive VIA 915's rear truck side frame (arrow) and separated battery box

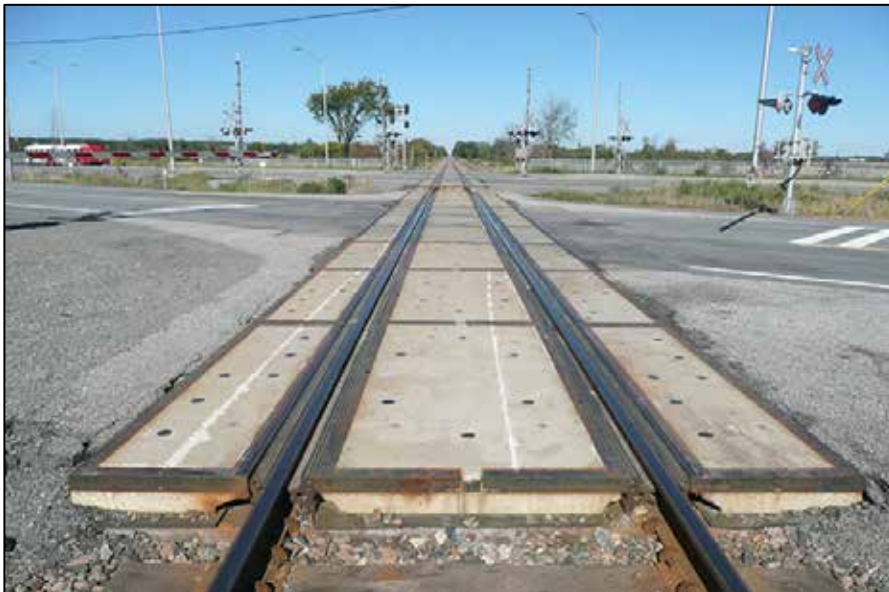
The south crossing gate had broken away. Train wheel flange marks were present, extending westward from near the middle of the Transitway to past the west end (Photo 7) of the crossing. From that point, wheel impact marks were observed on the track ties and ballast extending westward from the crossing onto the diverging VIA siding located just north of and adjacent to the main track.

Photo 7. Looking eastward from the west end of the crossing, train wheel flange marks were observed from the middle of the crossing extending westward

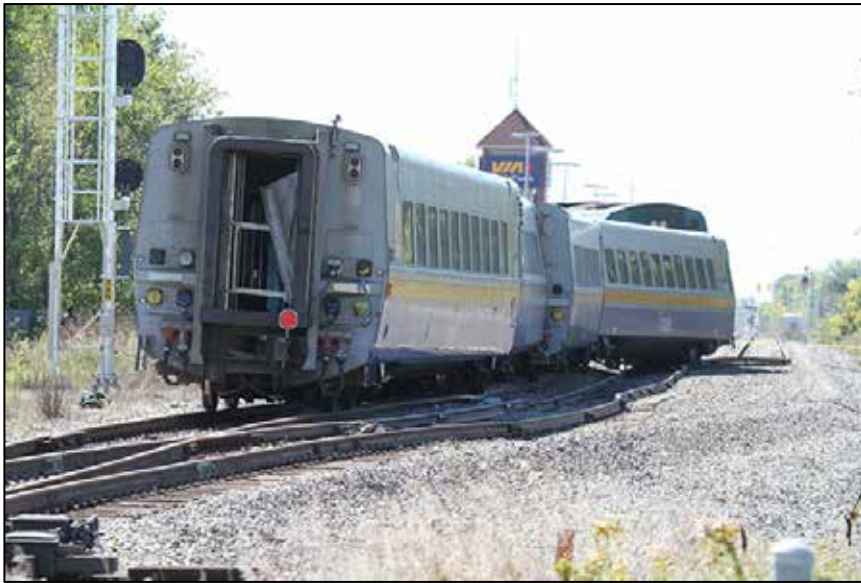
The main and siding tracks were displaced by the jackknifed equipment (Photo 8), as the track gauge had spread and rail on both tracks had rolled to the field side.

Photo 8. Westward view of derailed cars and displaced track

Track damage was present on both the main and siding tracks extending westward for about 600 feet (183 m) from the east end of the siding. The combined track damage for the main track and the siding track was about 1200 feet (365.8 m). The main track No. 12 turnout containing the east-end siding switch was also damaged.

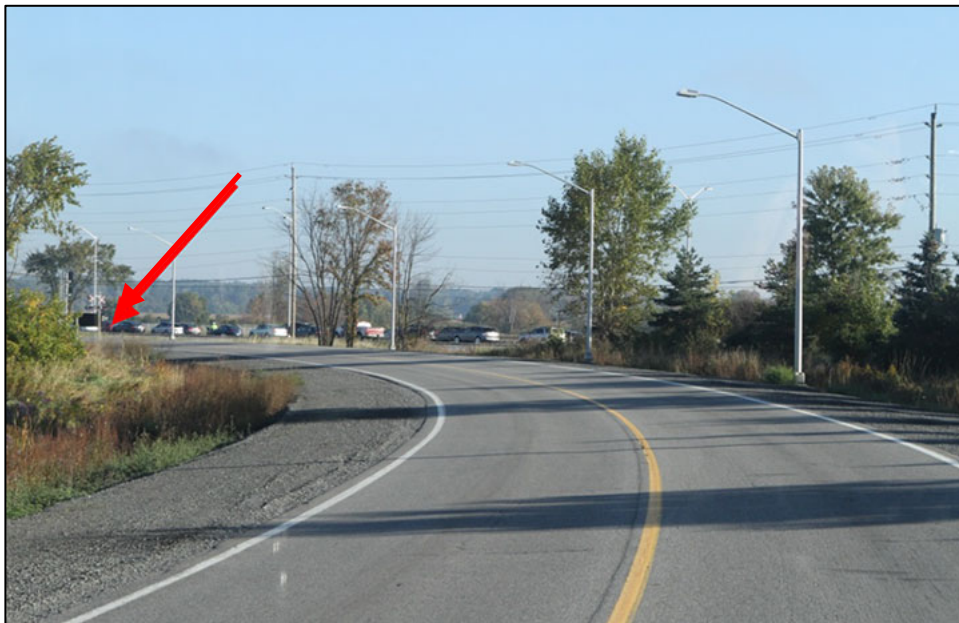
Photo 9. Crossing lights on Woodroffe Avenue were first visible when the bus was 748 feet (228 m) from the Transitway crossing (see location 2 on Figure 7)

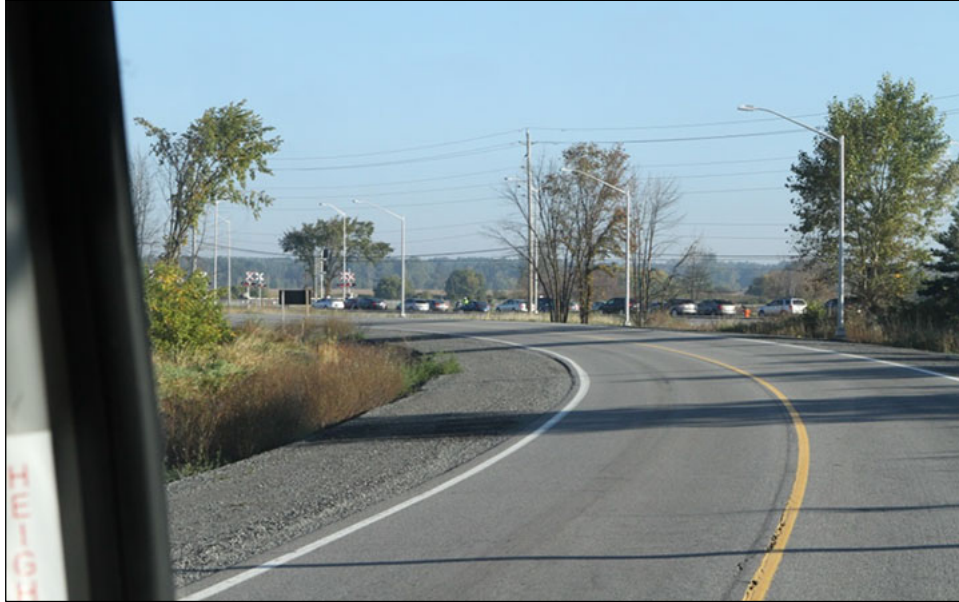
5. The Woodroffe Avenue crossing lights were fully visible from the Transitway when the bus was 694 feet (211.5 m) from the Transitway crossing (Photo 10).

Photo 10. Crossing lights on Woodroffe Avenue were fully visible when the bus was 694 feet (211.5 m) from the Transitway crossing (see location 3 on Figure 7)

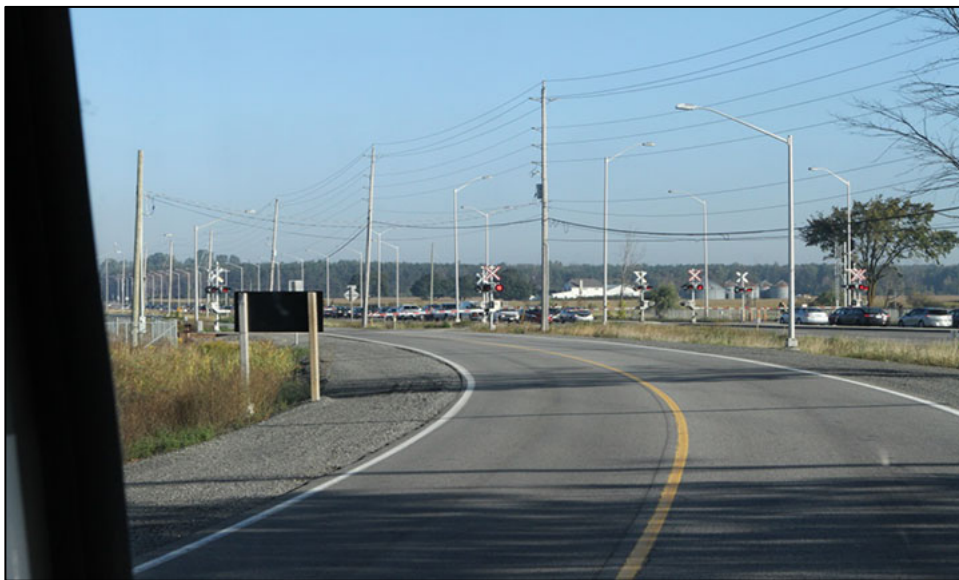
6. The crossing lights on Woodroffe Avenue and on the Transitway were fully visible when the bus was 402 feet (122.5 m) from the Transitway crossing (Photo 11).

Photo 11. Crossing lights on Woodroffe Avenue and on the Transitway were fully visible when the bus was 402 feet (122.5 m) from the Transitway crossing (see location 4 on Figure 7)

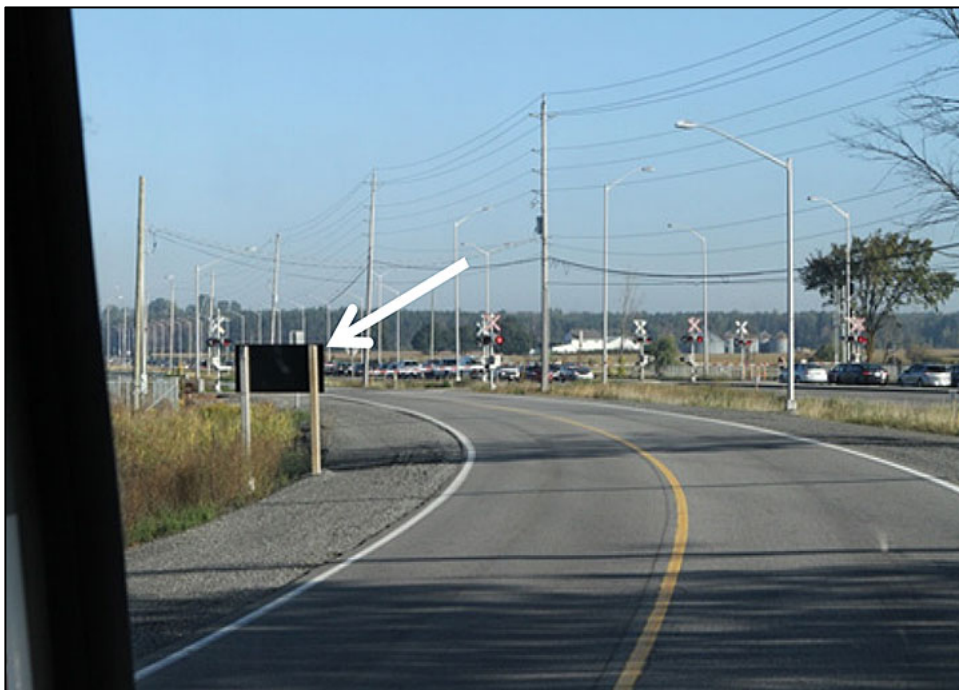
7. There were 2 road signs installed on the west side of the Transitway that obscured the driver's view of the crossing back lights (short) on the left side of the crossing at different times on the approach (Photo 12 and Photo 13).

Photo 13. OC Transpo Fallowfield Station sign

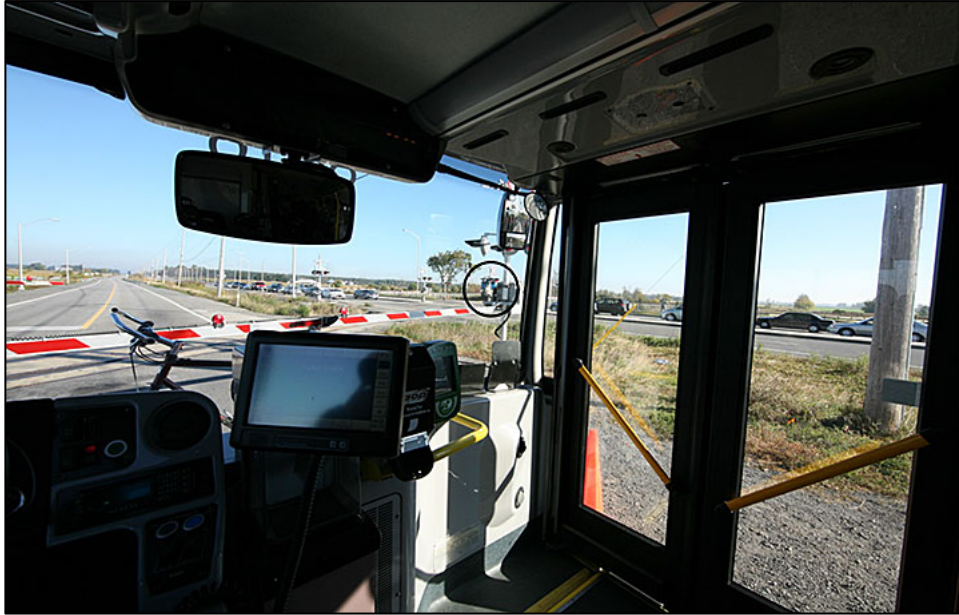
8. From the driver’s location stopped at the crossing, the bus window pillars and door structure obscured the driver’s view of the train (Photo 14).

Photo 14. Wide angle view of approaching train from a bus stopped at the crossing

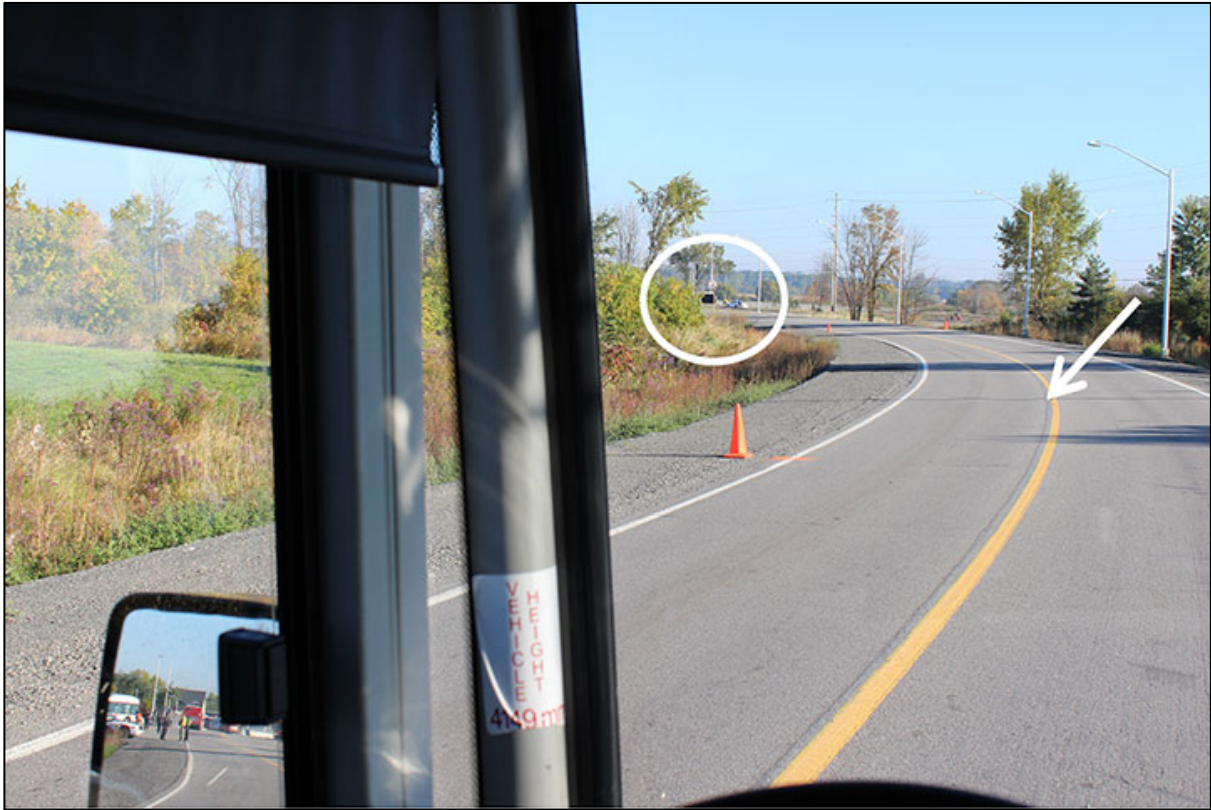
Photo 16. View of Transitway on approach to the crossing (TSB re-enactment 28 September 2013). The arrow identifies the tangent point of the curve. The circle identifies the occlusion point toward which drivers would make anticipatory glances. Note the large sign within occlusion point.
