**RAILWAY INVESTIGATION REPORT
R14V0215**

**MAIN-TRACK DERAILMENT
CANADIAN NATIONAL RAILWAY
TRAIN Q19771-09
MILE 48.41, SKEENA SUBDIVISION
KWINITSA, BRITISH COLUMBIA
15 NOVEMBER 2014**

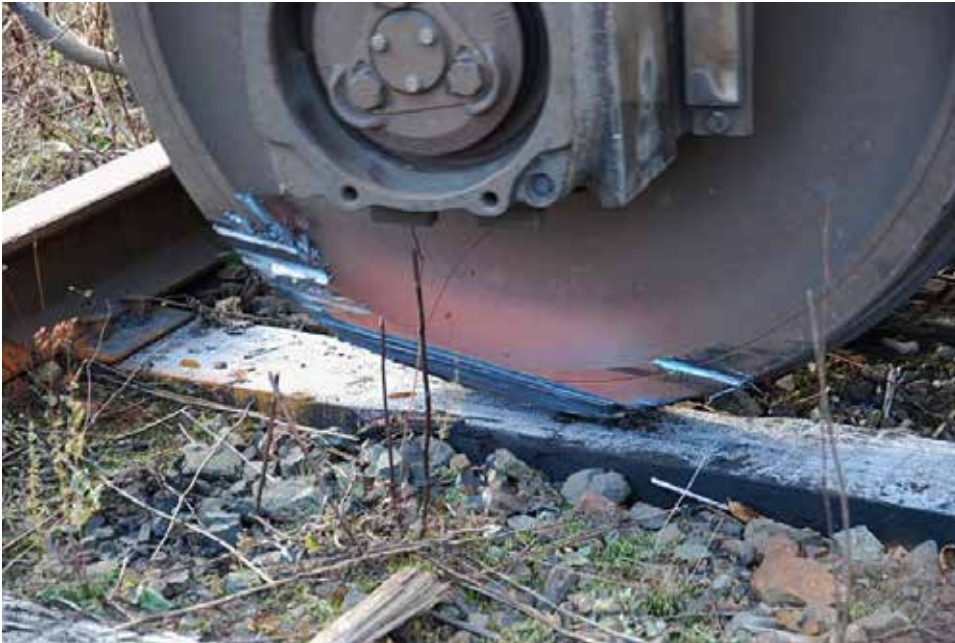
In this occurrence, the locked No. 4 axle on the trailing locomotive prevented the wheels from rotating. These wheels were sliding along the top of the rail head, resulting in wear to the wheel tread and rail burn damage (photo 1 and photo 2). As the wear progressed, the wheel flanges began to extend down below the head of the rail to a point where they made contact with the 2 inner heat-measuring transducers, dislodging them. Although the dislodged transducers remained operable, they could not take readings because they were out of alignment. When the transducers were knocked off the rail entirely, the detector stopped receiving pulses associated with train movement and began to process the end-of-train message. The train received a "No Alarms" message over the designated radio channel. However, only 9 axles (i.e., the 6 axles of the lead locomotive and the first 3 axles of the trailing locomotive) were measured by the bearing and wheel scanners.

Photo 1. Rail burn damage

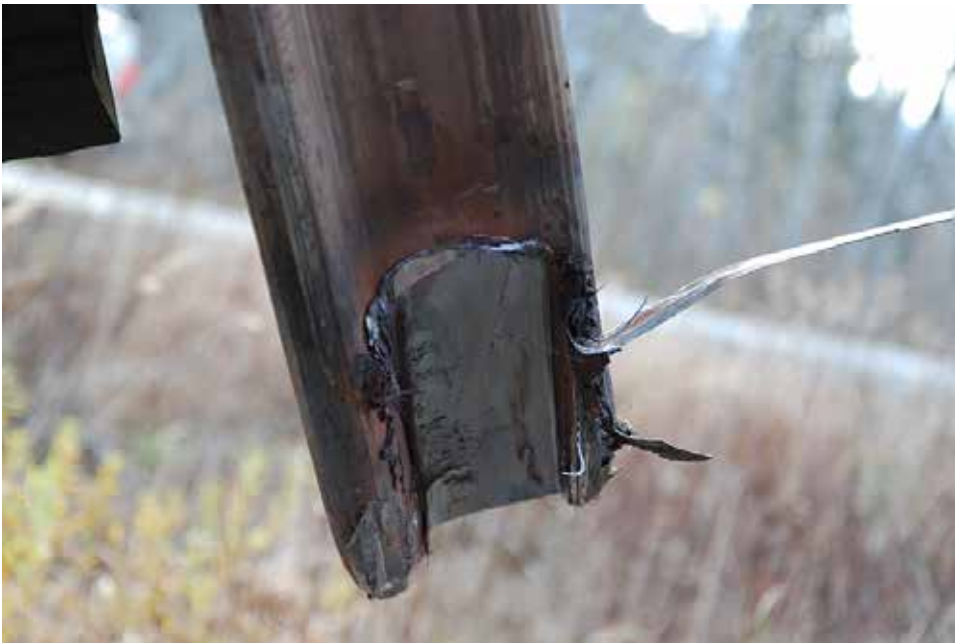
Photo 2. Damaged wheel tread

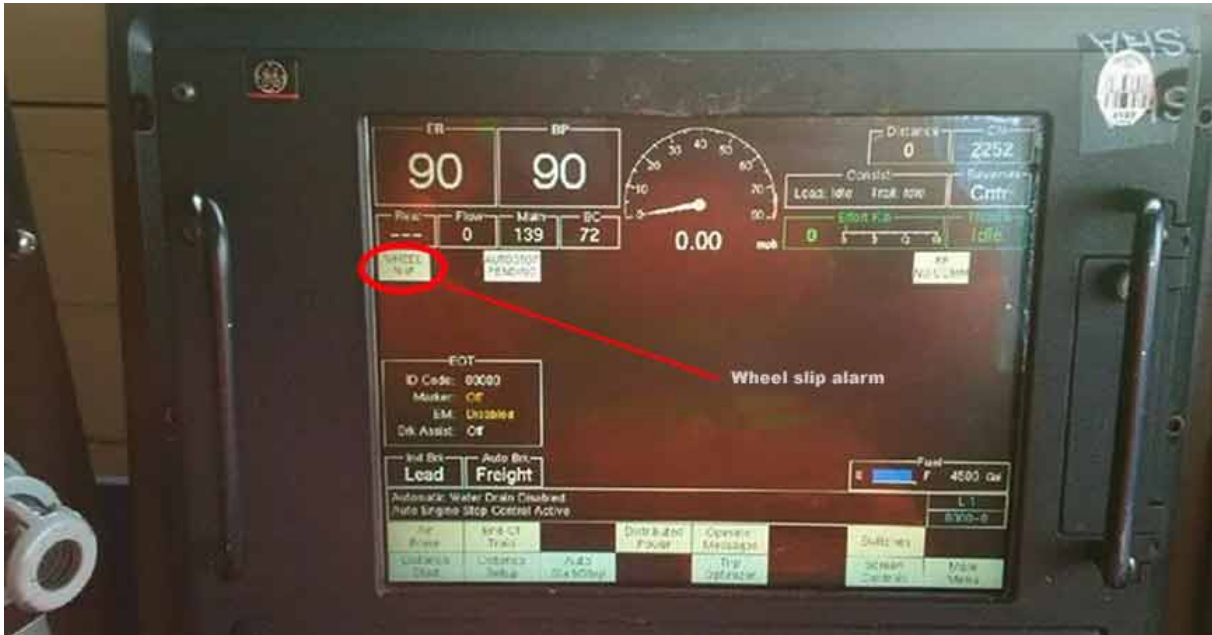
Photo 5. Wheel slip indicator on the SDIS display screen of an ES44DC locomotive (Source: Canadian National Railway, with TSB annotations)

From the SDIS screen, the locomotive engineer had no definitive means to determine whether the white wheel slip indicator represented a non-urgent ES44DC fault, a non-urgent SD60F fault, or an urgent SD60F fault. With the SD60F locomotive trainlined to the ES44EC locomotive, the alarm displayed did not provide sufficient information to the train crew to indicate that an urgent fault condition existed.

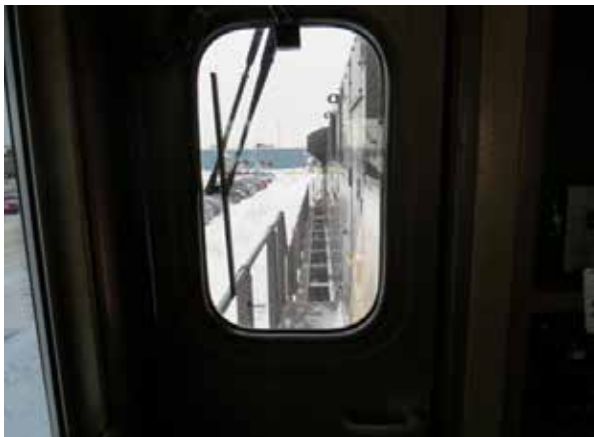
- On the right side (locomotive engineer’s view), there was a raised walkway leading from the cab to the rear of the locomotive (Photo 7).
- On the left side (conductor’s view), there was a raised platform extending from the engine compartment (Photo 8).

Photo 7. Rear window view behind locomotive engineer

These physical features extended along each side of the locomotive, obstructing the view of the wheels on the second locomotive. As the lead locomotive and the second locomotive were situated back to back (Photo 9), the locomotive engineer’s rear view was affected by the right-side obstructions of the lead locomotive and the left-side obstructions of the second

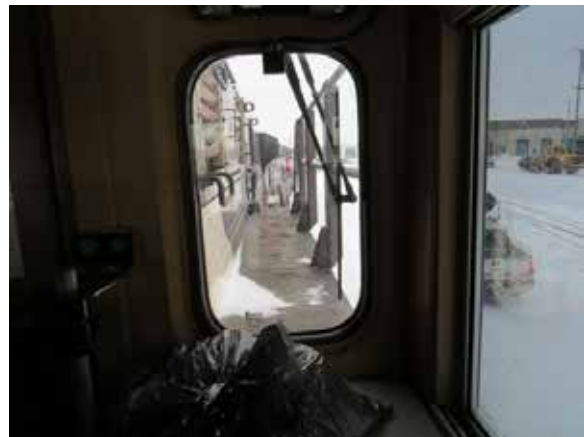
Photo 8. Rear window view behind conductor

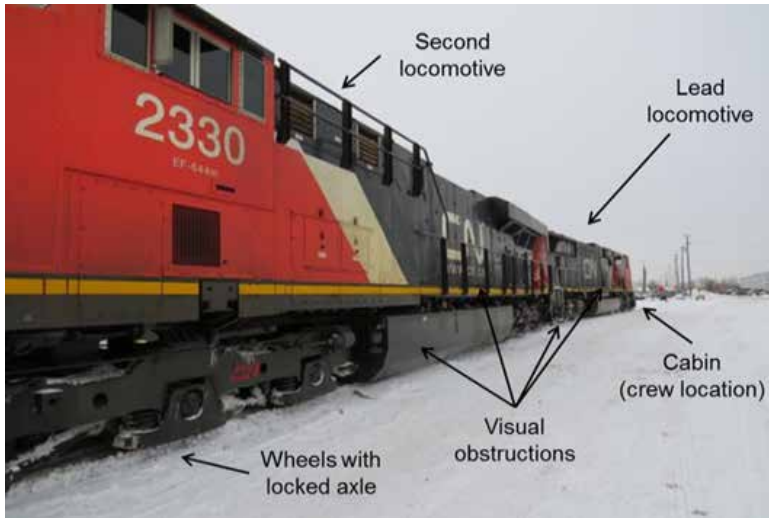
locomotive. Similarly, the conductor's rear view was affected by the left-side obstructions of the lead locomotive and the right-side obstructions of the second locomotive.

Photo 9. Locomotives situated back-to-back

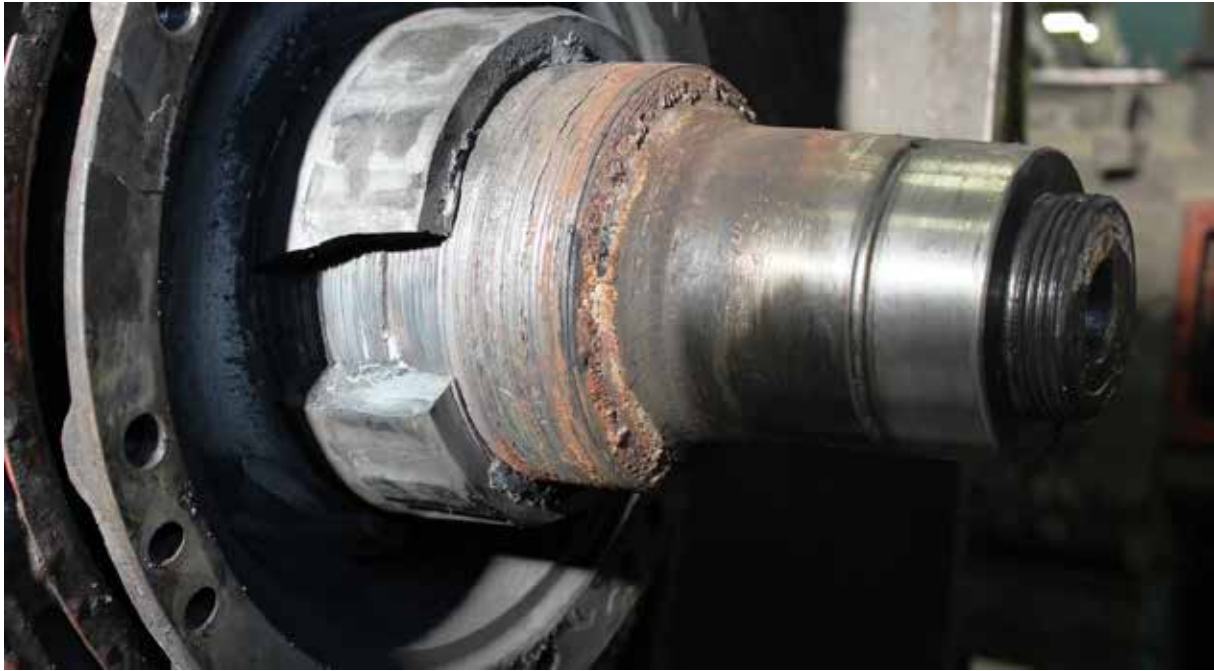
- At some point before the occurrence, operating conditions³⁴ had likely changed, such that the friction provided by the interference fit was insufficient to prevent the shaft from slipping relative to the bearing (Photo 10).

- Once the shaft had started to slip inside the inner ring, friction forces caused extensive wear and heat generation at the fit surfaces. This resulted in overheating of the inner ring to the point where its metallurgical properties changed.

- The train pulled into the siding at Salvus and stopped just before the occurrence. The failure sequence had likely begun by that time, so that the shaft and inner ring were very hot. When the train came to a rest, the shaft stopped rotating in the inner ring. The overheated shaft and pinion end bearing subsequently cooled down and seized together.

Photo 10. Close-up view of the inner ring during removal from the armature shaft

When the train was stopped in the siding at Salvus, the overheating shaft and pinion end bearing on the traction motor assembly of the No. 4 axle cooled down and seized together. The shaft and pinion end bearing had been overheating due to slippage inside the inner ring, which resulted in friction forces, extensive wear, and heat generation at the fit surface. The interference fit between the pinion end bearing inner ring and the traction motor shaft was 0.0007 inch below the minimum limit specified for an EMD ARS model traction motor. The decreased interference between the shaft and inner ring made the assembly more susceptible to slip. In this situation, the amount of interference between the shaft and inner ring was initially sufficient to allow the assembly to operate normally for some time before the slippage started.

5. The shaft and pinion end bearing had been overheating due to slippage inside the inner ring, which resulted in friction forces, extensive wear, and heat generation at the fit surface.
