# RAILWAY INVESTIGATION REPORT

## R15E0173

### **Non-main-track derailment**

Canadian Pacific Railway

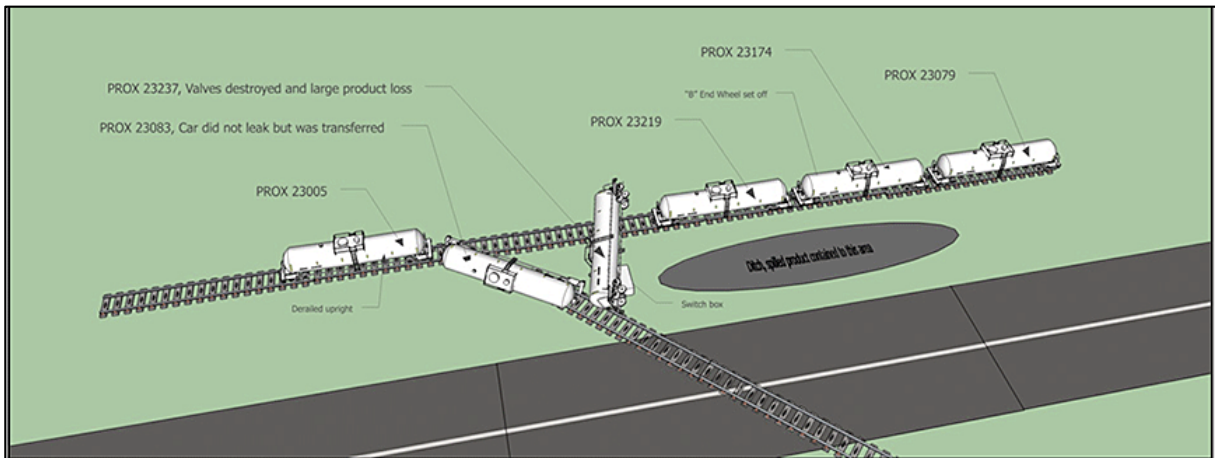
Figure 3. Derailment diagram (Source: Shell Canada)

The 4 tank cars involved in the derailment (PROX 23005, PROX 23083, PROX 23237, and PROX 23174) were loaded with styrene monomer, stabilized (UN2055), a Class 3 flammable liquid.<sup>6</sup> Two of the tank cars had derailed in an upright orientation (PROX 23005 and PROX 23174) and were subsequently placed back on the rails (Figure 3). PROX 23083 was damaged and had come to rest on its side (Figure 4). The product from this car was transloaded in place into 3 highway tank trucks and then transferred into another tank car. Tank car PROX 23237 had rolled over into the ditch adjacent to the track, coming to rest

upside down. The liquid line and the vapour line were sheared off during the derailment (Figure 5), and approximately 87 000 litres of product were released into the ditch. About 6000 litres remained in the breached tank car and were later recovered.

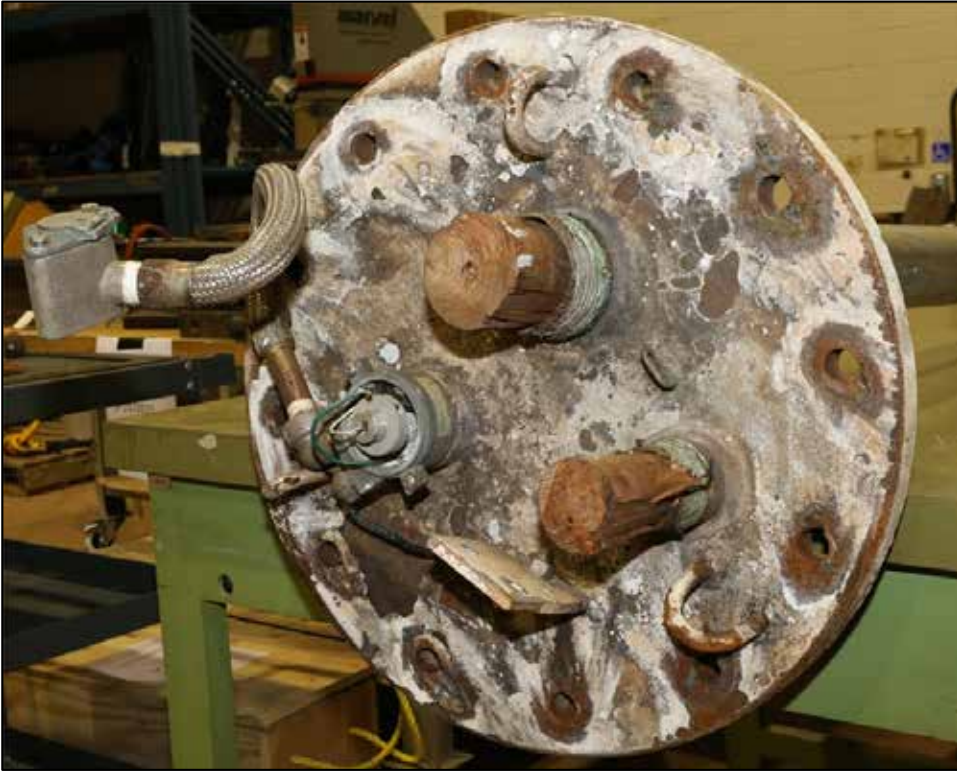
Figure 5. Top fitting assembly, wooden plugs are inserted at the valve locations where the liquid line and the vapour line were sheared off

The detailed examination determined that the top fittings of tank car PROX 23237 were breached from impact damage when the tank car rolled over during the derailment.

The top fittings of tank car PROX 23237 were breached as a result of impact damage when the tank car rolled over during the derailment. The damage (sheared off liquid and vapour lines) that resulted in the release of product was consistent with tank car damage noted in other TSB investigations. The damage resulting from this low-speed derailment highlights the vulnerabilities of legacy Class 111 tank cars and further reinforces the need for improved tank car design standards.

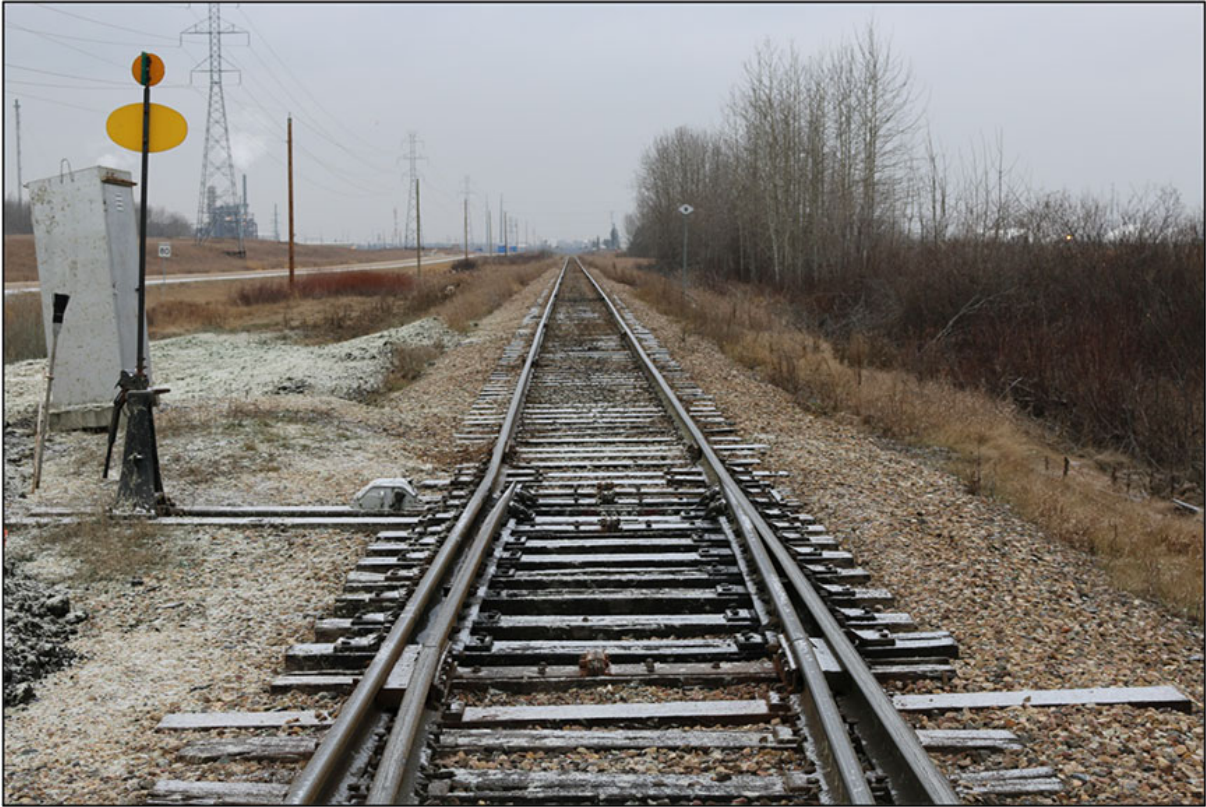
At the west wye switch, the rod connecting the switch points and the switch stand was bent. Consequently, the switch point was no longer being held tight to the stock rail. In this condition, the switch point “floats” as each wheelset trails through the switch. This damage was consistent with the cars having trailed through the switch. Inspection records indicated that the switch was serviceable before the accident.

The approach to the switch was on tangent track with an unobstructed view from the east (Figure 6). The switch target displayed green when the switch was lined for the through route and yellow when the switch was lined for the diverging route. The switch target, which was covered with retro-reflective material, was in good condition. At the time of the occurrence, the switch target was displaying yellow, indicating that the switch was reversed (i.e., lined in the opposite direction from the intended route).

Figure 6. View of the west wye switch in reverse position (looking west)

The west wye switch had been partially trailed through and damaged during the initial forward movement of the train. The derailment occurred when the switching movement reversed over the damaged west wye switch.
