RAILWAY INVESTIGATION REPORT

R15T0173

Non-main-track runaway, collision and derailment

Canadian National Railway Company

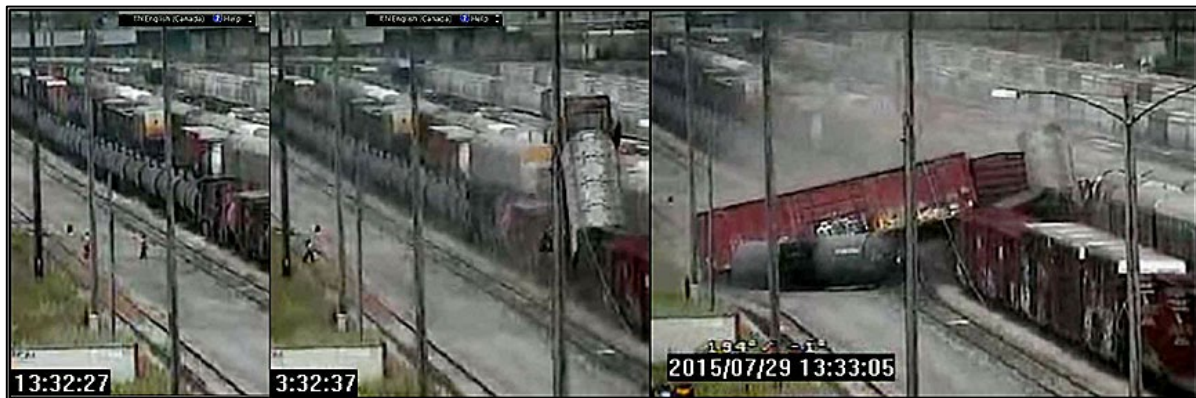
At 1332:29, the south end of the uncontrolled cut of cars collided head on with train 422 (Figure 2), as the crew of train 422 quickly evacuated the area.

Figure 2. Sequential images from the Canadian National Railway Company (CN) yard video recording of the collision and derailment. The crew of train 422 approached the train then quickly evacuated the area just before the collision. (Source: CN)

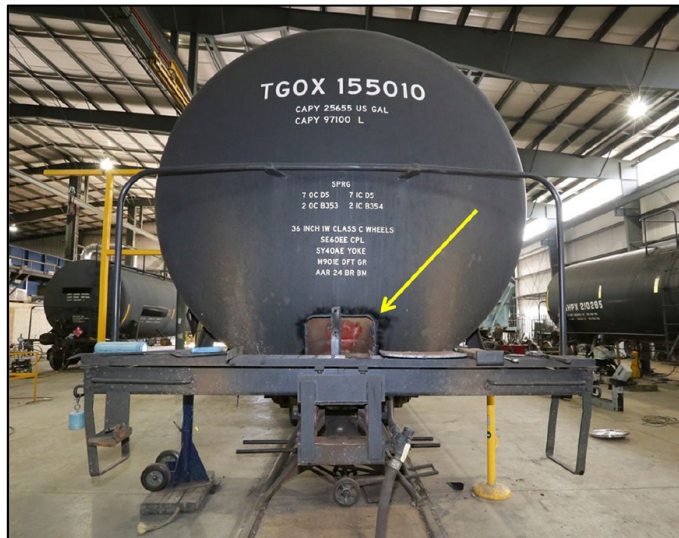
Figure 6. TGOX 155010 prepared for inspection with jacket and insulation removed (arrow)

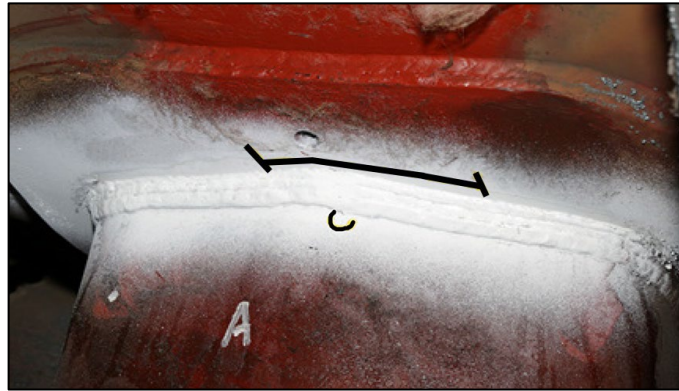
- There was no visible impact damage on the coupler, striker face or coupler horn.
- The head brace to pad weld exhibited cracking at the toe of the top weld pass. Magnetic particle inspection (MPI) confirmed the presence of intermittent cracking about 4.5 inches long, 1 inch to the left and 3.5 inches to the right of the tank car centreline.

- A small 3/16-inch crack long indication was observed at the toe of the bottom pass of the brace to pad weld, at the centreline of the car (Figure 7).

Figure 7. Location of cracking observed in A-end of car TGOX 155010 head brace weld outlined in black

The ½-inch buckle located at the bottom of the B-end of the TGOX 155010 tank shell was cut out and replaced. All crack indications observed on car TGOX 155010 were ground out and repair-welded. Repairs were completed in April 2016.

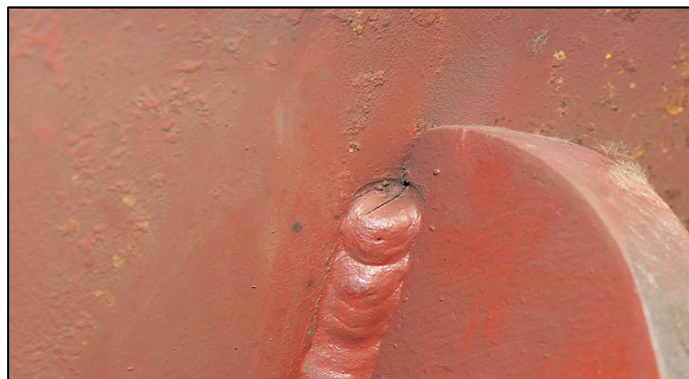
- The car body bolsters revealed cracks in the welds at the junction of the car body bolster extension and the bolster reinforcing pad. Cracks in these welds were visually apparent (Figure 8), and confirmed by MPI inspection, in the end of the weld bead on both sides of the bolster extension at all 4 locations at all 4 body bolster extensions.

Figure 8. Close-up of crack in weld at body bolster extension / bolster pad junction

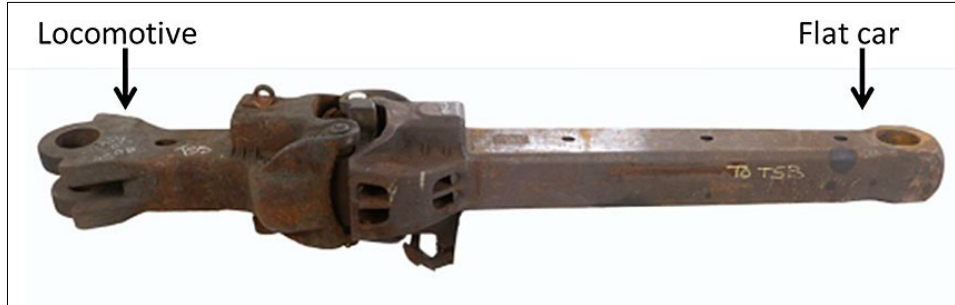
Figure 10. Locomotive CN 7506 and freight car CN 44257 coupler assemblies

There were no defects observed in the locomotive CN 7506 coupler assembly.

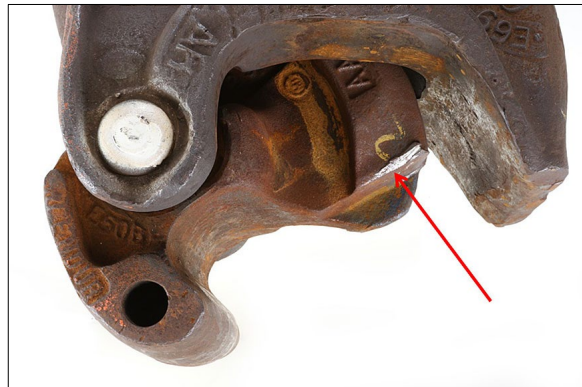
Figure 12. Top view of deformation on knuckle tail

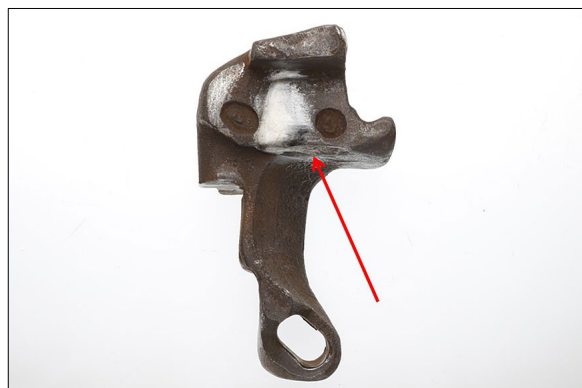
Figure 13. Corresponding locking block surface

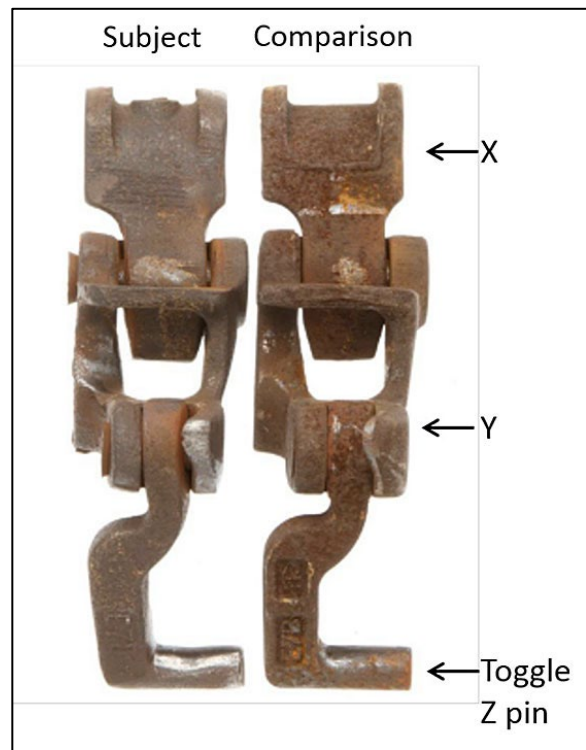
The lock-lift assembly exhibited extensive wear in the toggle joints and rivets when compared to a newer assembly (Figure 15). This extensive wear increased the lateral movement of toggle Z.

Figure 15. Lock-lift assembly wear compared with newer assembly

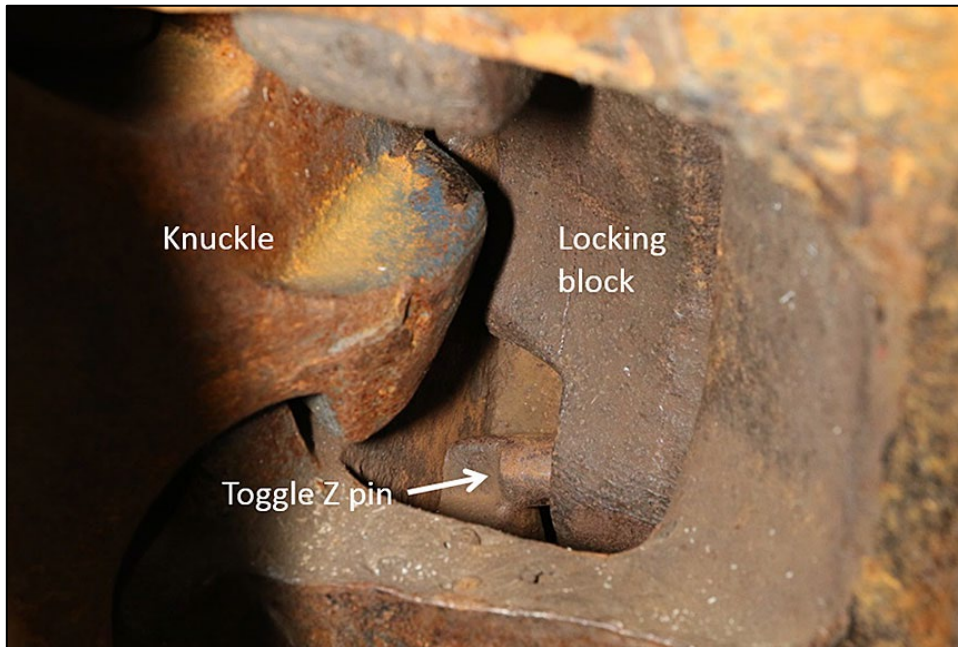
Anti-creep protection is provided to prevent unintentional uncoupling. An anti-creep test was performed on the coupler assembly in accordance with the AAR guidelines. The anti-creep protection functioned as intended. However, when closing the knuckle, the toggle Z pin of the lock-lift assembly occasionally jammed in the locking block hole, preventing the block from dropping into place (Figure 16).

Figure 16. Lock-lift assembly toggle Z pin jammed in the locking block hole

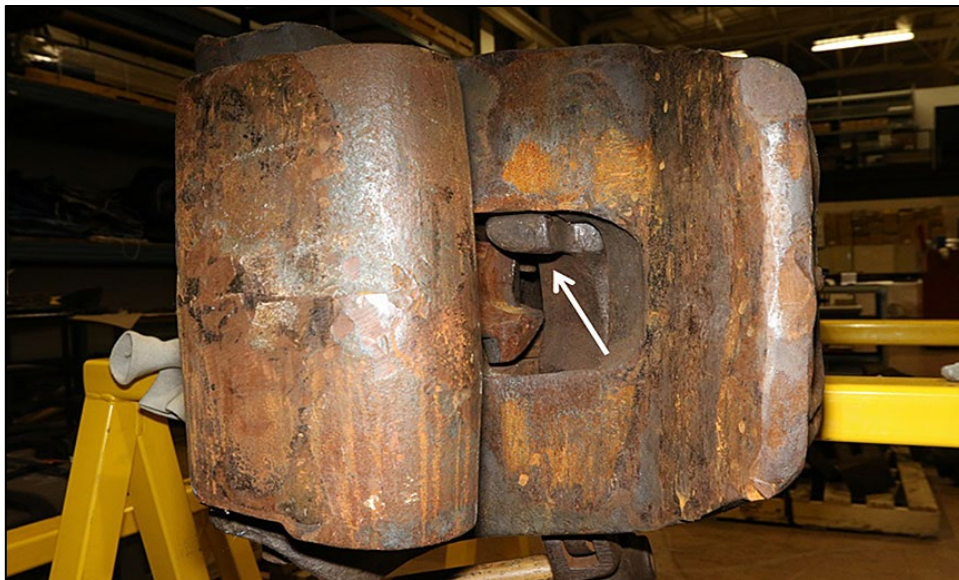
When the toggle Z pin of the lock-lift assembly jammed in the locking block hole, the locking block only partially engaged with the tail of the knuckle (Figure 17 and Figure 18).

Figure 17. Lock-lift assembly toggle Z pin jammed in the locking block hole

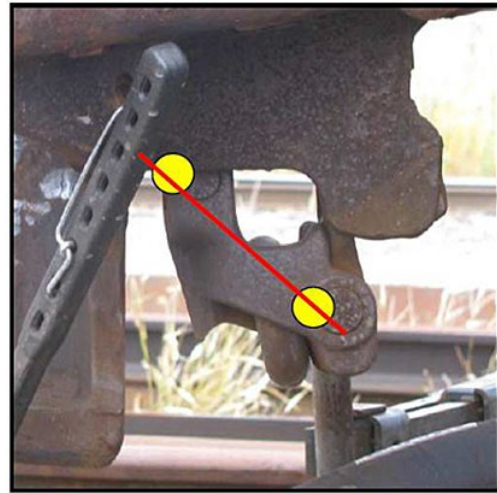
A secure joint with a seated pin will look like Figure 1 where both of the pivot points are aligned parallel to the ground. A pin that is not secured looks like Figure 2.

Figure 2: Pin NOT seated

1. When monitoring a joint look for this pattern to ensure the cars are securely coupled.
2. When performing a roll-by strive to ensure the lock-lift is in position (Fig 1).
3. Alert the crew when a pin is not secured to come to a controlled stop and then work the joint until it is secured.
4. When a coupler is not performing properly, ask mechanical staff for help to remedy the problem.
