RAILWAY INVESTIGATION REPORT

R16E0102

Main-track derailment

Mile 96.38, Grande Cache Subdivision
near Grande Cache, Alberta

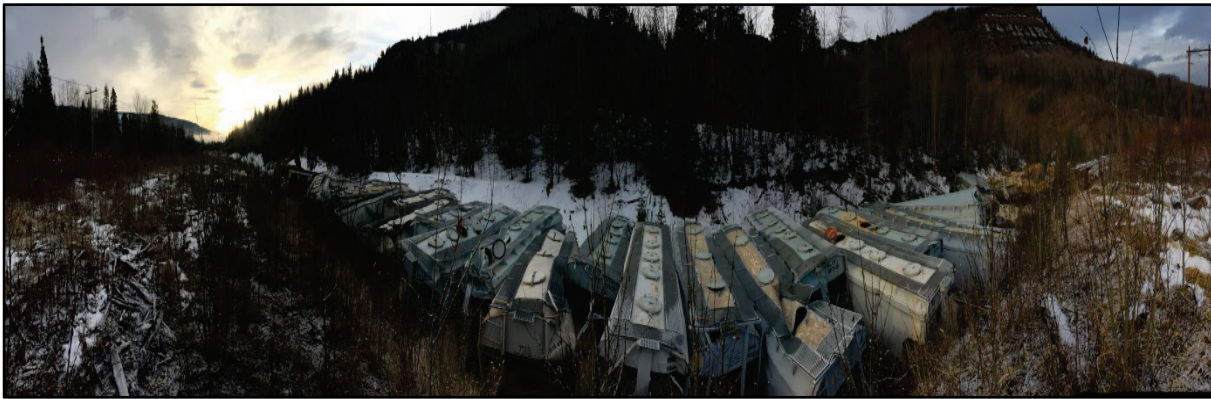
There were no marks on the ties from the derailed R3 locomotive wheels; however, there were marks on the base of the low rail and a rail break between the point where the locomotives initially stopped and the point where it stopped after reversing.

Figure 2. Derailed cars

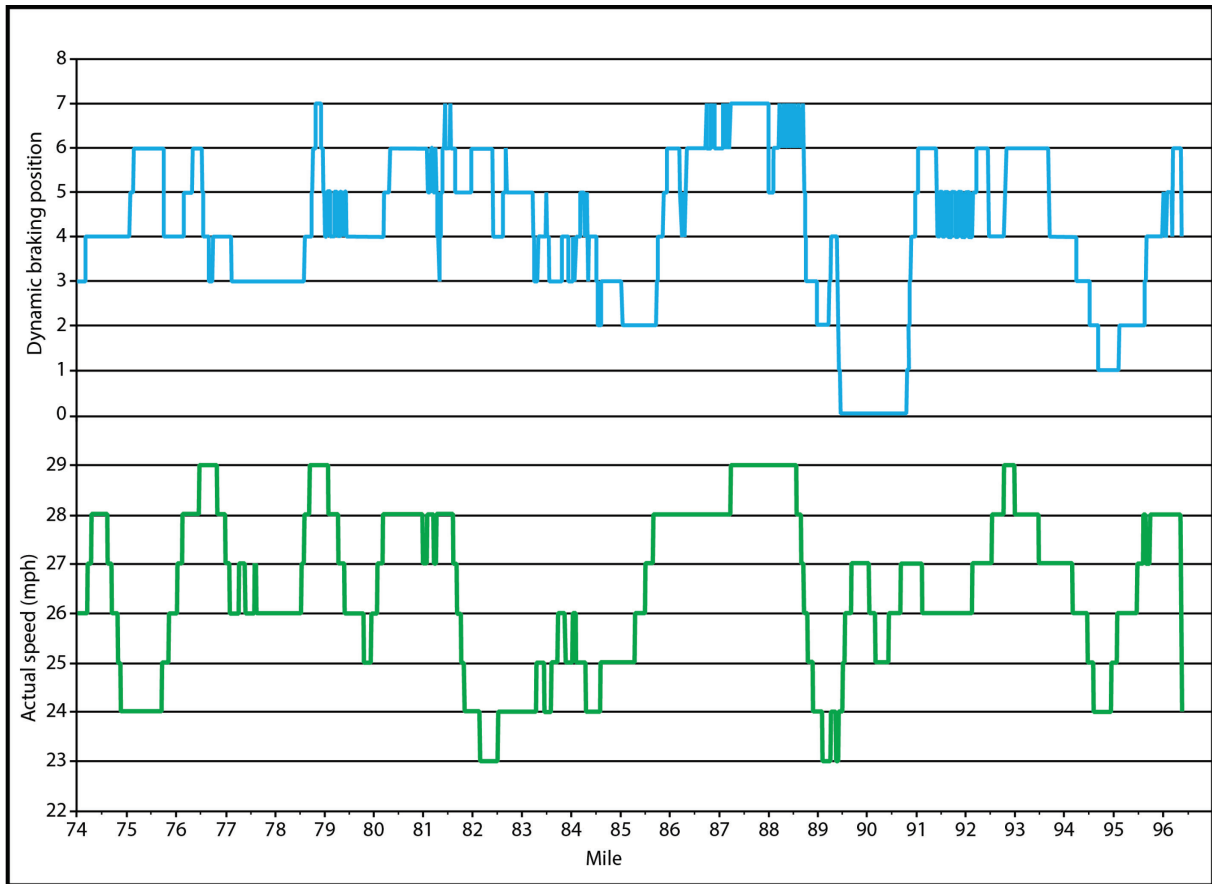
Figure 5. The occurrence train's speed profile and dynamic braking position from Mile 74 to Mile 96 (43" wheel data)

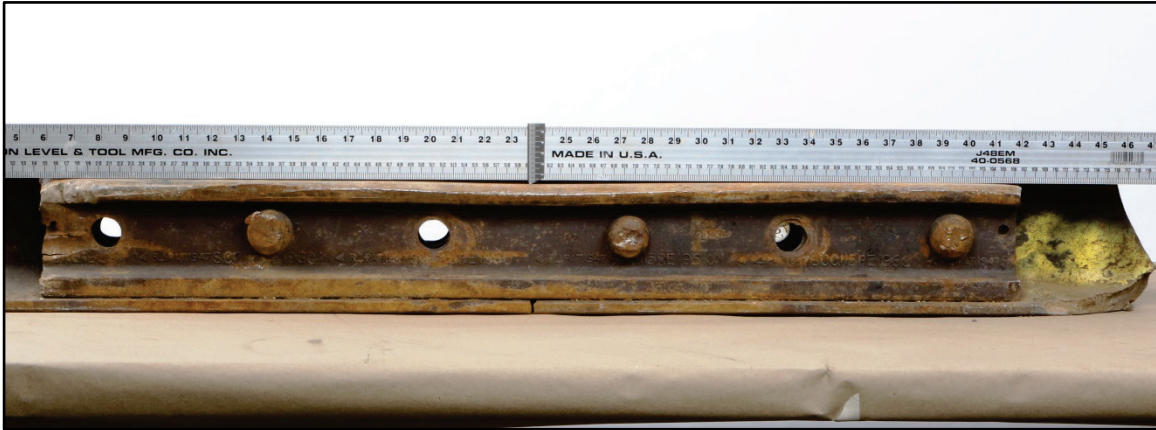
A 34-foot plug rail (1987 Sydney) had been previously installed in the high rail near Mile 96.38. Prior to the occurrence, both joints for the plug rail were reported to be fully bolted. Following the occurrence, both joints were intact, but the nuts (on the gauge side) for 3 bolts had been sheared off on each joint (Figure 6). The plug rail was also broken near the south joint.

Figure 6. Gauge joint bar with missing bolts

The gauge joint bars showed wheel flange contact. The rail head wear on the high rail was 7 mm, which was 1 mm less than the limit of 8 mm specified in the CN Engineering Track Standards (ETS) before high clearance joint bars are required.

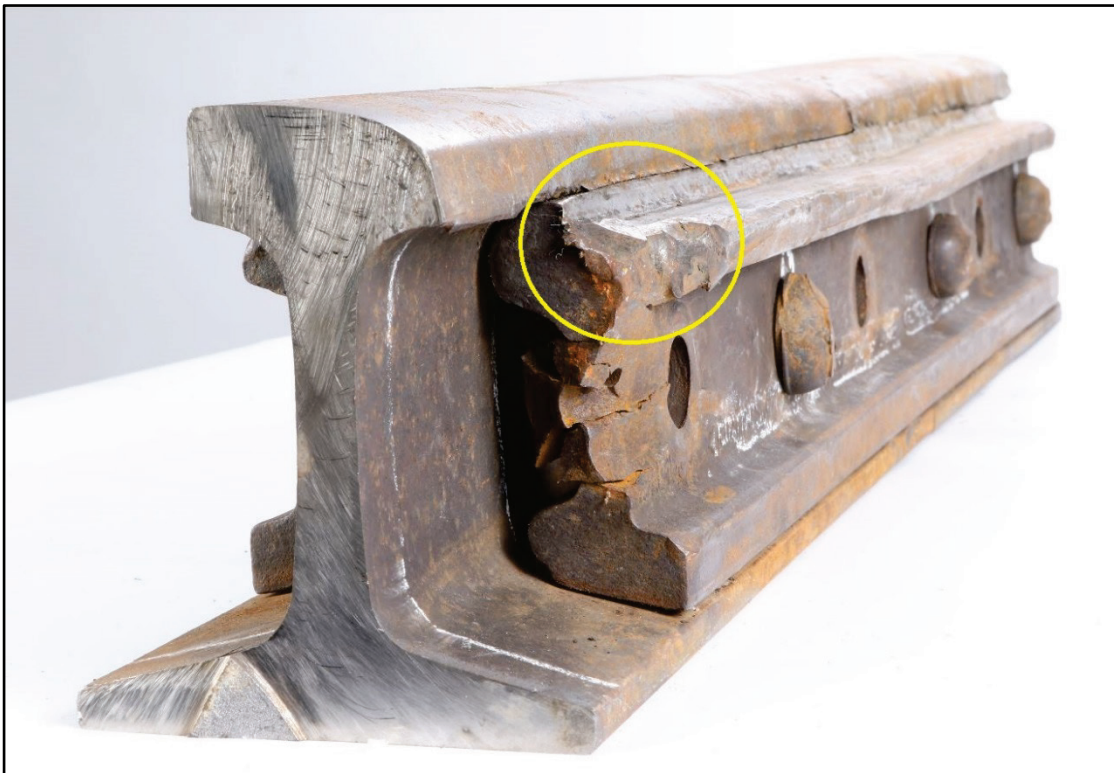
A detailed examination of the rail joint (Figure 8) made it possible to determine that the plug rail and piece of rail failed in overstress as a result of derailment forces. No pre-existing defect was observed.

The gauge-side joint bar and 3 empty bolt holes showed wheel flange impact damage. There were 3 missing joint bar bolts that were likely broken off during the derailment sequence.

Figure 8. Gauge bar and bolt hole with wheel flange impact damage on the corner of the joint bar (circled)

The joint bar was missing 3 of the 6 bolts. However, it was reported that both plug joints had been fully bolted at the time of the derailment.
