RAILWAY INVESTIGATION REPORT R17H0015

Crossing collision

Canadian Pacific Railway

Colborne, Ontario

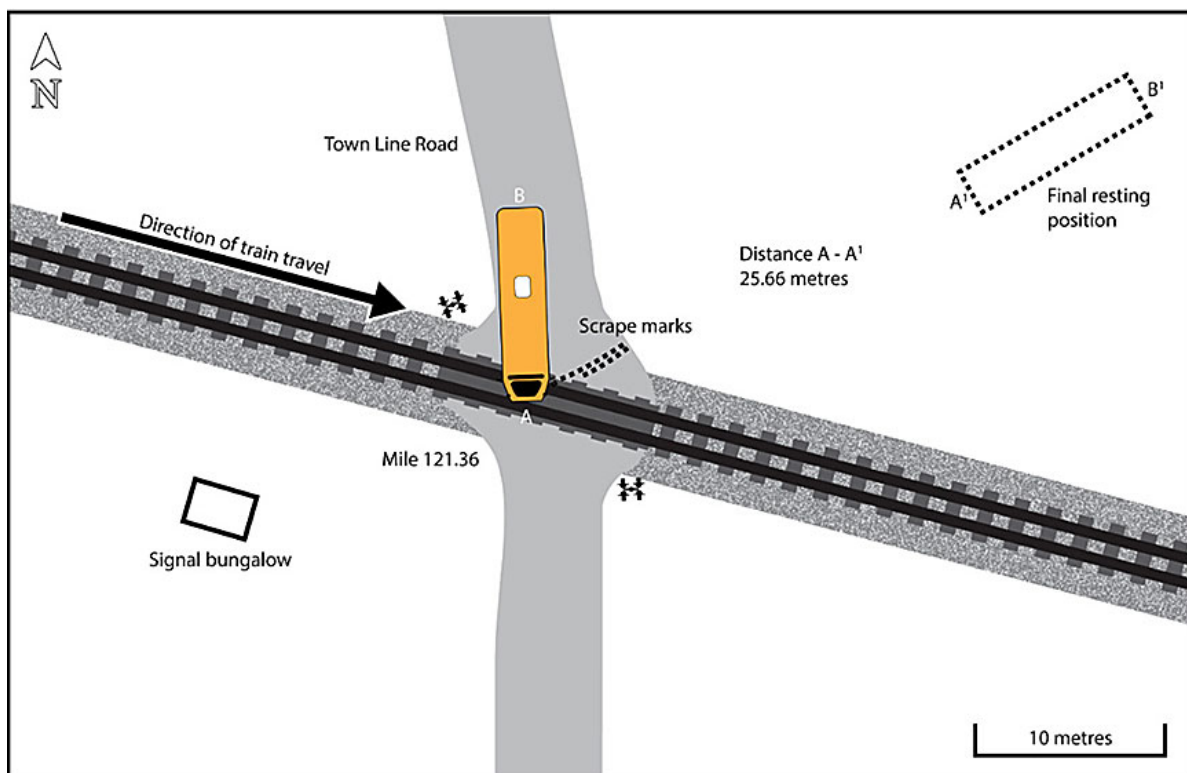
Figure 2. Site diagram

Following the collision, the bus came to rest off the roadway in the northeast quadrant of the crossing, about 26 m from the roadway (Figure 2). The bus sustained severe impact damage to its head end (cab) and its tail end (Figure 3, Figure 4). The passenger side of the cab was destroyed. The signal mast, positioned in the northwest quadrant of the crossing, was knocked over. Scrape marks were present on the surface of the roadway leading from the tracks toward the location of the bus.

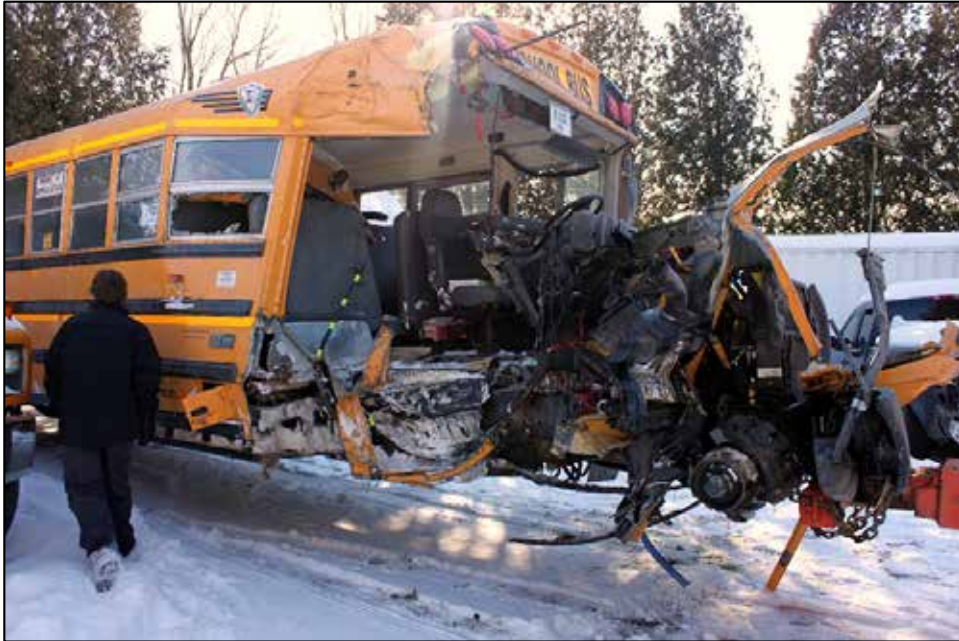
Figure 3. Front passenger side of the damaged school bus

- The impact damage to the front-right side of the bus was limited to the front wheel, the engine hood, the main entrance door, and the step well. The livable space for the driver and the floor beneath the driver's seat were not damaged, nor was the livable space for the passenger area right behind the main entrance door and in the middle of the bus.

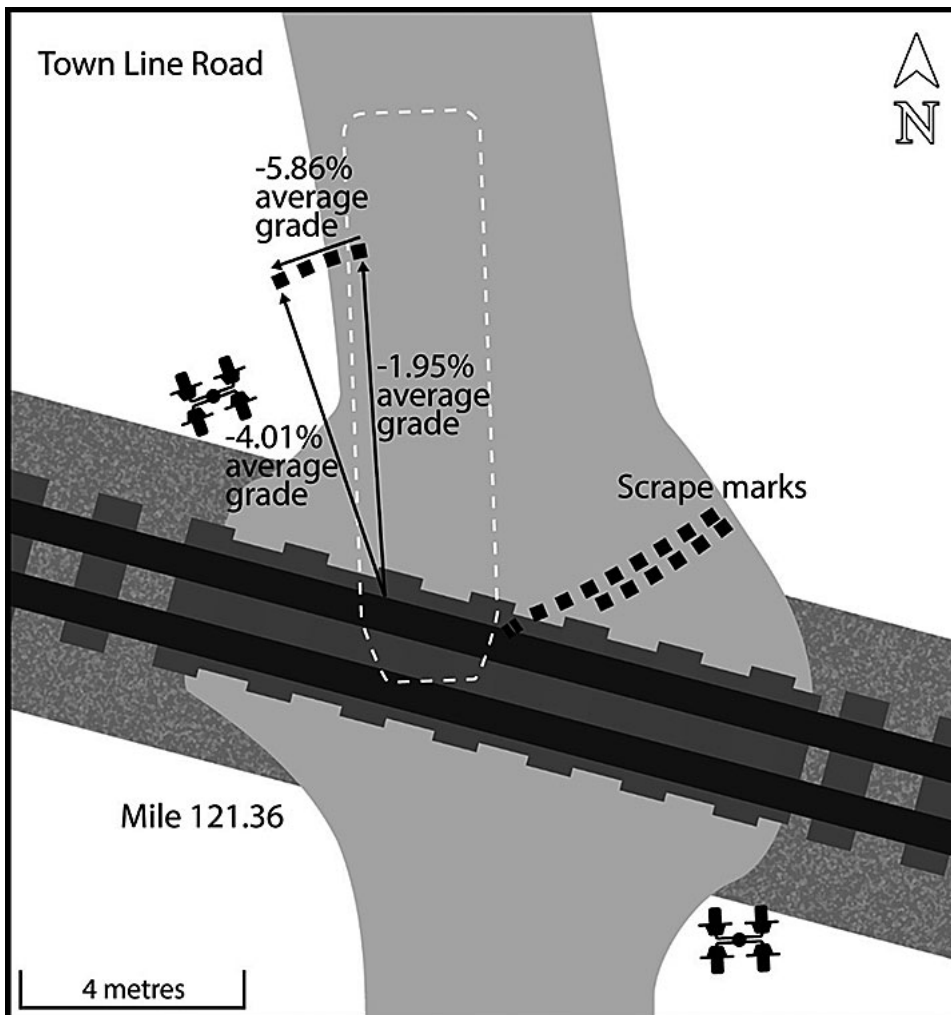
Figure 6. Roadway grade at the north approach of the crossing

Travelling south toward the crossing, the road ascends at a grade of 5.68% until about 8 m (26.2 feet) from the nearest rail, where it levels to an average grade of 1.66%. At 6.1 m (19.9 feet) from the nearest rail (approximately where the rear tires of the stationary bus were situated), the grade of the road was 1.95% (Figure 6). At this location, the perpendicular incline of the road (i.e., toward the west shoulder) was 5.86%, resulting in an effective grade of the roadway near the shoulder of 4.01%.
