RAILWAY INVESTIGATION REPORT

R17T0164

Main-track derailment

Canadian National Railway Company

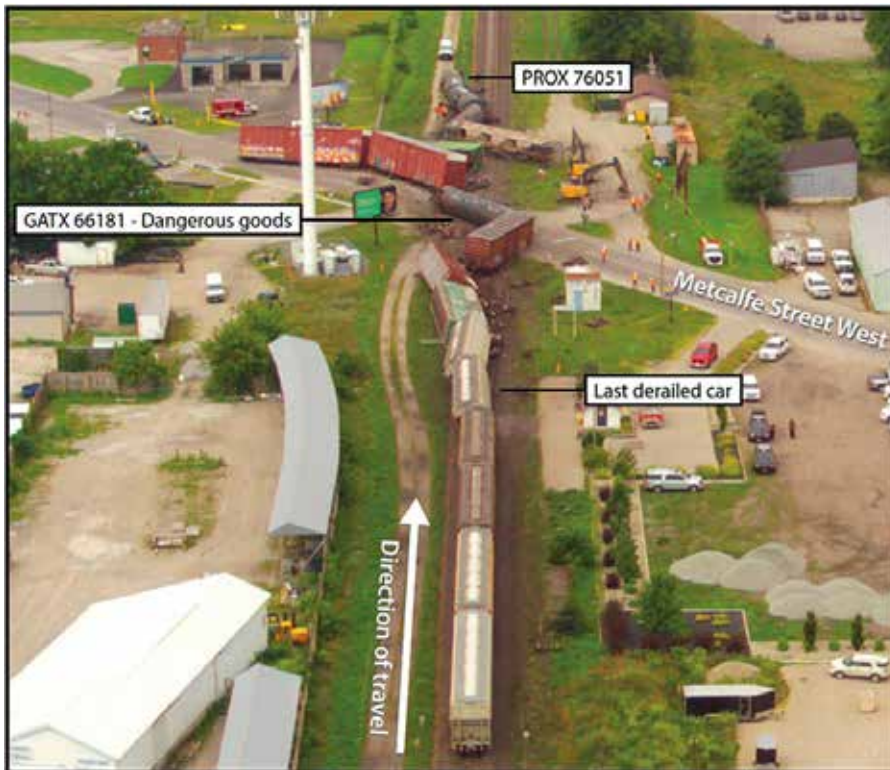
The site examination revealed that 14 cars had derailed (Figure 2). The 109th car from the head end, covered hopper car NAHX 35909 (load of cement) was oriented with the A-end³ leading. It remained coupled to the head end of the train with all wheels on the rail. It came to rest about 2000 feet west of the derailment site. Although car NAHX 35909 was not derailed at the time of the examination, all 8 wheel treads were extensively scraped and gouged, consistent with being recently derailed. The wheel treads on car NAHX 35909 had the most tread damage of any of the derailed cars.

Figure 2. Accident site (Source: Ontario Provincial Police, with TSB annotations)

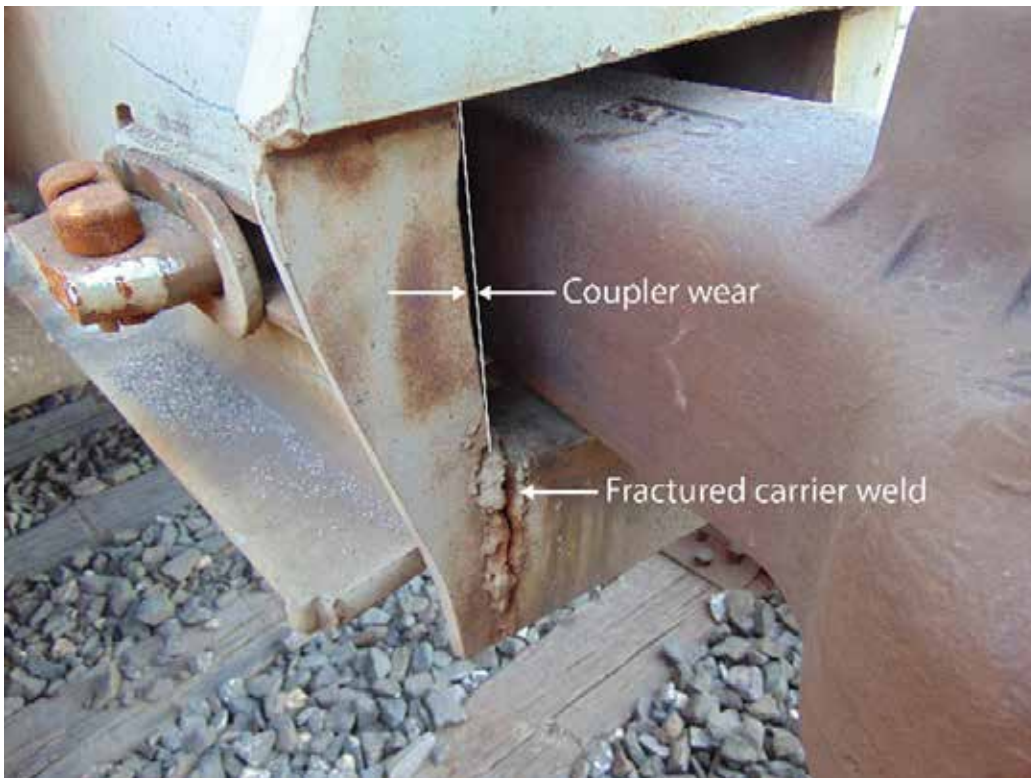
In addition to the damage to the wheels, a site examination of NAHX 35909 showed that both A-end carrier welds were fractured. The right-side⁴ (R-side) coupler striker plate displayed wear that corresponded to the profile of a coupler shank (Figure 3).

Figure 3. Right-side, A-end striker plate on car NAHX 35909

The R-side weld securing the A-end coupler carrier was cracked, which suggests that a higher-than-usual force was applied to the R-side coupler striker plate by the coupler shank. The A-end, R-side vertical coupler striker plate of car NAHX 35909 exhibited wear that permitted the coupler swing angle to increase beyond the established nominal limit of 7° for E60-type couplers.

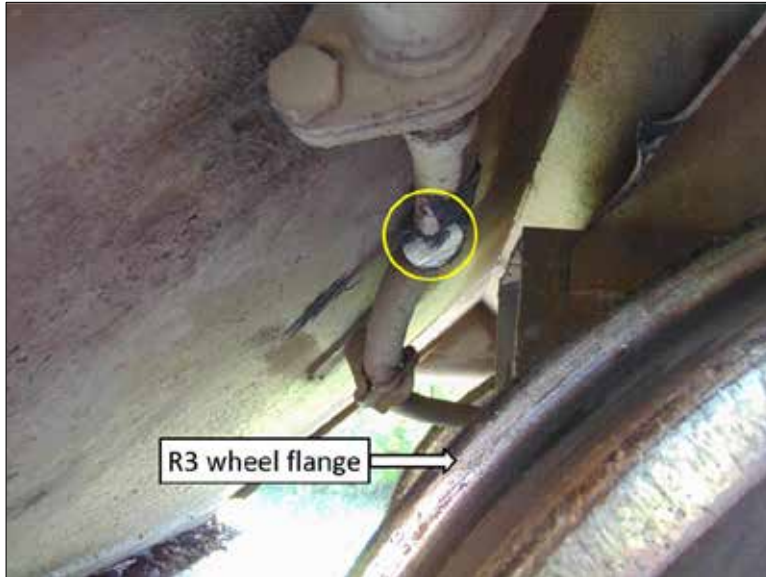
In addition, wheel flange friction burn/grind marks were observed on the air brake pipe near the R3⁵ wheel. The air brake pipe was partially severed, allowing air to escape. The cut ends displayed signs of heat damage, and the melted metal reduced the diameter of the air brake pipe (Figure 4 and Figure 5).

Figure 4. Burn/grind marks on air brake pipe (circled) from contact with the R3 wheel flange (arrow) from car NAHX 35909

Car NAHX 35909 travelled 1.15 miles between the Carroll Street East crossing, where it derailed, and the Caradoc Street South crossing, where it re-railed itself. As the car travelled westward in a derailed condition, the leading A-end truck was skewed such that the R3 wheel partially burnt/ground through the air brake pipe and released air pressure.

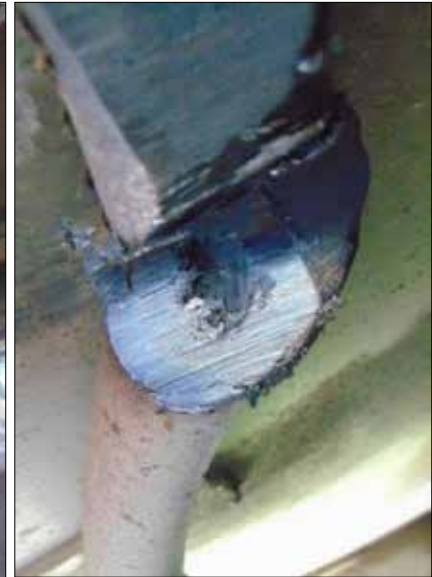
Figure 5. Close-up of air brake pipe burn/grind marks

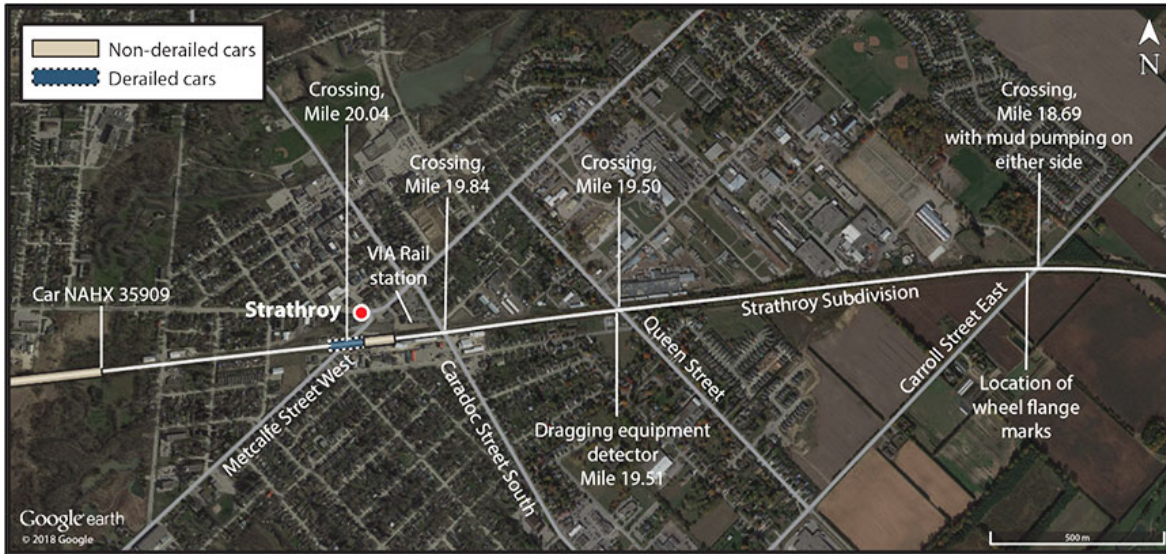
The wheel flange mark initiated on the gauge side of the rail and continued across the rail head diagonally westward for about 25 feet, then dropped off to the field side. From this location, wheel impact marks were observed on the rail base, tie plates, ties, spikes, and rail anchors, between the ties and on the field side of the north rail, extending westward to where the derailed cars came to rest in the vicinity of the Metcalfe Street West crossing at Mile 20.04 (Figure 6).

Figure 6. Accident site overview (Source: Google Earth, with TSB annotations)

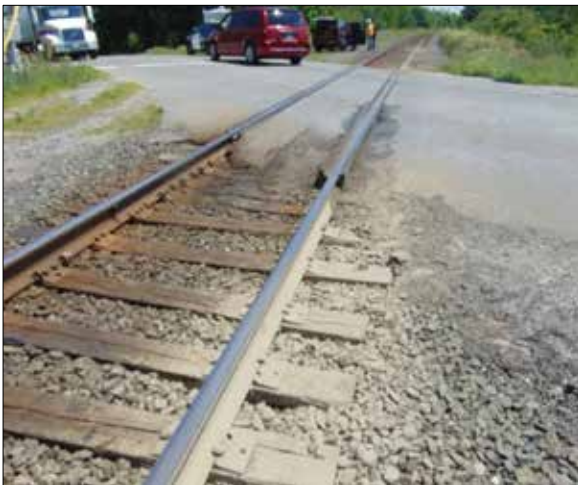
At the Carroll Street East crossing, ballast on both sides of the crossing was contaminated with mud. On the west side, the ballast between the rails and south of the south rail exhibited mud contamination along the first 30 feet west of the crossing (Figure 7). On the east side of the crossing, ballast between the rails and south of the south rail adjacent to the crossing was also contaminated with mud (Figure 8).

Figure 7. Mud contamination on the west side of the Carroll Street East crossing, looking east

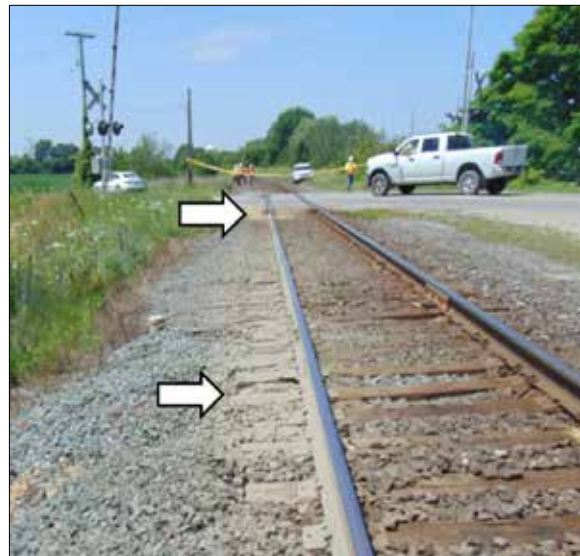
Figure 8. Mud contamination on the east side of the Carroll Street East crossing, looking west

Just east of the POD, track stiffness had been diminished by the presence of areas of heavy mud pumping on the south rail, which could contribute to reduced vertical force for mate wheels traversing the north rail. The heavy mud pumping not only produced uneven track stiffness distribution between the crossing surface and the track section to the west, but also affected the track surface and cross-level. Emerging track surface and cross-level conditions approaching the POD were identified in the 12 April 2017 track geometry inspection, but were not severe enough to require any immediate remedial action because they were below

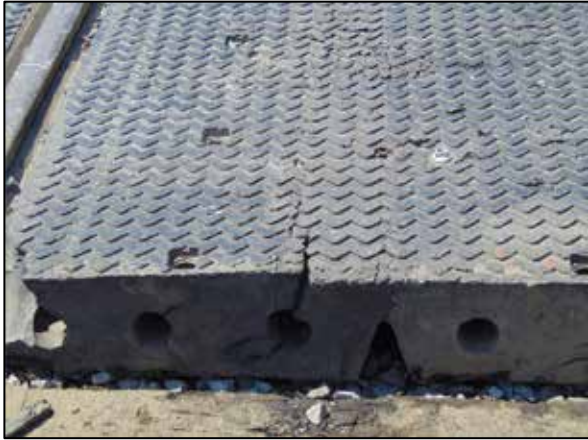
Slightly further west, the Queen Street crossing (Mile 19.50) displayed wheel impact marks on its rubber surface (Figure 9). A DED, located immediately west of the crossing (Mile 19.51), showed 3 sets of wheel impact marks on its deflection paddles (Figure 10). These marks continued on the ballast and track structure between the rails for about one third of a mile further westward to the Caradoc Street South crossing (Mile 19.84). At the Caradoc Street South crossing, the east end of the concrete surface displayed wheel flange

Figure 9. Queen Street crossing rubber surface (Mile 19.50)

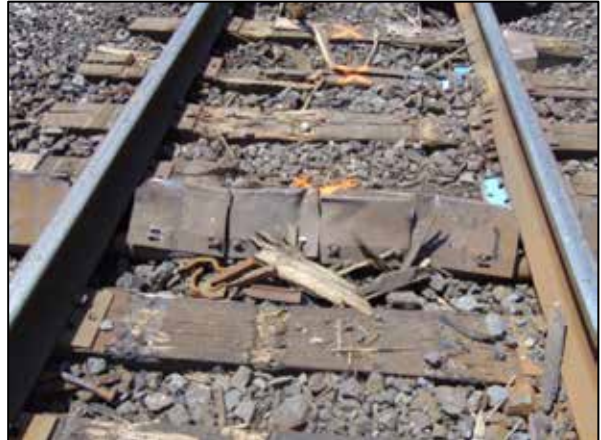
Figure 10. Wheel impact marks on dragging equipment detector deflection paddles (Mile 19.51)

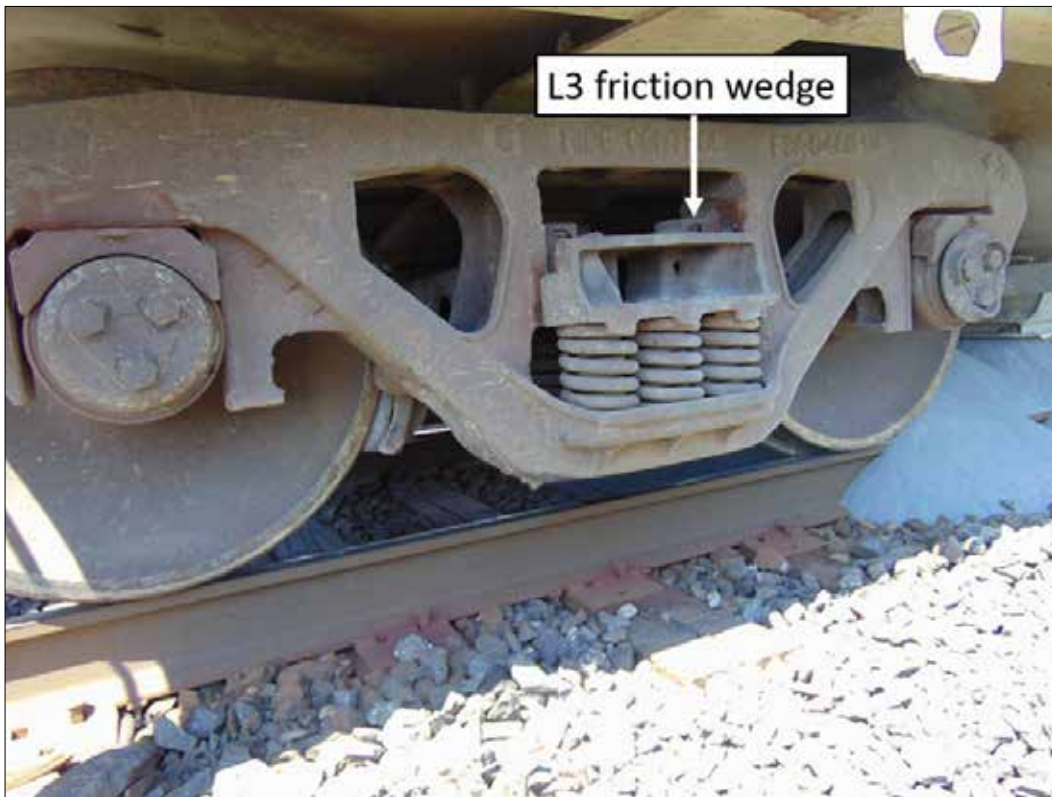
When new, the ASF ride control truck has a friction wedge rise of $\frac{15}{16}$ inch. According to Rule 46 of the AAR Interchange Rules, when wedge rise on ride control trucks exceeds $\frac{13}{16}$ inches, it is condemnable when the car is on a repair track. Theoretically, wear on an individual friction wedge, side frame column, or bolster pocket may not be condemnable, but the combined wear of the 3 components in 1 location could result in wedge rise that is condemnable. Friction wedge rise is considered to be indicative of a truck that is losing stability and may become problematic (Figure 11).

Figure 11. NAHX 35909 A-end truck with L3 friction wedge rise

1. **Friction wedge rise.** The L3 wedge rise on car NAHX 35909 had reached the AAR Rule 46 limit of $1^{13}/_{16}$ inches. This reduced the truck squaring and damping forces, and contributed to the elevated L/V ratio. When compared with the calculated L/V ratio of 0.82 in the occurrence case, with no wedge rise, the maximum L/V ratio at the initial derailment location was calculated to be 0.25. The wedge rise was the most influential of the 6 conditions that contributed to this occurrence.
2. **Wheel/rail contact.** When compared with the calculated L/V ratio of 0.82 in the occurrence case, with optimal wheel rail contact, the maximum L/V ratio at the initial derailment location was calculated to be 0.33. The effect of wheel/rail contact was another influential contributing factor in this occurrence (Figure 13 and Figure 14).

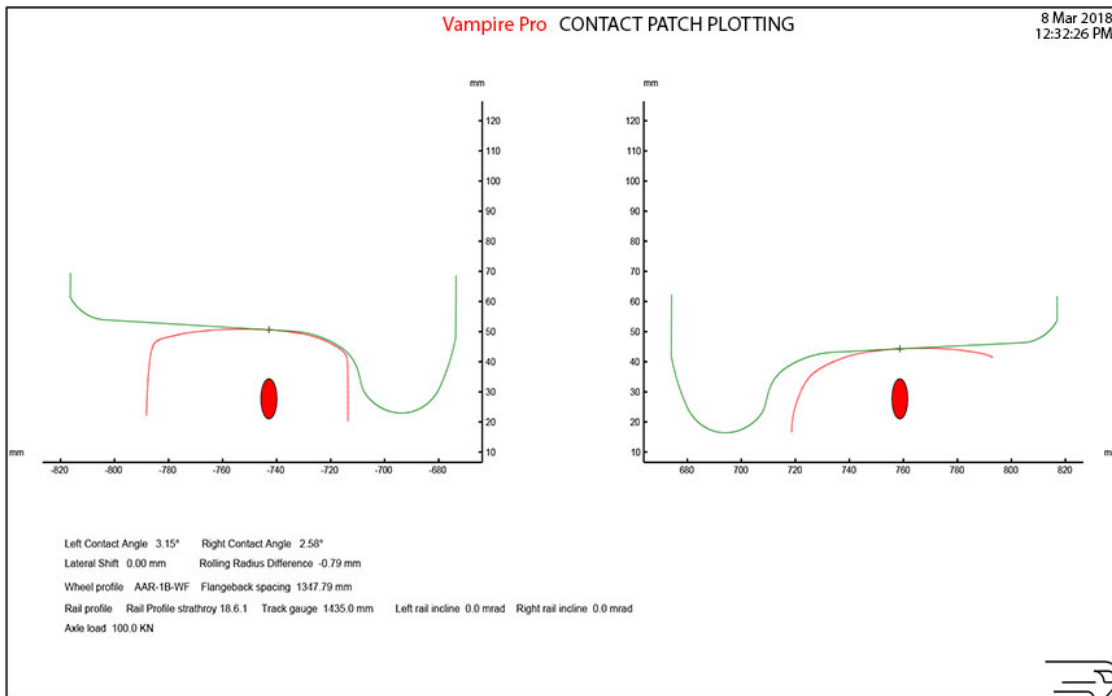
Figure 13. Contact patches (indicated as red circles) of train wheel and rail between axle 4 and the rail at Mile 18.616

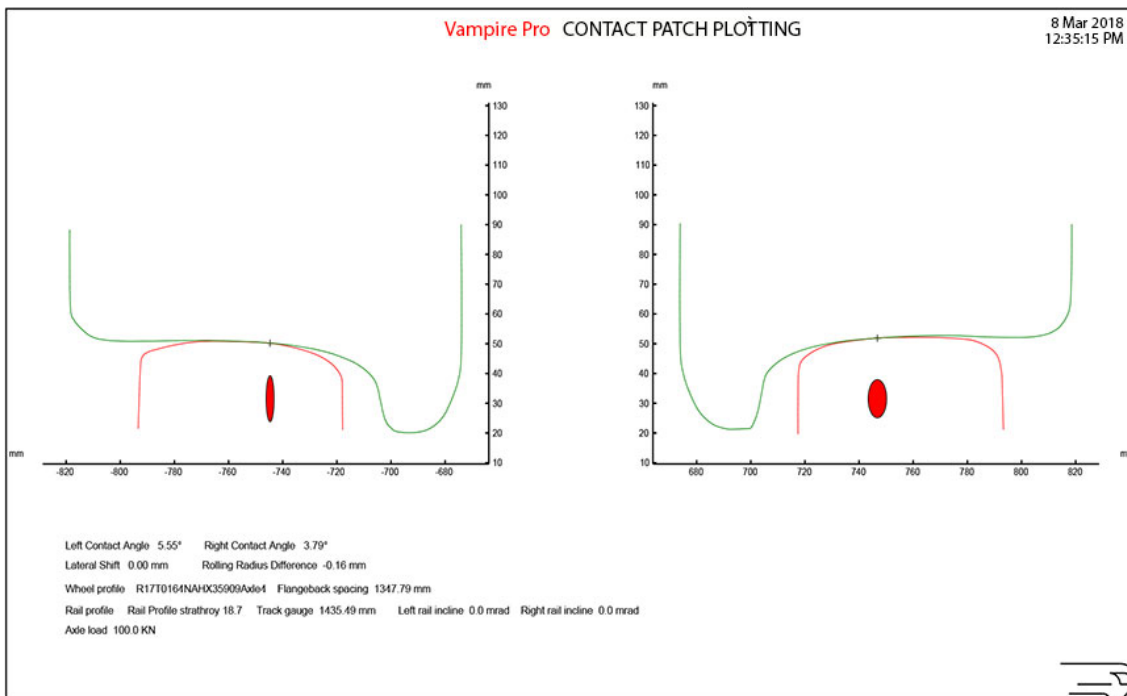
Figure 14. Contact patches (indicated as red circles) of train wheel and rail between axle 4 and the rail at Mile 18.70
