RAIL TRANSPORTATION SAFETY INVESTIGATION REPORT R17V0096

NON-MAIN TRACK UNCONTROLLED MOVEMENT, COLLISION, AND DERAILMENT

Englewood Railway, Western Forest Products Inc.
Cut of cars
Woss, British Columbia
20 April 2017

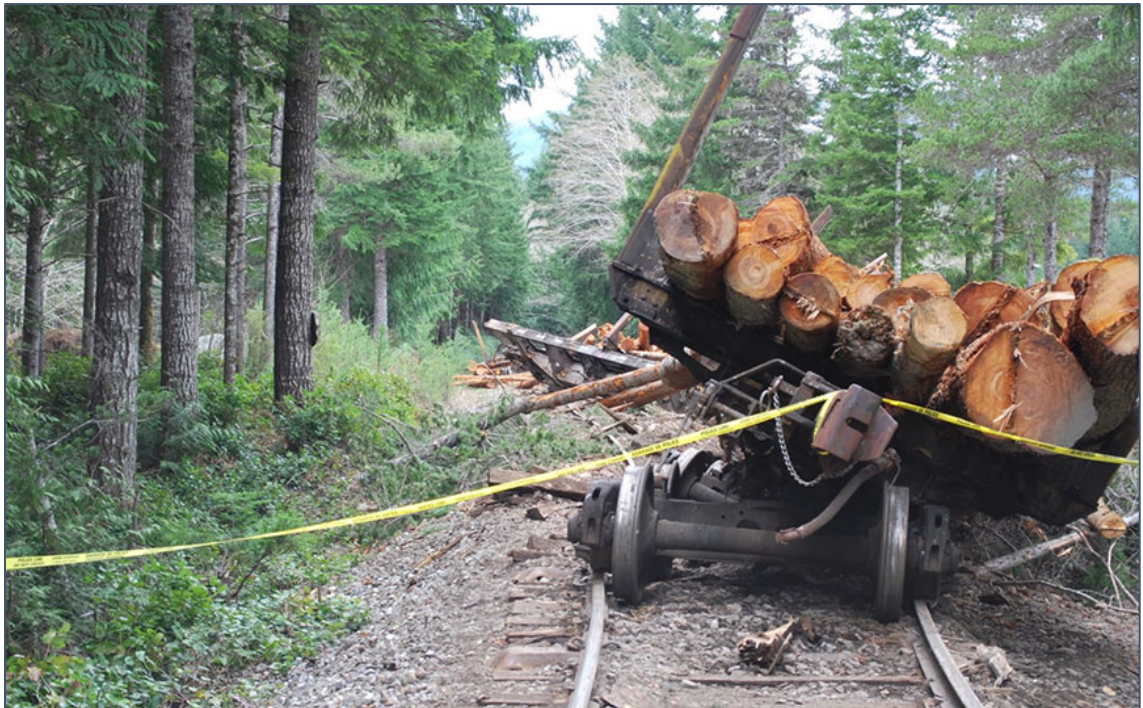
Figure 8. First derailment location, with derailed cars leaning or rolled to the high side of the curve

At the first derailment location, the 7 derailed cars were positioned in various orientations through the curve, predominantly leaning or rolled to the high side (the right-hand side) of the curve (Figure 8). Damage to the vertical braces on the north side of some of the cars (e.g., car 738) matched gouge marks in the ballast to the north of the track. There were no wheel flange marks between the rails at the point of derailment and no wheel flange marks on the rails or ties approaching the curve. The cars were tipped over with their loads of logs strewn throughout the curve and on top of some of the derailed cars. The 7th car (car 738) had derailed on the exit spiral of the curve, just north of the A Browne crossing.

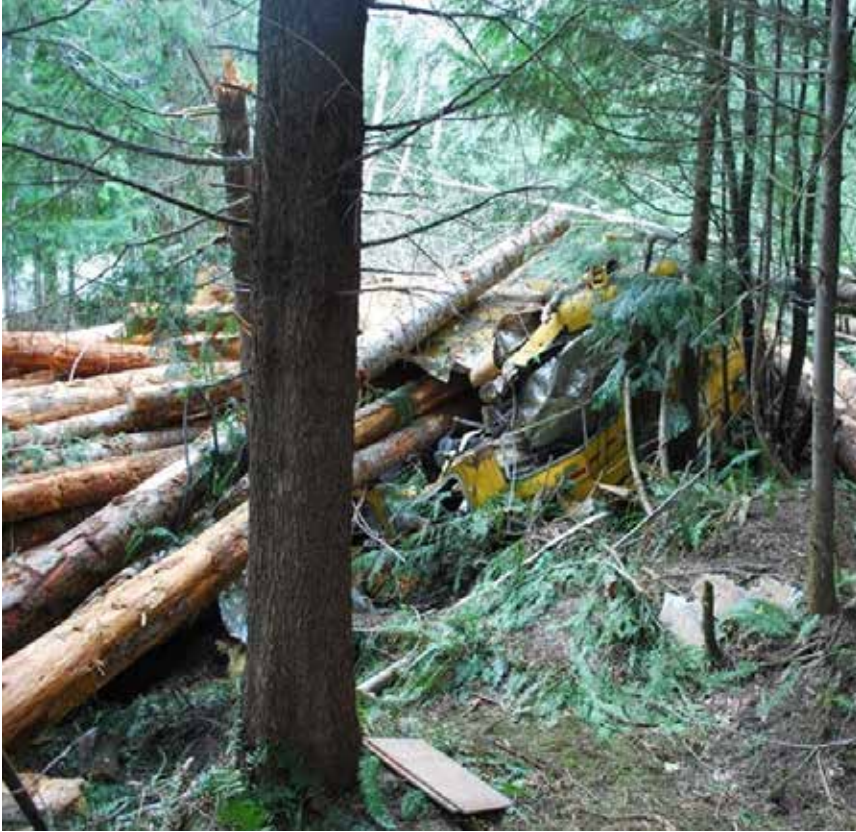
At the second derailment location, the remaining 4 cars, the speeder and the backhoe had derailed to the high side, in the body of the 14° right-hand curve. At this location, the track had shifted to the inside of the curve, which is consistent with cars tipping to the high side. The cars had lost their loads of logs, with some logs burying the backhoe and the speeder (Figure 9). The weight of the logs and the impact forces during the collision and derailment severely damaged the speeder and the backhoe.

Figure 9. Second derailment location, showing the speeder buried under logs

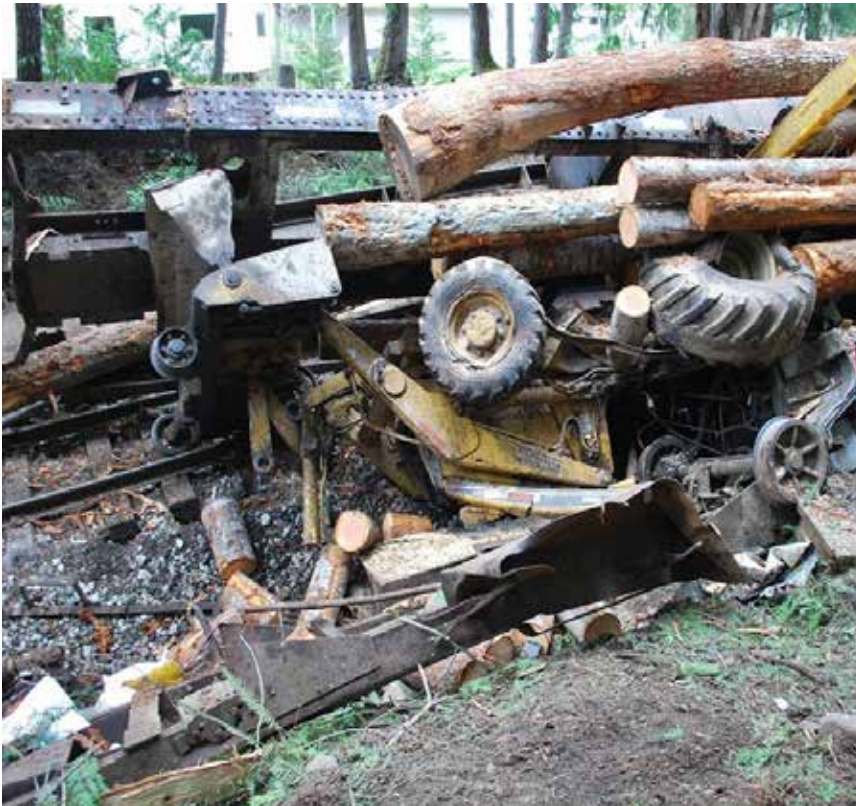
Figure 10. Second derailment location, showing the backhoe buried under logs

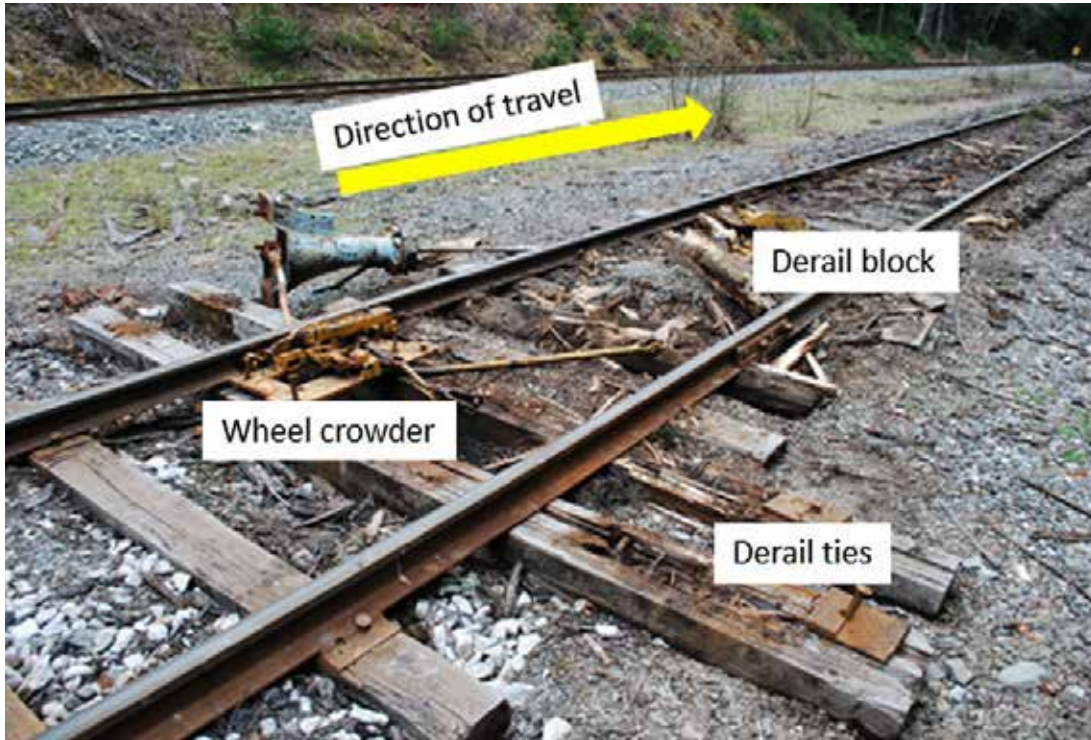
- At the derail protecting Track 1 at the Woss Reload Centre, the derail block had been completely removed.
- The switch stand was pulled over and the ties were displaced to the north as the sliding derail was removed, allowing the crowder to disengage.
- Spikes were ripped out and the derail ties were destroyed. The derail ties had been displaced laterally by about 28 inches.
- The ties were severely degraded. Interior rot in the centre of these ties was more visible following the removal of the derail block.
- The derail block had 12 holes in the flat tie flanges of the guide box that could be filled with spikes. Only 8 derail spikes were recovered at the site.
- The spikes used were straight spikes, which is acceptable according to the manufacturer's installation instructions.
- The ballast was fouled with fine grain particulate matter inhibiting proper support and drainage.

Figure 14. Derail damaged and rendered inoperable

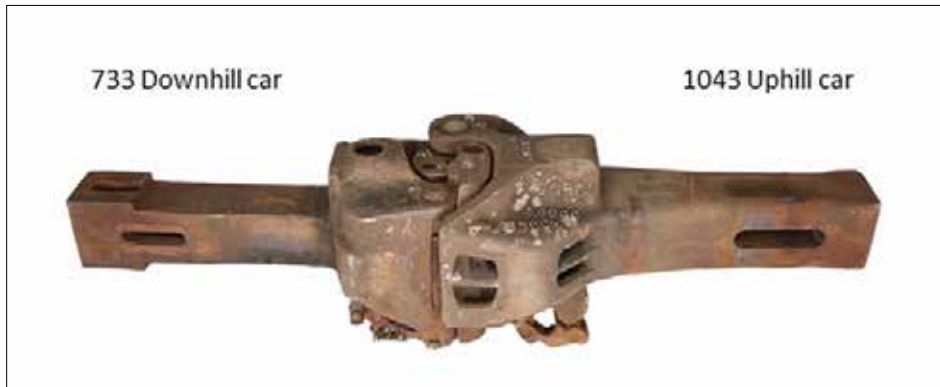
The couplers from the 2 subject cars (car 1043 and car 733) were sent to the TSB Engineering Laboratory for a detailed examination (Figure 14). The primary focus of the examination was to determine why the coupler knuckle of car 1043 inadvertently released after a pull test had been performed and deemed successful.

Figure 15. Occurrence couplers

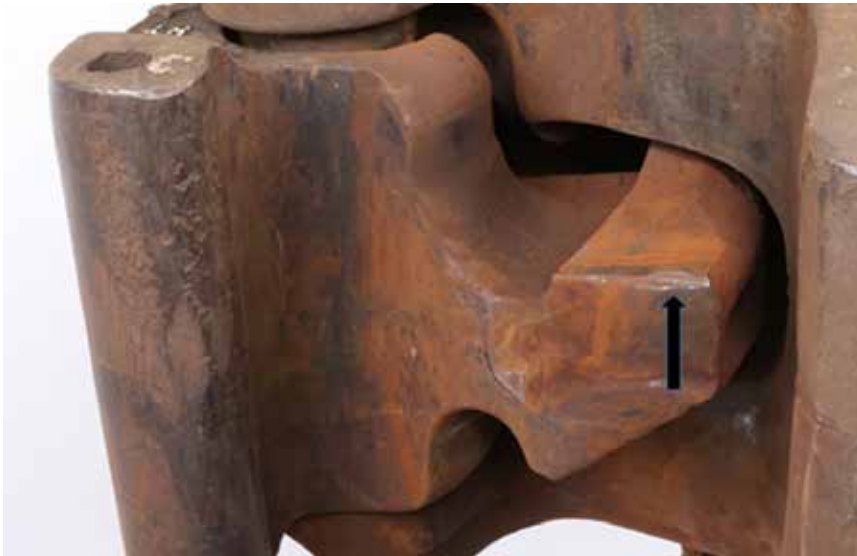
As part of the laboratory examination, the coupler and its knuckle were inspected using gauges 25623-1 and 44057, as per the AAR guidelines. The contour of the knuckle and its fit in the coupler body were determined to be acceptable.³⁰ However, there was minor deformation with a fresh (not rusted) appearance present on the top edge of the knuckle tail (Figure 16).

Figure 17. Knuckle of uphill car 1043, showing deformation on knuckle tail (indicated by an arrow)

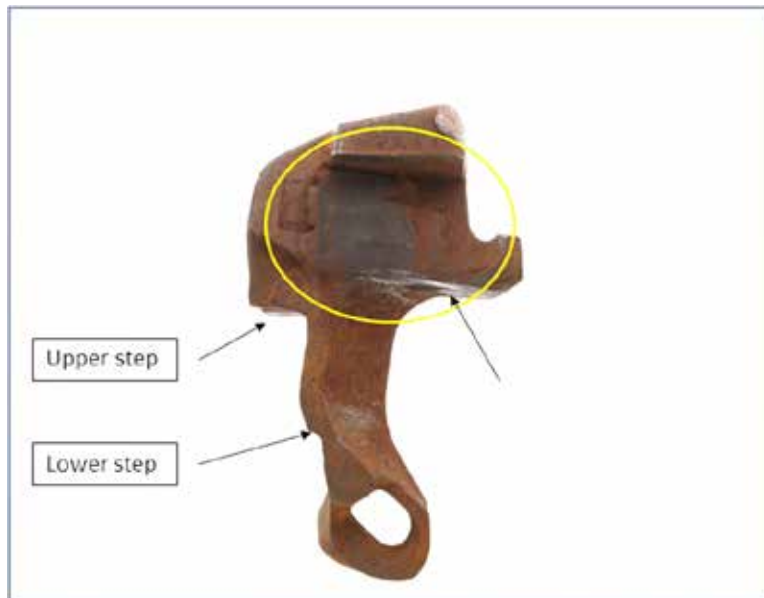
Although not evident from an external visual examination of the coupler, weld metal with an aged appearance was present on the lock's knuckle engagement surface, indicating a previous repair. Englewood Railway had no records of having performed any weld repairs on the couplers on car 1043. Repairs can be made on coupler locks with a worn knuckle

engagement surface by welding and heat-treating the lock, as long as they are performed according to AAR specifications.³¹ However, the weld repair did not meet the original material requirements.

Figure 18. Subject coupler lock, with weld repair circled

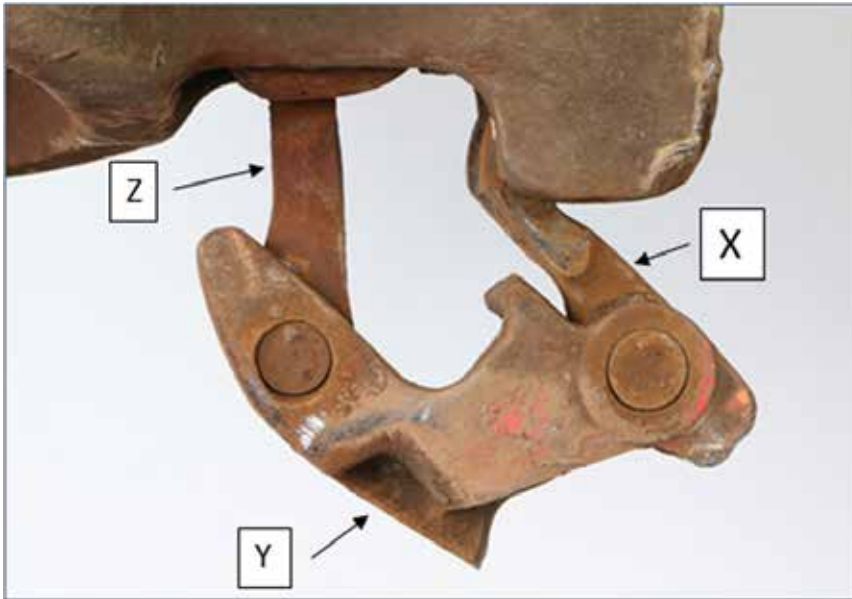
Figure 19. Bottom-operated lock-lift assembly of uphill car 1043 showing toggles X, Y, and Z (arrows)

The subject lock-lift assembly was examined and showed wear in the toggle joints and rivets. This wear allowed for increased lateral movement of toggle Z, such that the lock could be removed without pulling the lock-lift up through the lock hole.

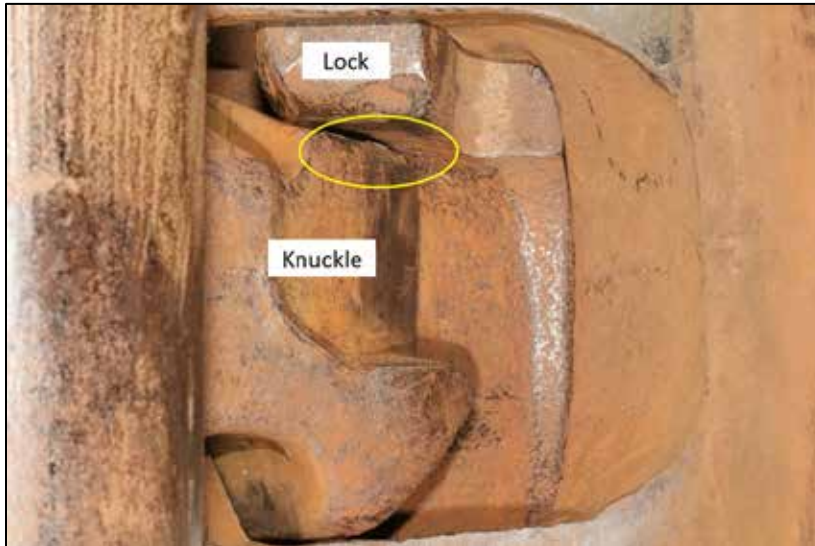
Several times when closing the coupler knuckle, the lock was observed to engage only partially with the knuckle tail (Figure 19 and Figure 20). Deformed areas were present at the top edge of the knuckle tail and on the lower edge of the lock. The deformation on these coupler components was identical.³³

Figure 20. Subject coupler lock partially dropped

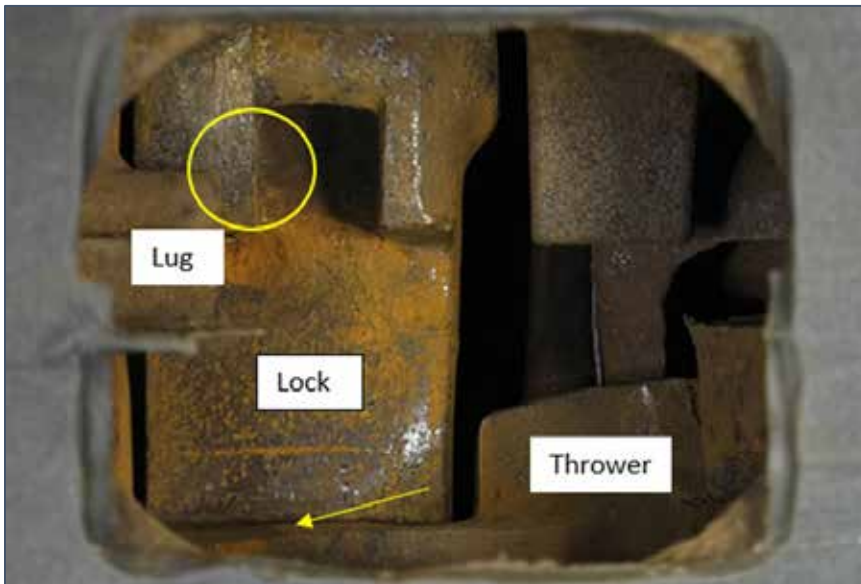
With the lock in the set position, partial interference occurred between the tail of the knuckle and the lock at the front. The radius and hardness of the lock contributed to the partial jamming of the knuckle such that the lock was not in the fully dropped and locked position. For the lock to drop off the set step and down to the fully dropped and locked position (Figure 23), it was necessary to open the knuckle a second time and to close it again.

Figure 23. Close-up of subject lock after closing the knuckle, with lock partially dropped. The lock is sitting with the set step on the top edge of the knuckle thrower (indicated by the arrow).
