Rail Transportation Safety Investigation Report R18D0020

CROSSING COLLISION

Track unit PNR 728

Mile 12.15, Canadian Pacific Railway Vaudreuil Subdivision

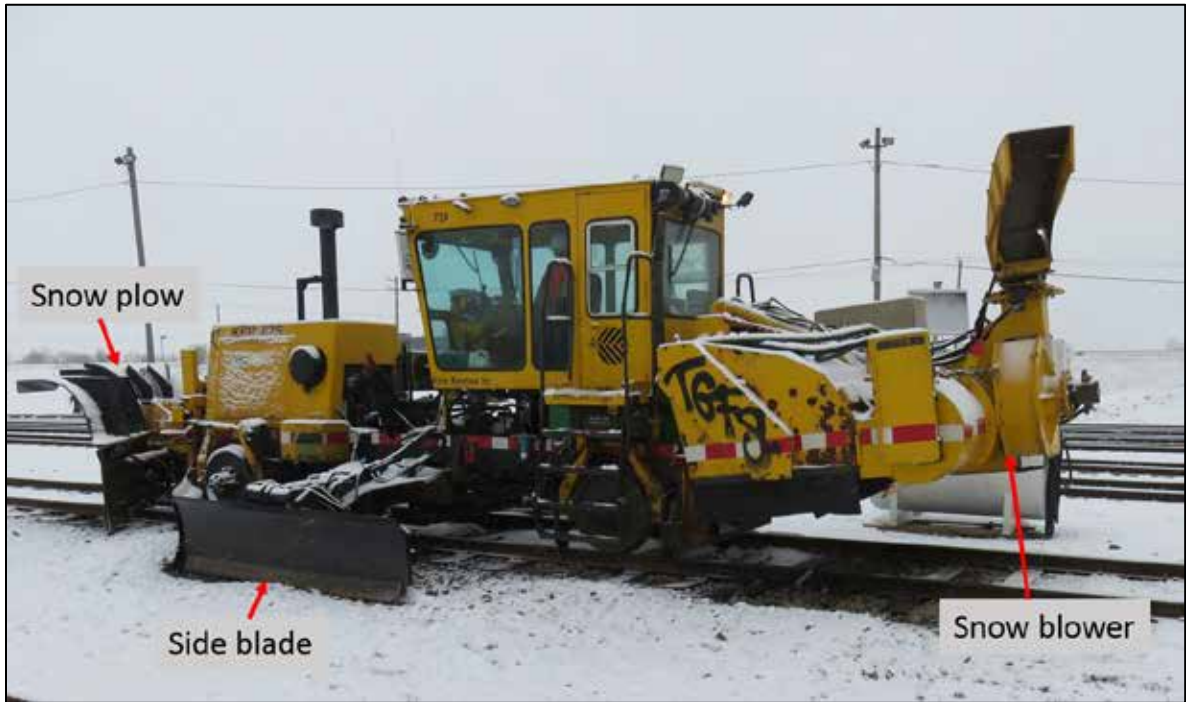
Figure 1. Track unit PNR 728

The TU's last overall mechanical inspection had taken place on 27 December 2017; all noted defects were corrected. After the collision, the TU was inspected and no defects were noted. However, it was determined that mechanical inspections and repairs were not being recorded in the TU's logbook.

In this occurrence, because of the size of the side blades mounted on the TU, the operator was to ensure that the blades were lifted and locked when the TU was approaching passenger platforms at train stations or any other obstacle. To do so, the operator would slow down and use the control handle attached to the seat. When the TU was travelling east, the snow plow was facing forward and the operator was facing in the direction of the movement. When the TU was travelling west, the operator's view was partially obstructed by the snow blower.

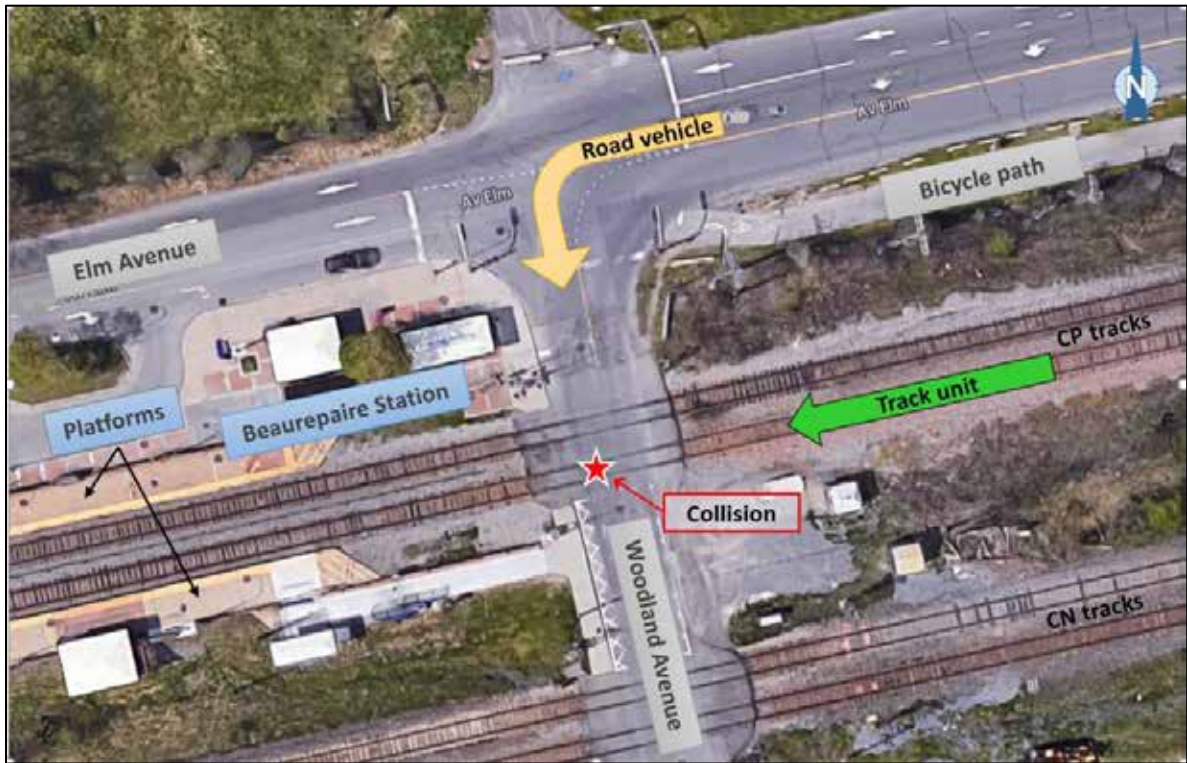
Figure 3. Collision site at Mile 12.15 of the Vaudreuil Subdivision (Source: Google Maps, with TSB annotations)

The collision occurred at a public crossing equipped with a warning system (bell, flashing lights, and gates) that was not activated by the TU.³ The crossing traverses 4 tangent railway tracks⁴ at a 90° angle in an urban neighbourhood. Elm Avenue is located to the north of the CP right-of-way and runs parallel to the tracks. A bicycle path, trees, and utility poles are located along the south side of Elm Avenue. The Beaurepaire commuter train station is located directly to the west of the crossing. There are passenger platforms on both sides of the CP tracks (Figure 3). The crossing gives road vehicles travelling on Elm Avenue access to Highway 20 and the southern part of the city of Beaconsfield.

After the collision, the TU came to a stop on the crossing, obstructing it. There was no apparent damage to the TU, the railway track, or the warning system. The surface of the crossing was partially covered with snow and there were no visible marks. The road vehicle came to a stop on the south side of, and parallel to, CP's south track. The road vehicle was struck above the rear axle on the left side. There was no fuel spill.
