## **RAIL TRANSPORTATION SAFETY INVESTIGATION REPORT R18V0016**

### **MAIN-TRACK TRAIN DERAILMENT**

Canadian National Railway Company  
Freight train C76751-17  
Mile 49.07, Bulkley Subdivision  
New Hazelton, British Columbia  
19 January 2018

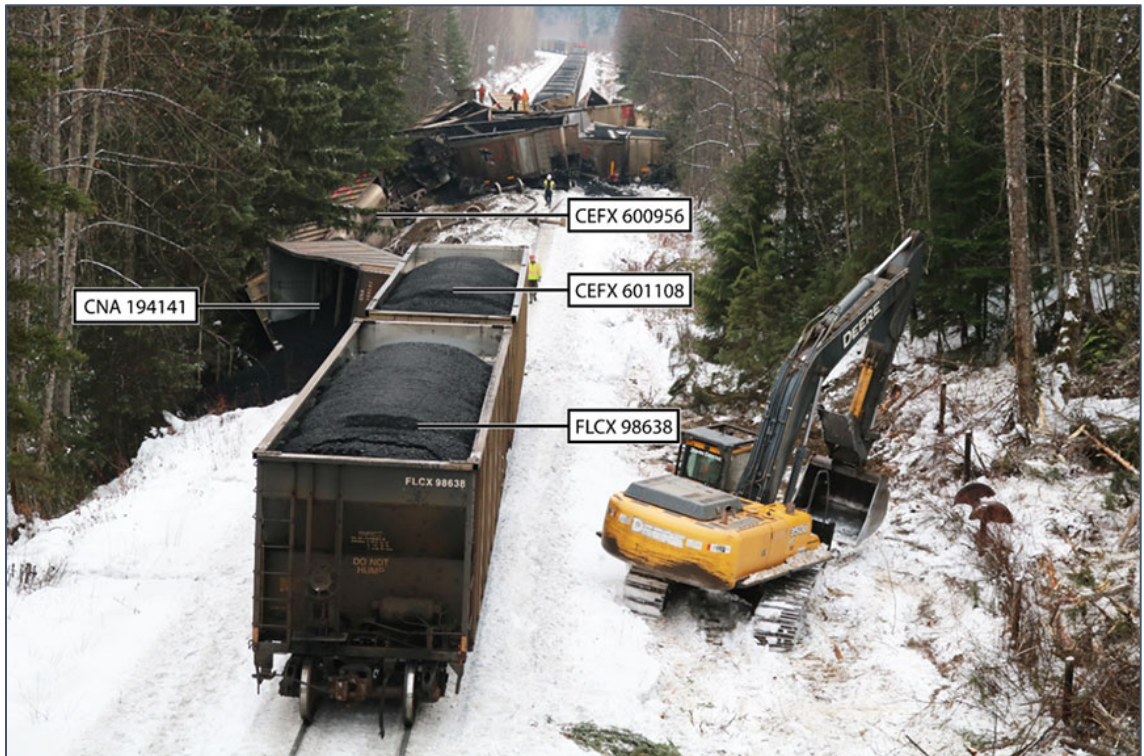
Figure 2. Eastward view of the derailed cars (Source: Interior News, with TSB annotations)

At about 0718, while proceeding at 29 mph through New Hazelton, British Columbia, on the Bulkley Subdivision, the train experienced a train-initiated emergency brake application. The crew made the required emergency radio call. When the train came to a stop, the crew inspected the train and determined that 27 cars had derailed (Figure 2).

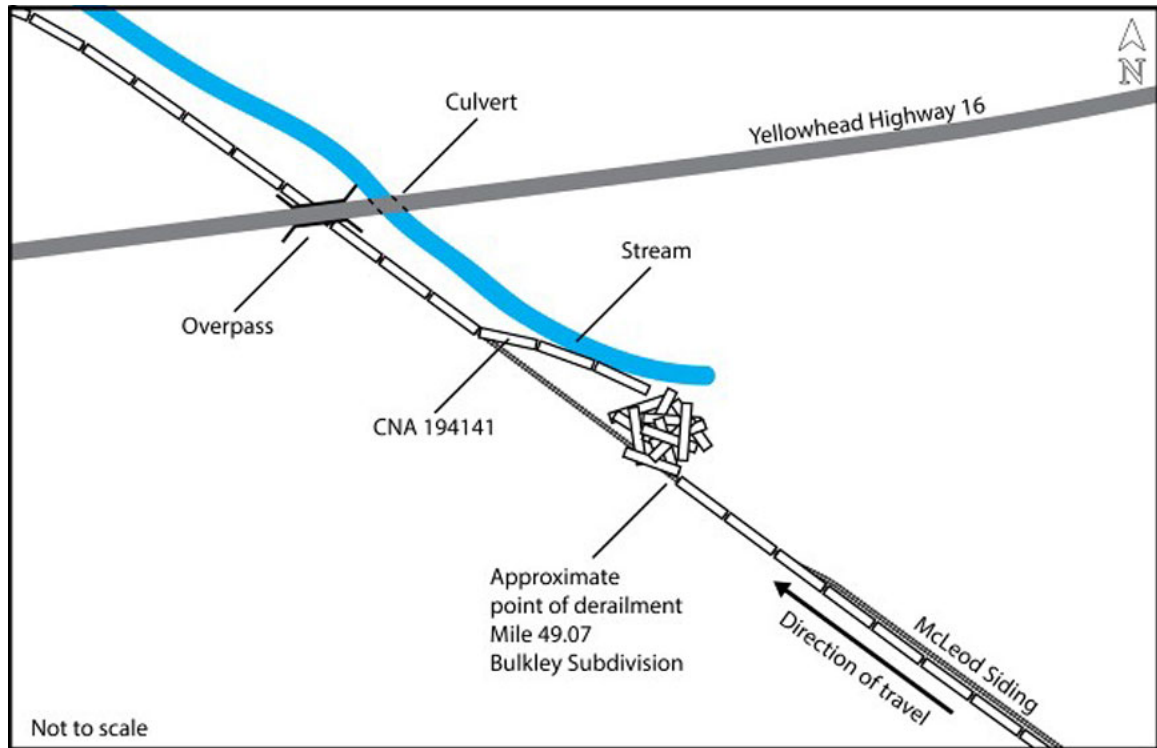
Figure 3. Diagram of the occurrence site

The 50th to the 76th cars derailed. The derailment spanned over 400 feet of track, resulting in localized track damage, including damage to a switch and a switch heater at Mile 48.6. Of the 27 derailed cars, the 2 west-end cars had remained upright and the following 3 cars had rolled over onto their sides and slid down the right-of-way toward Mission Creek, a nearby waterway. The remaining 22 cars had come to rest in a pile at various angles and orientations (Figure 3).

The 52nd car, CNA 194141, sustained a broken axle. The approximate point of derailment was determined to be at Mile 49.07.

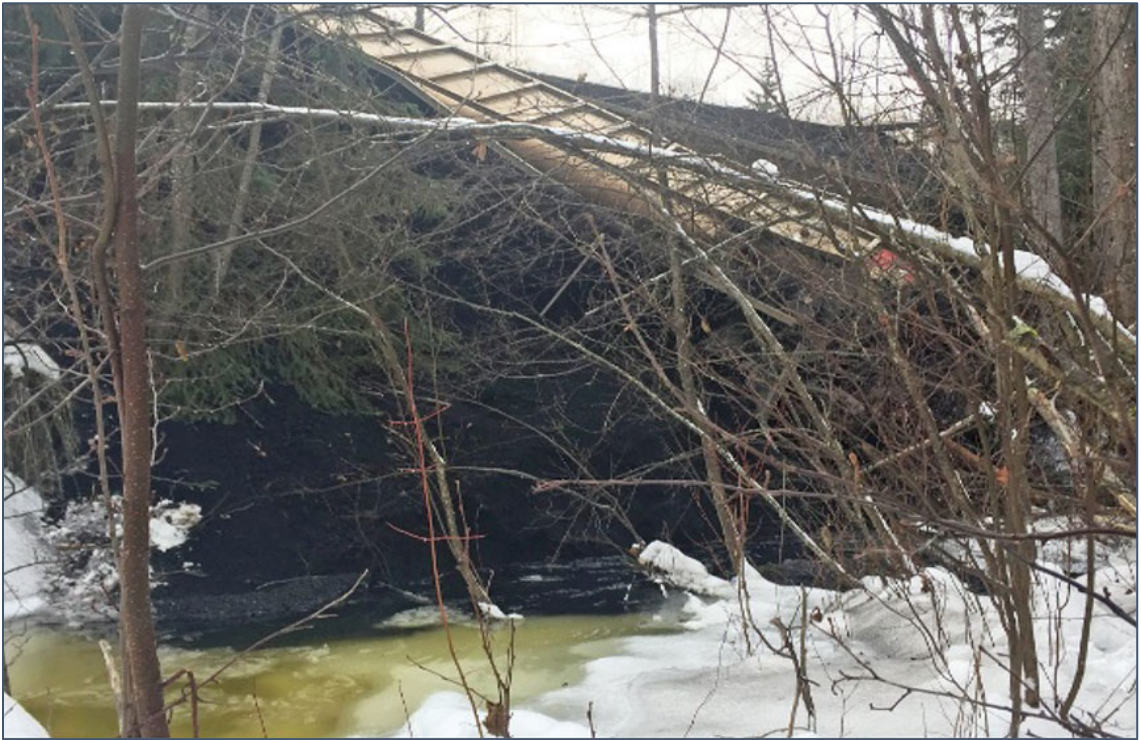
Figure 4. Coal spill with some product entering the nearby waterway (Source: Interior News)

The derailment resulted in the release of approximately 2900 tons of thermal coal<sup>2</sup> from 24 of the derailed gondola cars. Most of the coal remained on the railway right-of-way. The estimated total volume of coal recovered was 2800 tons or 97% of the coal spilled. A small amount of coal was spilled into Mission Creek (Figure 4).

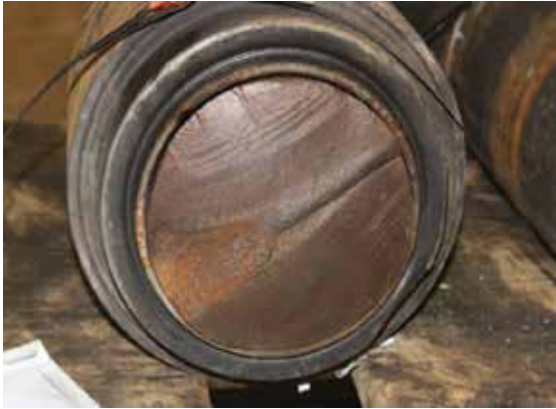
The axle had fractured between the L1 bearing seal wear ring and the backing ring, at the location where the axle journal merges into the fillet. As a result, the journal (with the bearing) separated from the rest of the assembly (Figure 6).

Figure 6. Mating fracture surface from the broken axle at the L1 bearing (view toward end of axle)

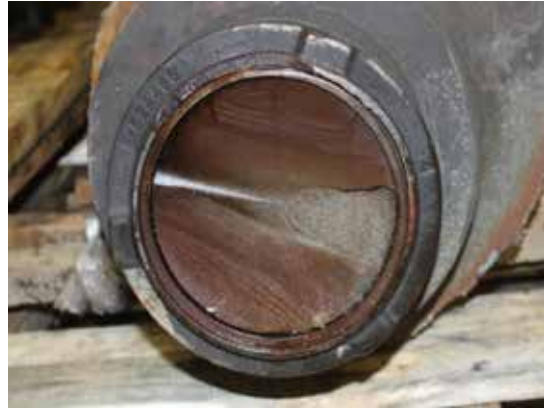
The fracture was due to fatigue cracking in the journal near the fillet. Crack arrest lines (beach marks) were present on the relatively smooth areas of the fracture surface (Figure 7).

Figure 7. Mating fracture surface from the broken axle at the L1 bearing (view toward centre of axle)

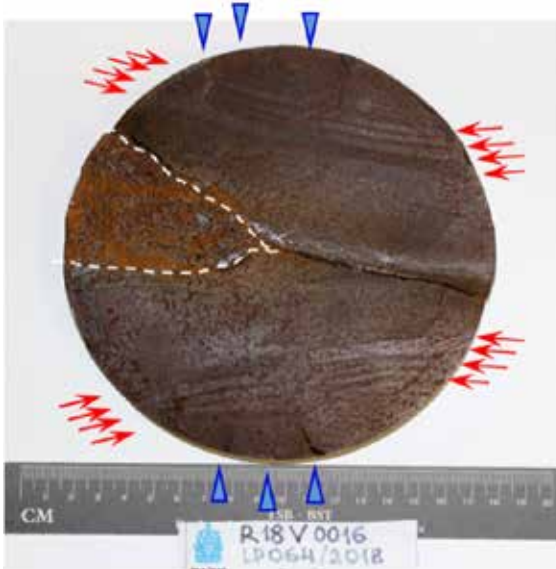
The multiple ratchet marks at the edge of the fracture surface indicate multiple fatigue origins on the opposite sides of the axle journal cylindrical surface. Fatigue cracks propagating from these origins had merged, forming 2 large fatigue cracks propagating toward each other (Figure 8 and Figure 9).

Figure 8. Fracture surface (view towards end of axle). The red arrows identify beach marks, and the blue pointers identify ratchet marks.

These fatigue cracks met approximately at the middle of the cross-section. The axle eventually failed in overstress when the remaining cross-section could no longer bear the load. The area of overstress fracture (the irregular sector delineated in Figure 8) was about 13% of the total fracture surface area.

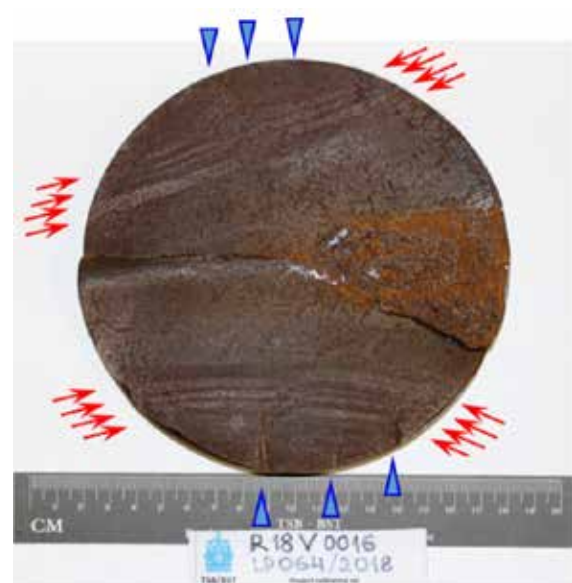
Figure 9. Fracture surface (view towards centre of axle). The red arrows identify beach marks, and the blue pointers identify ratchet marks.

The fracture surface features, such as 2 fatigue areas propagating towards each other from the opposite sides, indicate that the rail car axle failed due to reverse bending fatigue. The extent of the fatigue regions with a small final overstress area suggests that the amplitude of

the cyclic load driving the crack was relatively low. Multiple fatigue origins suggest that a general stress condition of the axle, rather than any one particular surface defect, caused the fatigue cracking and the axle failure.
