RAIL TRANSPORTATION SAFETY INVESTIGATION REPORT R19C0002

NON-MAIN-TRACK COLLISION AND DERAILMENT

Canadian Pacific Railway
Yard Assignment CW11-06
Alyth Classification Yard
Calgary, Alberta
06 January 2019

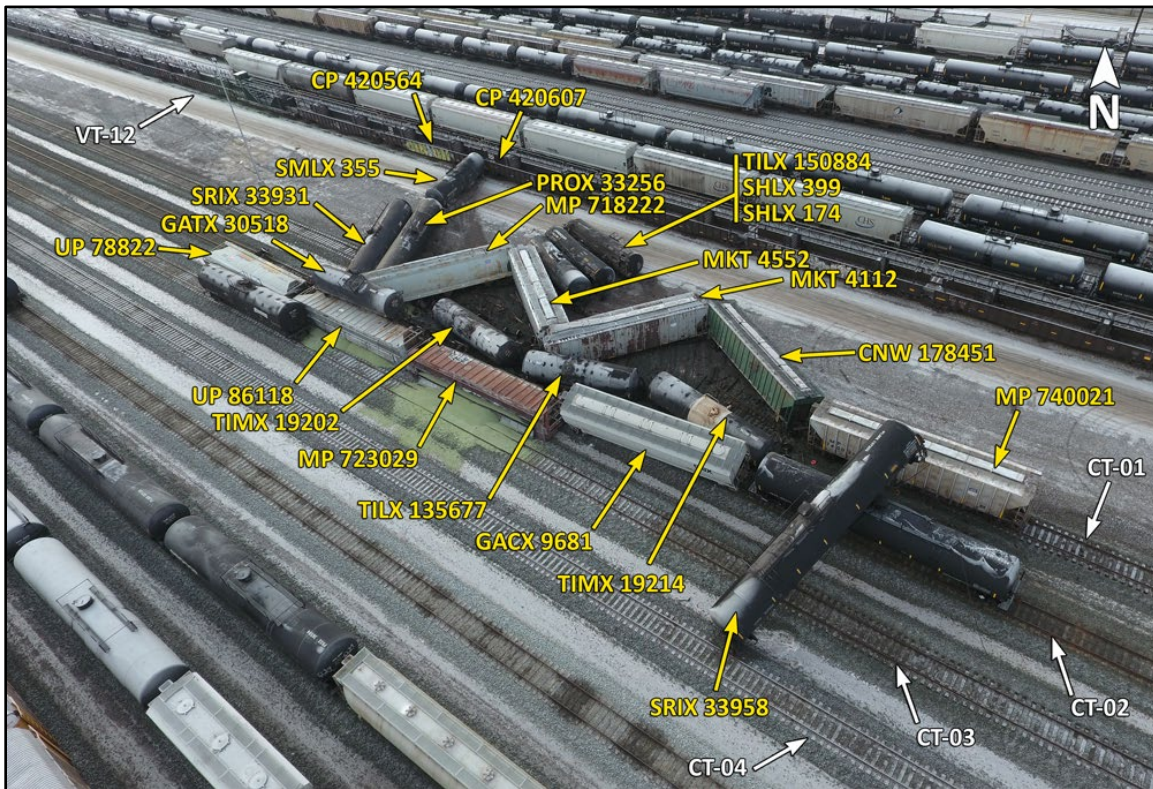
Figure 2. Photo of derailment location with derailed cars labelled (Source: Canadian Pacific Railway, with TSB annotations)

As a result of the collision, 22 cars derailed (Figure 2). Of these, 20 had derailed on tracks CT-01, CT-02, and CT-03, including 13 of the 14 hopper cars that were struck by the uncontrolled movement (the first car struck, LAFX 40177, was damaged but did not derail). These 3 tracks were separated by standard yard track centres. The remaining 2 cars had derailed on an adjacent track (Track VT-12) that is also used for mobile car repairs when they were struck by tank car SMLX 355, which had crossed the yard roadway by about 25 feet. Track VT-12 was not being used for mobile repairs at the time of the occurrence.

The 22 derailed cars consisted of 2 empty flat cars, 8 covered hopper cars loaded with fertilizer (non-regulated), 1 residue covered-hopper car last containing ammonium nitrate (UN 1942), and 11 residue tank cars. Of the residue tank cars, 4 last contained anhydrous ammonia (UN 1005) and 7 last contained molten sulphur (UN 2448). Eighteen cars were subsequently scrapped, and 4 cars were repaired and placed back into service.

None of the residue tank cars that last contained dangerous goods spilled any product. Four of the covered hopper cars loaded with fertilizer spilled varying amounts of product.

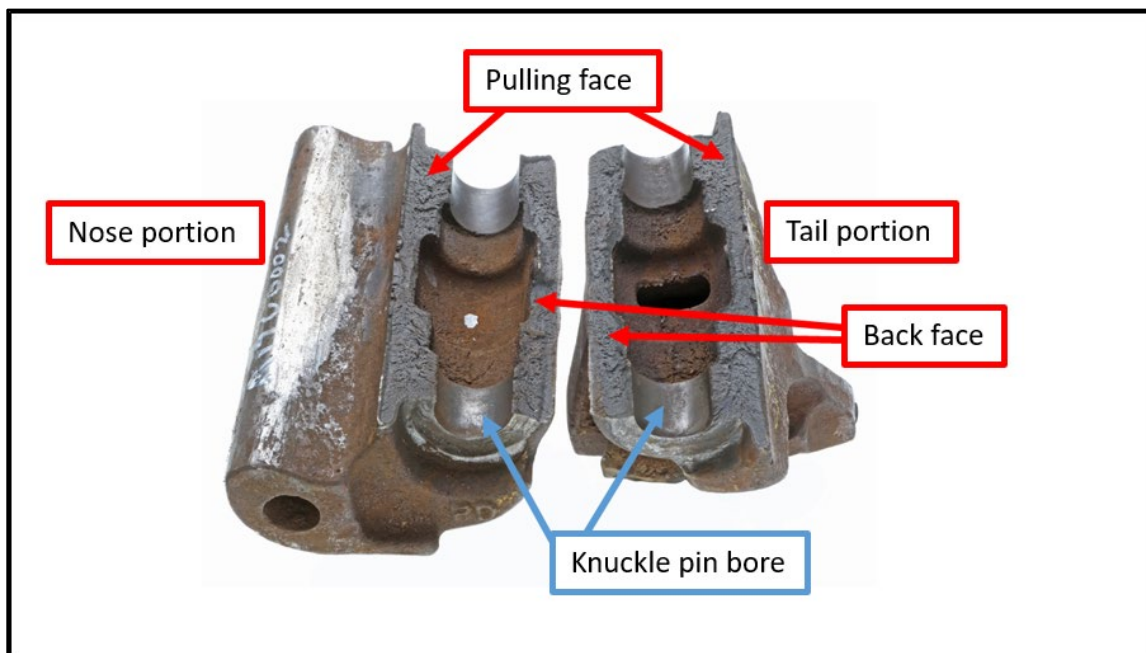
Figure 8. Fracture surface in the knuckle pin bore (Source: TSB)

- The knuckle fracture initiated as fatigue cracking in the knuckle pin bore (throat), a highly stressed area of the knuckle.
- The fracture had divided the knuckle into approximately 2 halves—the nose portion and the tail portion (Figure 8).

Testing at the TSB laboratory confirmed that the knuckle had developed fatigue cracking that initiated in the area of the knuckle pin bore and failed in the overstress extension of fatigue cracking.

The knuckle fracture initiated as fatigue cracking in the throat, a highly stressed area of the knuckle. During normal train operations, both the direction and magnitude of the forces in the couplers vary significantly. For instance, when cars are being kicked, stress in the throat of the knuckle alternates between tension and compression as the coupler forces alternate between draft (stretched train) and buff (bunched train).

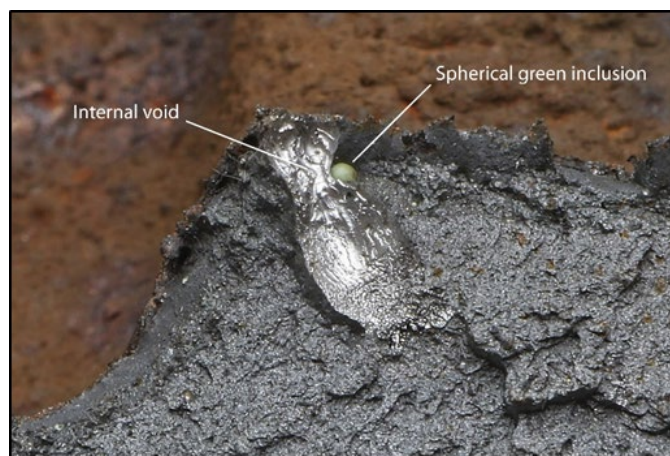
Figure 9. Photo of fracture face with spherical green inclusion and internal void (Source: TSB)

- Each portion contained 2 distinct fractures—one on the pulling face and the second on the back face. The pulling face fracture was approximately 1.25 inches deep by 8 inches tall with a reduced cross-section of approximately 0.75 inches at the mid-section. The back face fracture was approximately 1 inch deep by 8 inches tall.
- One large and several smaller internal voids were observed on the fracture face (Figure 9). Several spherical green inclusions were observed, primarily at the periphery.
- Porosity and inclusions in the throat of the knuckle served as stress risers as well as fatigue crack initiators.
- Brinell hardness test results averaged 285 HBW.¹⁶ This is consistent with the specified hardness range of 241 to 291 HBW for the knuckle.¹⁷ Standardless energy dispersive spectrometer

Optical and metallurgical examination of the fracture showed inclusions and porosity in the material. Porosity and inclusions in the throat of the knuckle served as stress risers as well as fatigue crack initiators.

The age of the fatigue cracks in addition to the observed porosity and inclusions suggest that manufacturing deficiencies in the casting process weakened the knuckle and it failed under normal service stresses.

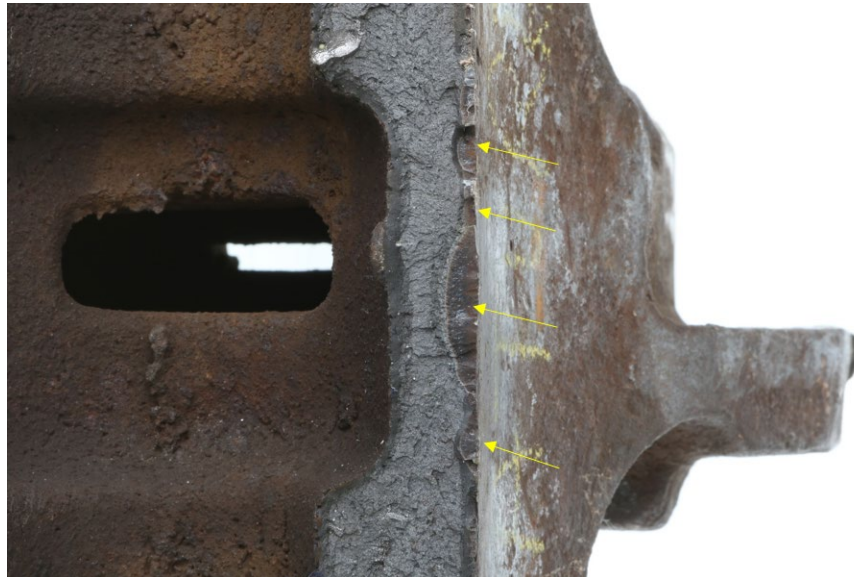
Figure 10. Fatigue cracks (Source: TSB)

- To assess the wear of the knuckle nose, partial re-assembly of the fractured knuckle allowed gauging with the Go-No-Go gauge (#49822) for type F knuckles. As the gauge would not pass over the nose, the knuckle was within allowable wear limits.
- Portions of the fracture face were sectioned and examined using the scanning electron microscope (SEM). The fatigue crack at the origin area showed that corrosion had erased most of the fracture detail. Examination of the fresh fracture showed cleavage as the mode of failure, confirming an overstress rupture. SEM examination of the spherical inclusions showed that they varied in size, some of which were approximately 1 mm in diameter.

- The dark colouration and depth of the corroded fatigue cracks indicate that they had been progressing for an extended period. The largest of the fatigue cracks had propagated through approximately one third of the section thickness (Figure 10). Although cracks of that size and depth were likely visible, when the car was coupled to another car, the subject area of the knuckle would have been obscured.

The dark colouration and depth of the corroded fatigue cracks on the knuckle indicate that they had been progressing for an extended period. The largest of the fatigue cracks had propagated through approximately one third of the section thickness. Although cracks of the size and depth that were present on the knuckle were likely visible and would have been deemed a condemnable safety defect under Transport Canada’s *Railway Freight Car Inspection and Safety Rules*, operating circumstances may provide infrequent opportunity for the detailed inspection and gauging of knuckles in service. Unless cars are uncoupled and the knuckles are fully opened, freight car inspectors are not able to identify the types of fatigue cracks that were present on the occurrence knuckle.

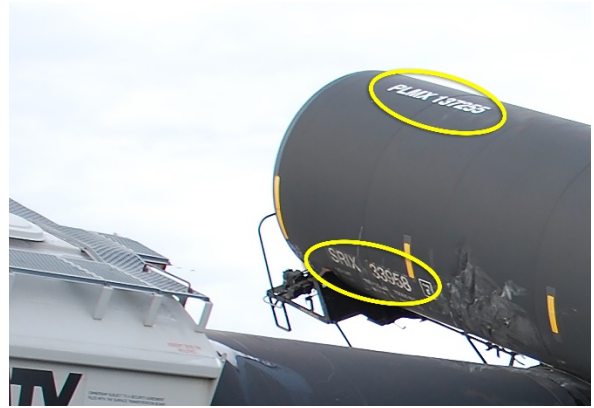
Figure 11. Reporting marks on tank car SRIX 33958 (circled) (Source: Canadian Pacific Railway, with TSB annotations)

At the derailment site, it was noted that tank car SRIX 33958 had a different reporting mark, PLMX 137255, stencilled on the top of the car (Figure 11). The car identification was changed from PLMX 137255 to SIRX 33958 on 10 December 2012, and the reporting marks on the sides and end of the car were changed accordingly. However, the reporting marks on the top of the car were not changed.
