# Rail Transportation Safety Investigation Report R19Q0092

## PASSENGER INJURY

VIA Rail Canada Inc.  
Passenger train VIA 600  
Mile 199.24, Canadian National Railway Company Lac St-Jean Subdivision  
Jonquière, Quebec  
28 May 2019

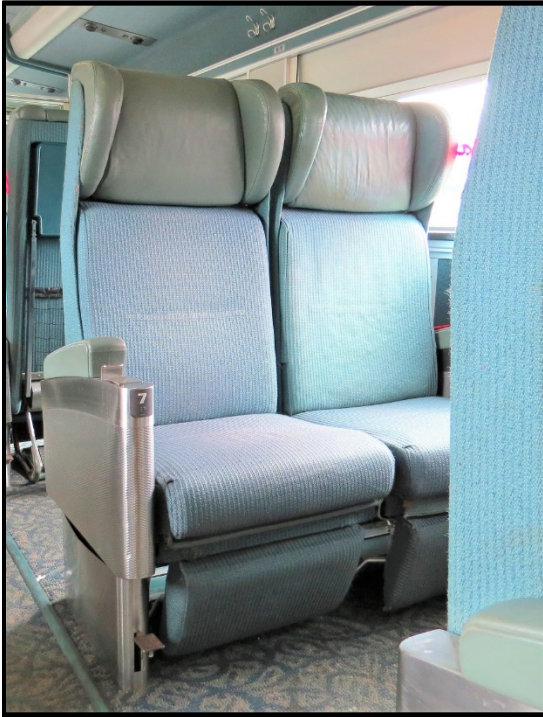
Seat 7B (as well all other seats in the car) was equipped with a stowable legrest. When the legrest is in its normal (undeployed) position, it is folded over double and stowed between the underside of the seat and the floor (Figure 3).

Figure 3. Seat 7B of car VIA 8147, with the legrest in the stowed position (Source: TSB)

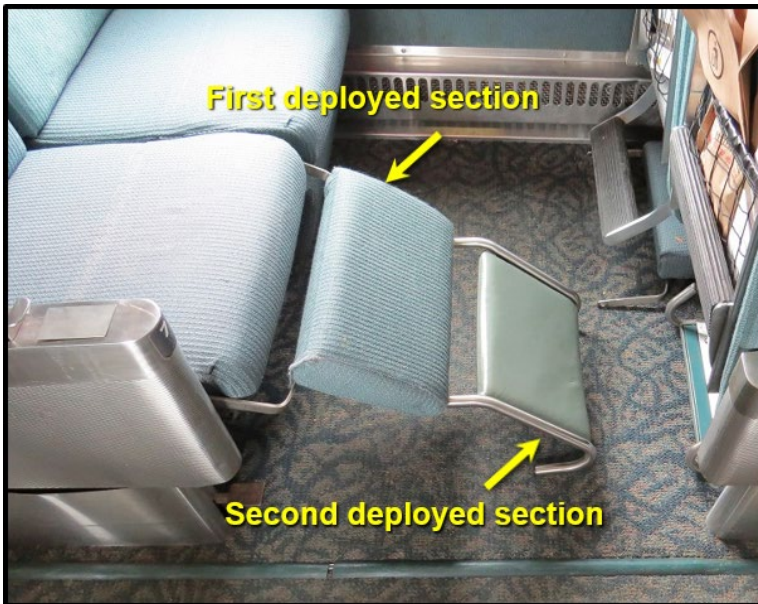
The stowable legrest assembly is composed of 2 sections attached to each other that support the full length of the passenger's legs (Figure 4). The legrest assembly is deployed in 2 separate steps. First, the legrest assembly is pulled out of its stowed position under the seat and moved forward. Second, the bottom section of the assembly is unfolded forward and brought to rest on the floor. The legrest assembly weighs about 5 kg.

Figure 4. Seat 7B with its stowable legrest deployed (Source: TSB)

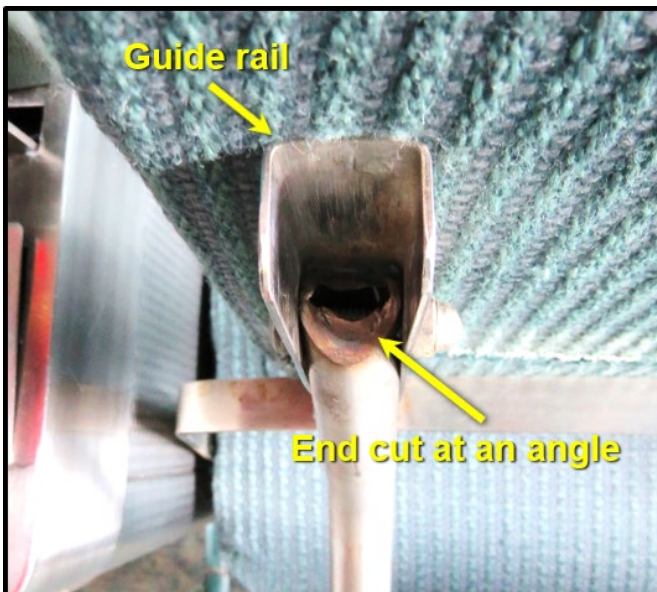
The first section of the legrest is attached to each side of the seat by 2 pivoting metal arms. The second, smaller section unfolds with 2 pivoting arms made of metal tubing that slide into guide rails attached to the bottom of the first section. The ends of the metal tubes are cut at an angle to allow them to pivot freely from front to back and vice versa within the metal guide rails (Figure 5).

Figure 5. Metal tube on the second section of the legrest assembly (Source: TSB)

The passenger was trying to deploy her seat's stowable legrest assembly to familiarize herself with its operation so that she could help another passenger travelling with her. While the passenger was raising the sections of the assembly, the tip of her right ring finger got stuck between the end of the metal tube and the guide rail. When the second section of the legrest assembly fell forward, the

passenger felt a sharp pain in her right hand. The tip of her finger, starting at the base of the fingernail, had been severed by the tapered end of the metal tube. She immediately informed the person responsible for the group she was travelling with that she had been injured and needed emergency medical care.

In 2018, VIA launched the Heritage Program in order to renovate and modernize a large portion of its fleet, including 25 of the 43 VIA HEP 1-type Economy Class passenger cars. The renovation of the first cars is expected to be completed in early 2020. As part of this program, VIA had already started to modify the stowable legrests in these cars by removing the sharp edges of the metal tubes and installing a plastic tip.
