RAIL TRANSPORTATION SAFETY INVESTIGATION REPORT R19W0017

MAIN-TRACK TRAIN DERAILMENT

Canadian National Railway Company
Freight train G86742-21
Mile 11.35, Warman Subdivision
Saskatoon, Saskatchewan
22 January 2019

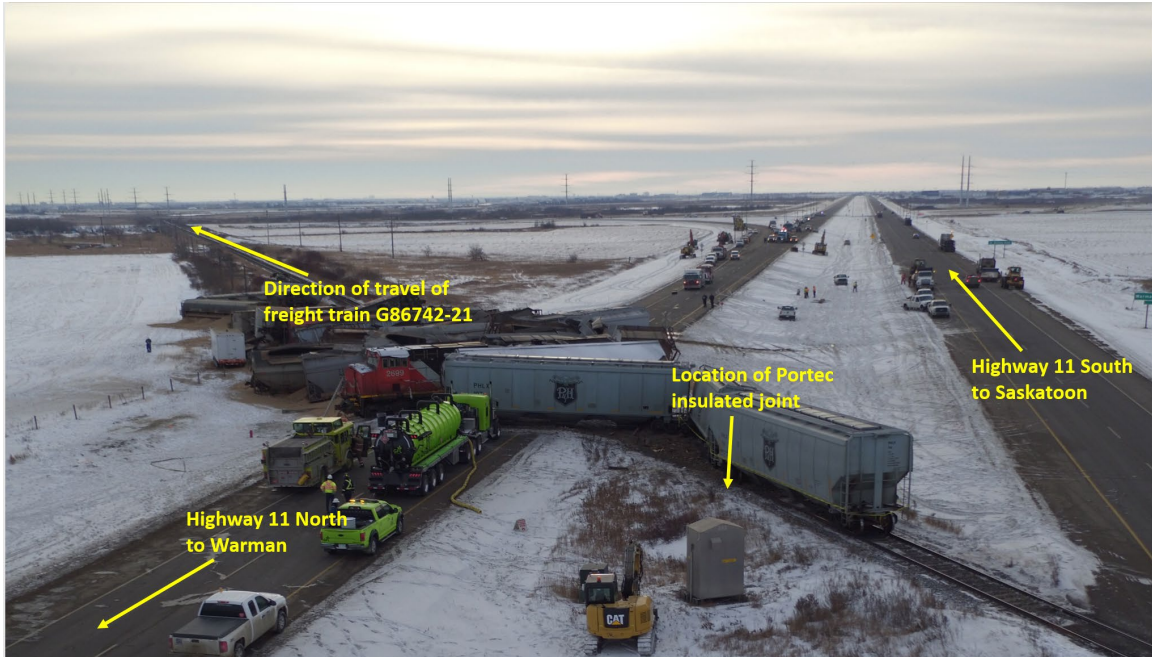
Figure 2. Site photo (Source: Saskatoon Police, with TSB annotations)

In the highway median (between the northbound lanes and southbound lanes of Highway 11), a damaged Portec insulated joint (PIJ) was discovered in the east rail (Figure 2). The joint itself was intact. However, about 3 feet of the head of the rail had separated from the web of the rail, and had broken into several pieces. The PIJ and the associated pieces of rail were sent to the TSB Engineering Laboratory in Ottawa, Ontario, for detailed examination.

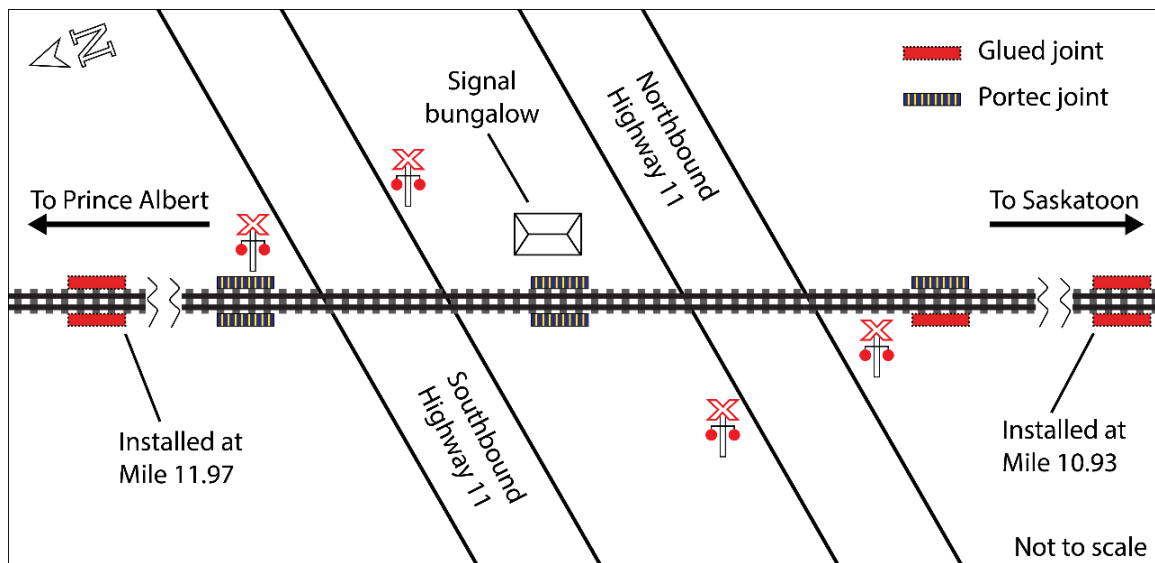
Figure 4. Diagram of the Highway 11 crossing (Source: TSB)

In the vicinity of the crossing, 10 insulated joints supported the crossing signal operation (Figure 4). They comprised

- 2 glued insulated joints at Mile 11.79,
- 2 glued insulated joints at Mile 10.93,
- 2 PIJs immediately north of the crossing,
- 1 PIJ and 1 glued insulated joint immediately south of the crossing, and
- 2 PIJs on the median between the 2 highway roadways at Mile 11.35.³

In the median between the northbound and southbound lanes, mud and debris from the crossing roadway had collected and contaminated the track ballast. Poor drainage conditions necessitated shimming, frequent lifting by hand, and tamping of the ties to address the deteriorating track geometry conditions.

A crossing upgrade, planned for later in 2019, was to include concrete crossing pads, rubber flange way fillers, new 136-pound track panels with 10-foot ties through the crossing, and 14-inch tie plates.

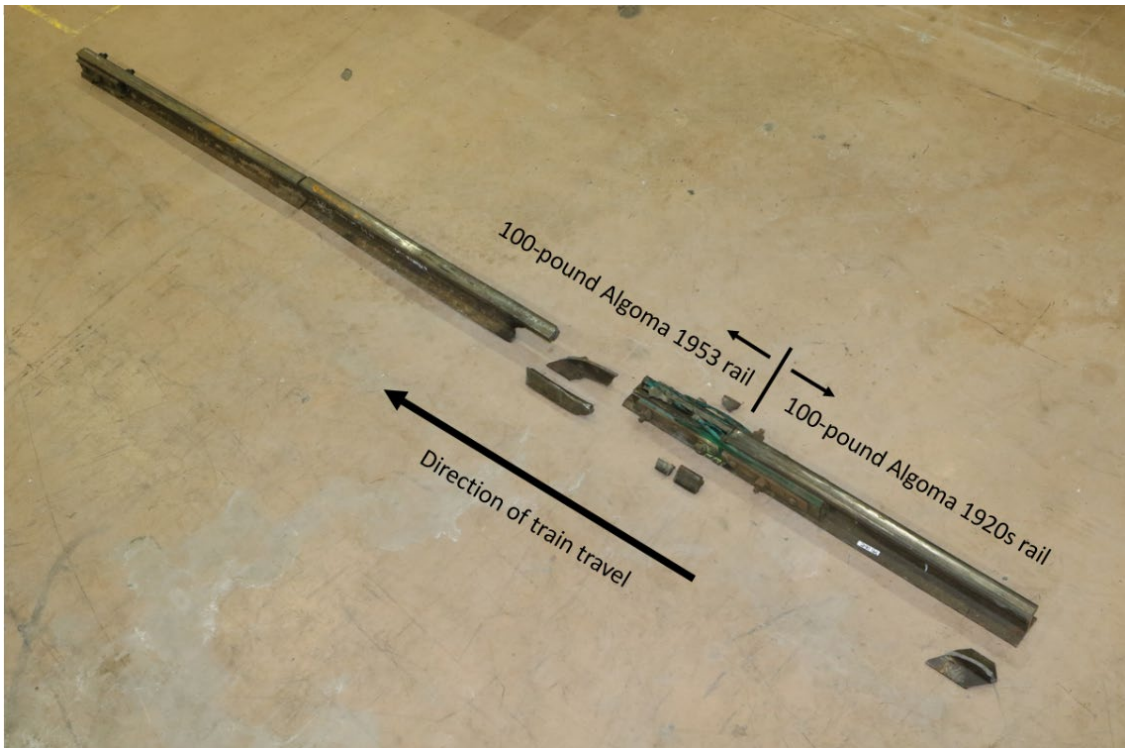
Figure 5. Portec insulated joint (Source: TSB)

The joint in the median between the northbound and southbound lanes of Highway 11 was a PIJ situated in the east rail. It was one of the joints that supported the operation of the grade-crossing warning devices (Figure 5).

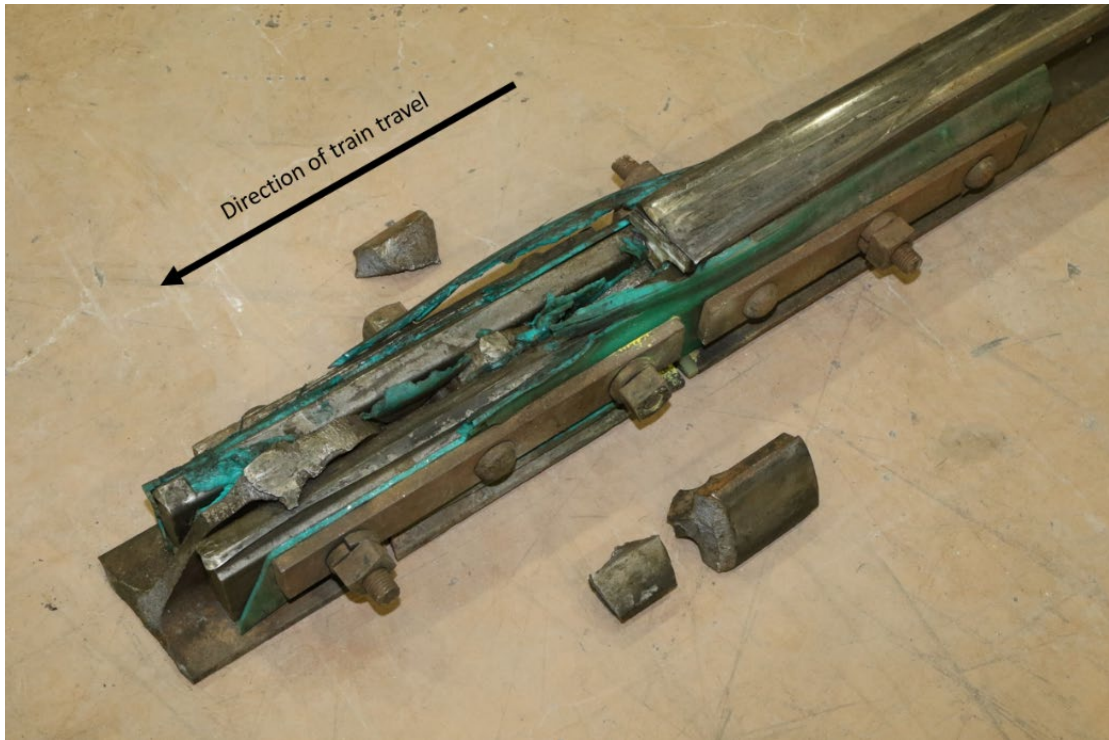
Figure 6. Portec insulated joint (Source: TSB)

The joint bars, which remained intact following the occurrence, joined a piece of 100-pound rail manufactured in 1953 by Algoma Steel with another piece of 100-pound rail manufactured by Algoma Steel in the 1920s.⁴ Only the 1953 rail extending toward the south had fractured. Between the joint bars, the 1953 rail head had fractured horizontally and separated along the web (Figure 6). Three small pieces of rail head, which exhibited significant signs of pounding, were recovered. At this location, the web also exhibited extensive signs of pounding, indicating that the head and the web had been fractured for some time.

Three pieces of 1953 rail web and base were contained between the joint bars. There were indications of a significant amount of rubbing between the pieces. The characteristics of the rubbing suggests that the cracking may have originated in the most northerly bolt hole. The rail at the south end of the joint bars was fractured through its full section. Only small sections of its fracture face exhibited indications of rubbing. As a result, the fractures within the joint were likely the first to occur.

The broken rail that failed within the south portion of the insulated joint likely had a fracture that initiated at a bolt hole crack. The most recent rail flaw inspection, conducted less than 1 month before the accident, did not identify any internal defects within the rail in the vicinity of the crossing. Less than 1 month after the most recent rail flaw inspection, the fracture had grown from a size that was not detected during ultrasonic inspections to a size that was sufficiently large to lead to a rail failure.

The rail extending to the south of the joint had been manufactured in 1953. Rail of this vintage was typically manufactured with much coarser microstructures, as compared to rail today. Therefore, older rail has a lower fracture toughness and a lower tolerance to withstand the initiation and propagation of internal cracking.

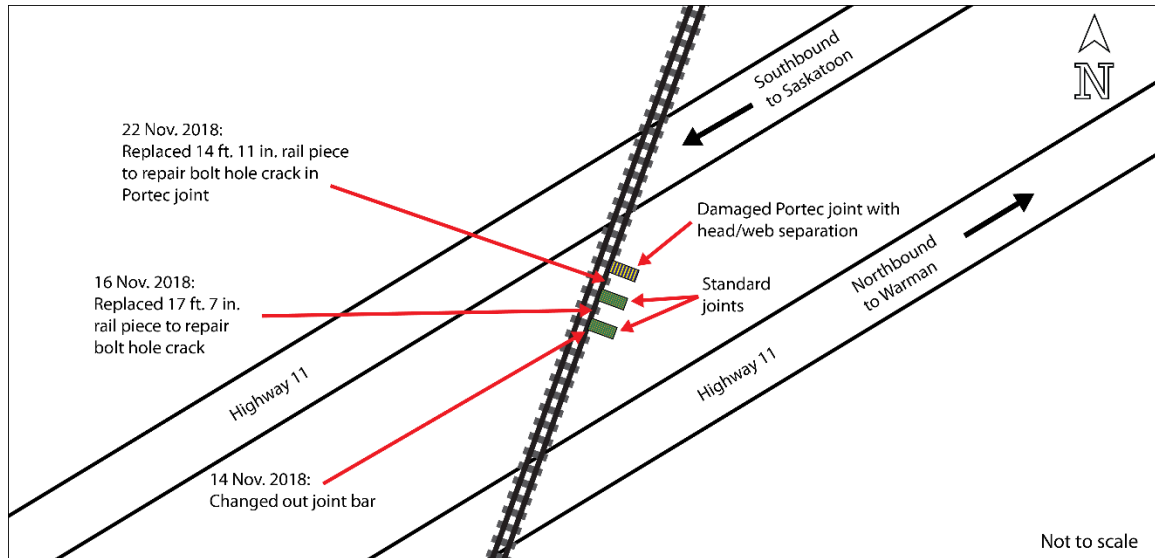
Figure 7. Rail maintenance at the Highway 11 crossing (Source: TSB)

In the vicinity of Mile 11.35, a rail flaw detection test on 18 April 2017 identified a location where the rail head was separating from the web of the rail. To repair the rail, a plug rail measuring 22 feet 5 inches long was installed.

- On 14 November 2018, during a visual track inspection, a cracked joint bar in the east rail between the 2 highway roadways was identified. While the joint bar was being changed, a bolt hole crack was observed in the rail extending to the south.
- On 16 November 2018, the rail with the bolt hole crack was changed out. A piece of rail 17 feet and 7 inches in length was installed between the joint and a joint to the south.
- On 22 November 2018, the rail flaw detection car identified a bolt hole crack in the PIJ situated just north of the rail that had been installed on 16 November 2018. A piece of rail 14 feet and 11 inches in length, manufactured in 1953 by Algoma Steel, was installed that day; it extended from the rail installed on 16 November 2018 northward to the PIJ. The PIJ was disassembled and then reassembled.
