RAILWAY OCCURRENCE REPORT

R96T0111

DERAILMENT

CANADIAN NATIONAL
TRAIN NO. 698, ONTARIO NORTHLAND RAILWAY
MILE 225.8, NEWMARKET SUBDIVISION
NORTH BAY, ONTARIO
31 MARCH 1996

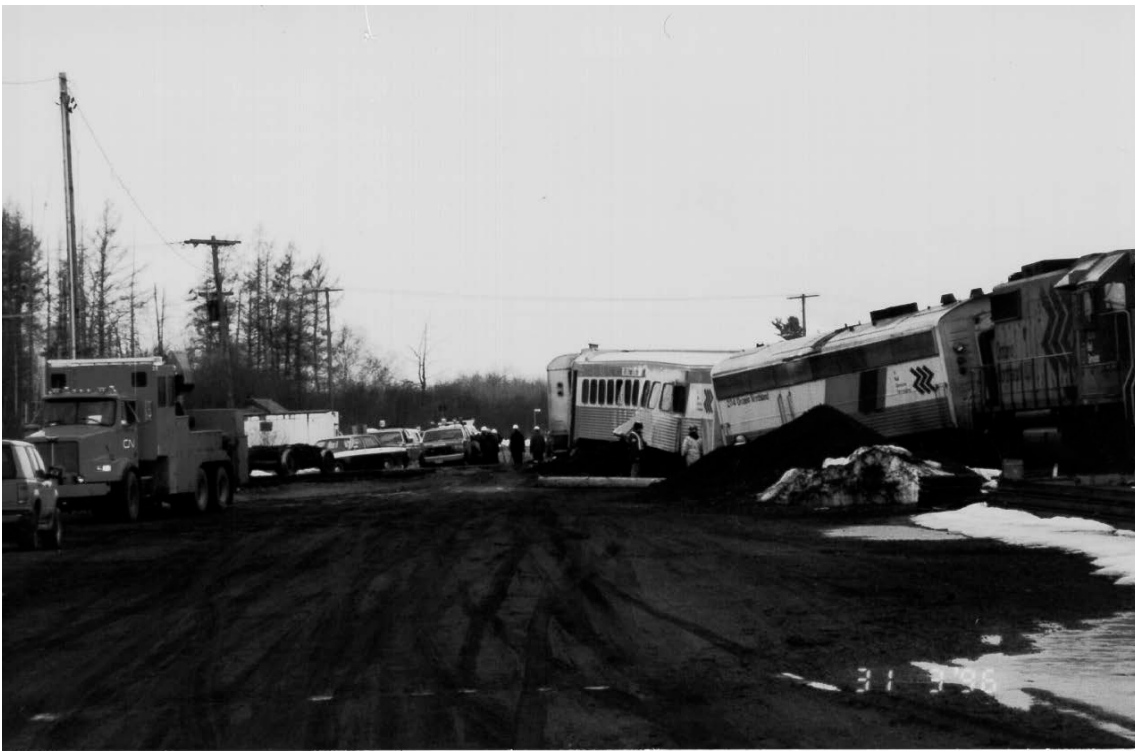
Southward Ontario Northland Railway (ONR) passenger train No. 698 (train 698) was en route from Cochrane, Ontario, to Toronto, Ontario, with 54 passengers. At approximately 1414 eastern standard time, while moving west to east approaching Mile 225.8 of the CN Newmarket Subdivision, just south of North Bay, Ontario, at a speed of approximately 44 mph, the locomotive engineer observed that the siding switch stand at Mile 225.8 was canted off-centre. Concerned that the switch might be damaged, he immediately initiated an emergency brake application. The locomotive engineer estimated that the train contacted the switch area at a speed of 20 mph. When the train came to a stop, the locomotive engineer looked back and observed that a portion of the train had derailed. All cars were upright (Figure 1).

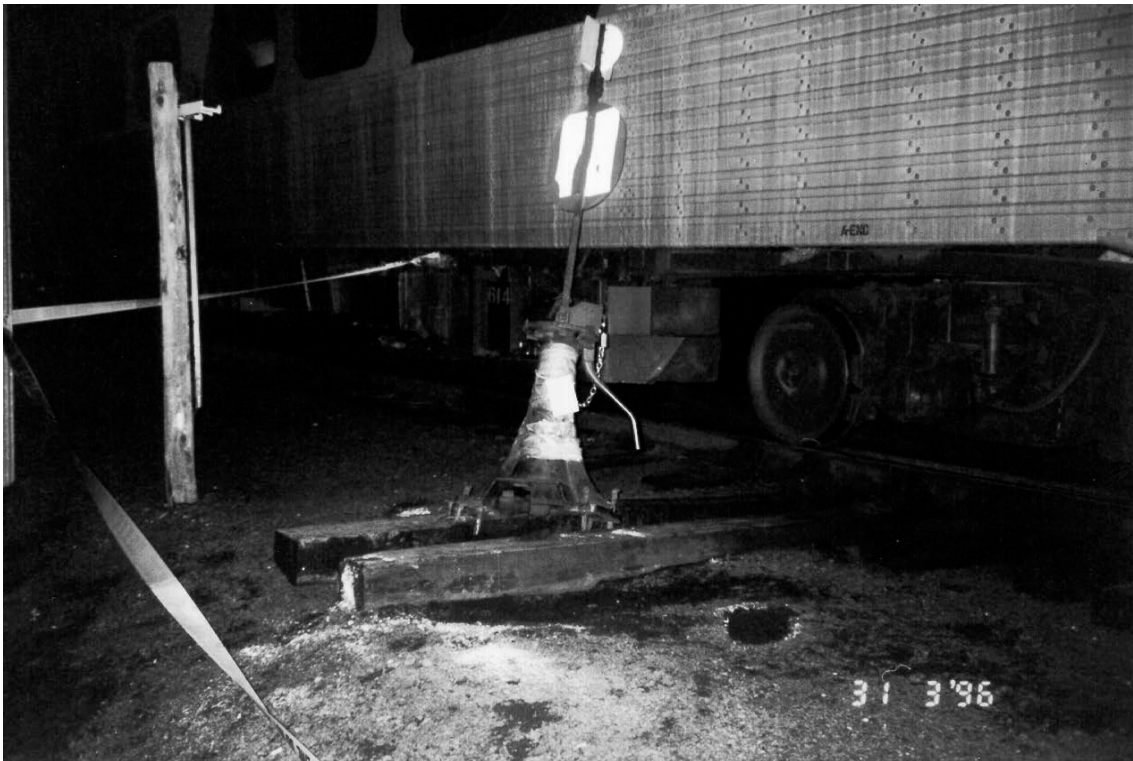
The switch was canted over at approximately 20 degrees from vertical. There were tire tracks from the gravel road stopping at the switch stand. There were scuff marks on the switch stand approximately 14 inches (36 cm) from the base of the stand and particles of white paint were imbedded in the scuff marks. The switch stand securing spikes were loose and the anchoring ties were dislodged (Figure 2). The switch was lined for the normal position and the switch target was in place and properly indicated that the switch was lined for the main track. An examination of the switch revealed that the components were in good condition, properly adjusted and well maintained. The force required to dislodge the switch stand was considerable. The person(s) responsible should have been aware of the impact, as damage to the vehicle would have been significant.

3. The switch had been struck and damaged by a highway vehicle that had been operated on CN property without permission.
4. The damaged switch could not maintain the positioning of the switch points necessary for safe train passage.

TC has verified that ONR has complied with the Board's recommendations and has outlined that they will continue to monitor the ONR for compliance to passenger train safety requirements. TC has also indicated that a switch point lock has been installed to prevent a similar occurrence at this location.

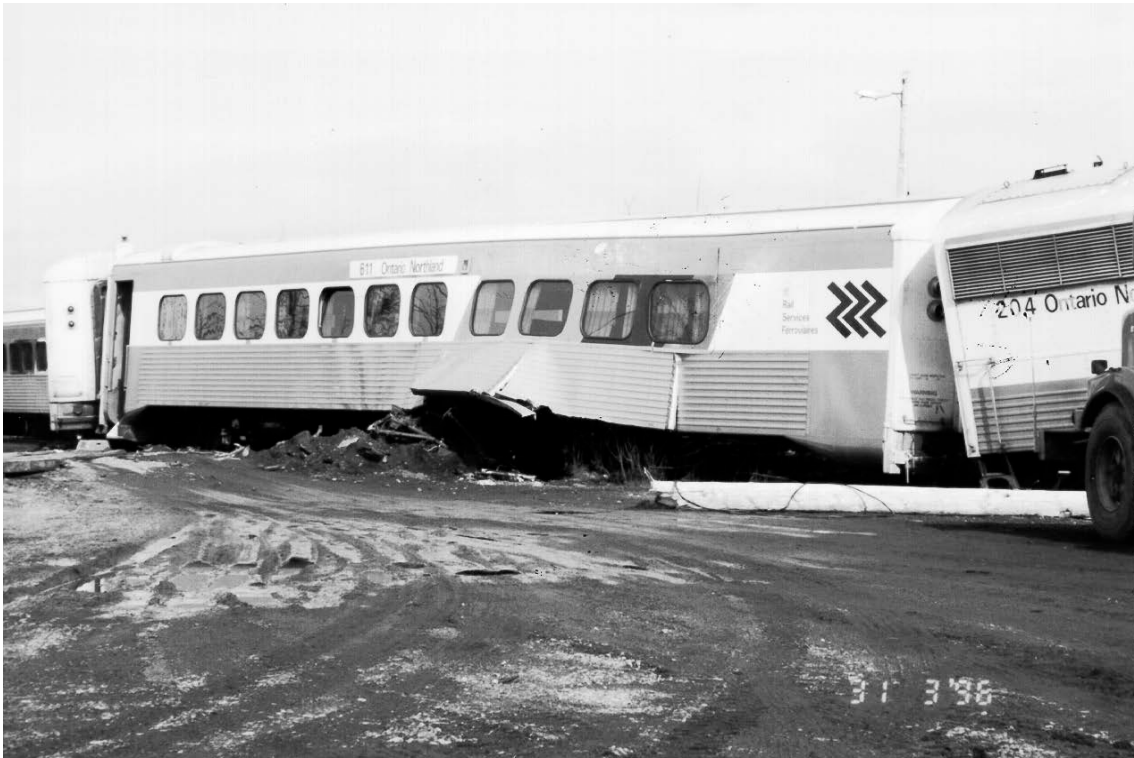
The first coach was completely derailed and in line with the north wye track. A gap, approximately 18 inches (46 cm) by 48 inches (122 cm), had opened between the south wall and floor. A hole had been punched in the leading end roof line and, due to minor frame deformation, the side vestibule door would only partially open. Most underslung components, including the hot water tank, had been torn away. The hot water tank was leaking and steam had escaped and entered the interior of the coach via the opening between the wall and the floor (Figure 3).

In the first coach, the forces of the derailment ripped away most of the underslung features, including the emergency power source. The design of the coach deck-to-side-wall configuration also permitted the forces of the derailment to tear a portion of the side wall away. Such an opening could expose passengers to the danger of being thrown out onto the roadbed while also enabling the entry of fire, smoke or noxious fumes, which are potentially present at a derailment. VIA equipment has protection against deck-to-side-wall damage; a passenger car design standard should address both side wall securement and under-car protection.

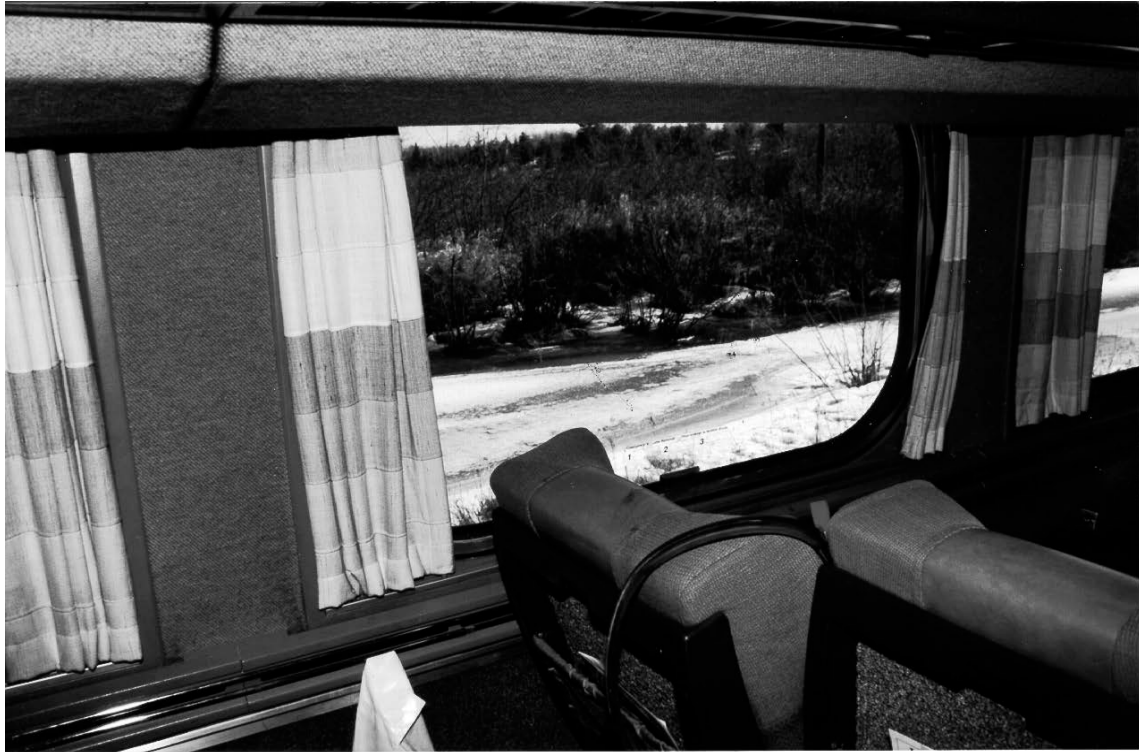
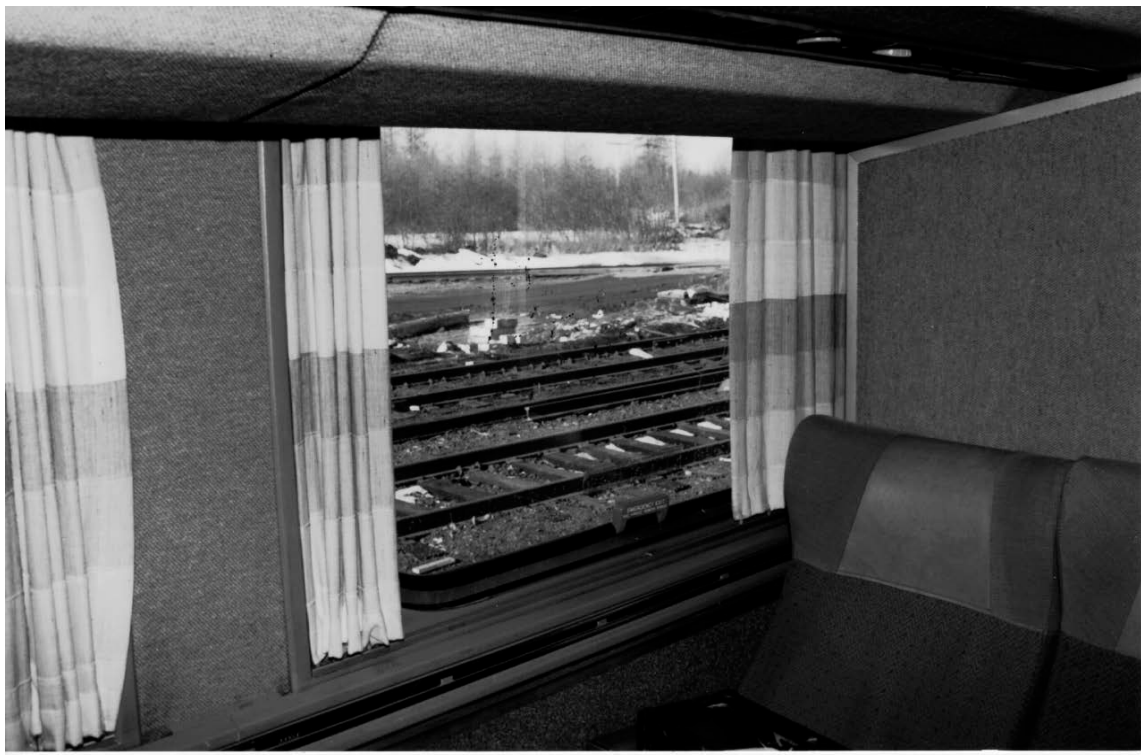
Five of the emergency exit windows in the first coach had their rubber gaskets partially or completely removed; however, the window panels were still in place. One of the five windows had been struck from the inside and cracked, and two had been loosened from their securement. One of the windows, with the gasket completely removed, was of the non-emergency window type with no lift-out handle. This window was still tightly in place. Some reclining seat backs were found to have partially obstructed direct access to the window handles (Figure 4). The rearmost emergency window (south side) was partially obstructed by a baggage containment area (Figure 5).

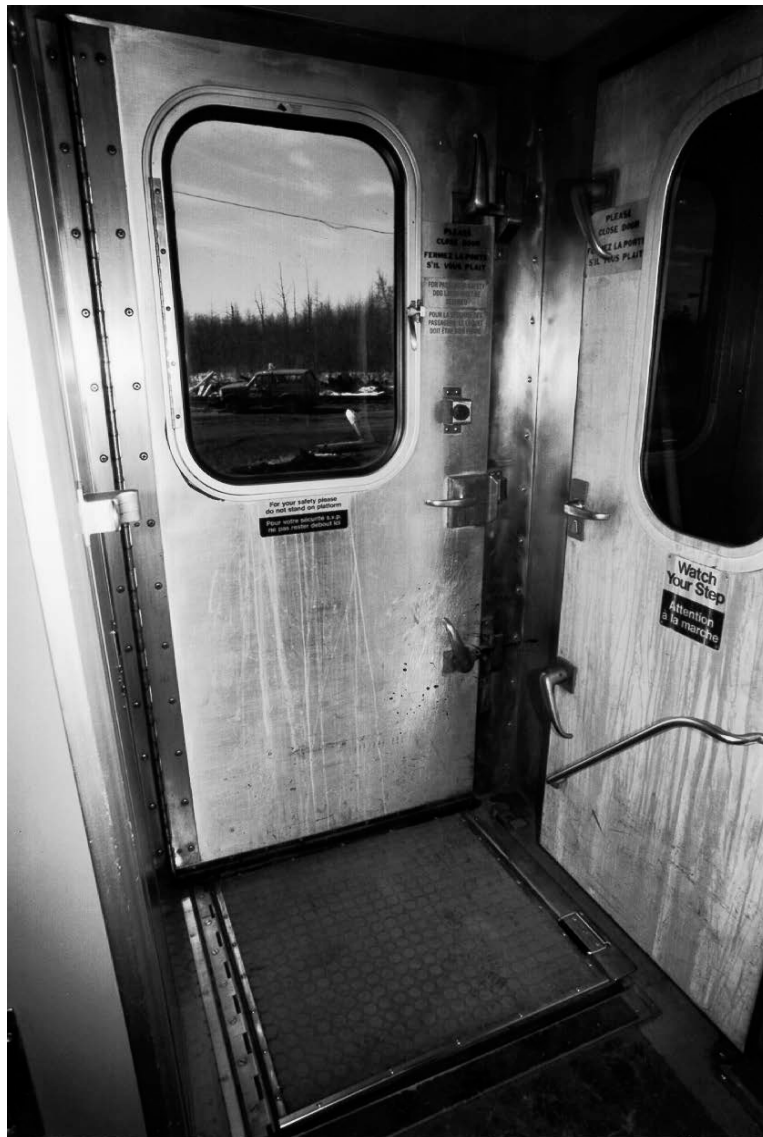
A panel covers the vestibule steps. The stairs are exposed by stepping on a release latch and manually lifting the panel, which then automatically exposes and lowers the steps. There were no written instructions posted on the interior or exterior to advise passengers or rescue personnel of the operation of the release latch and its location, neither of which is obvious (Figure 6). During an emergency evacuation, deployment of the stairs would help passengers exit the train and would lessen the risk of injury.

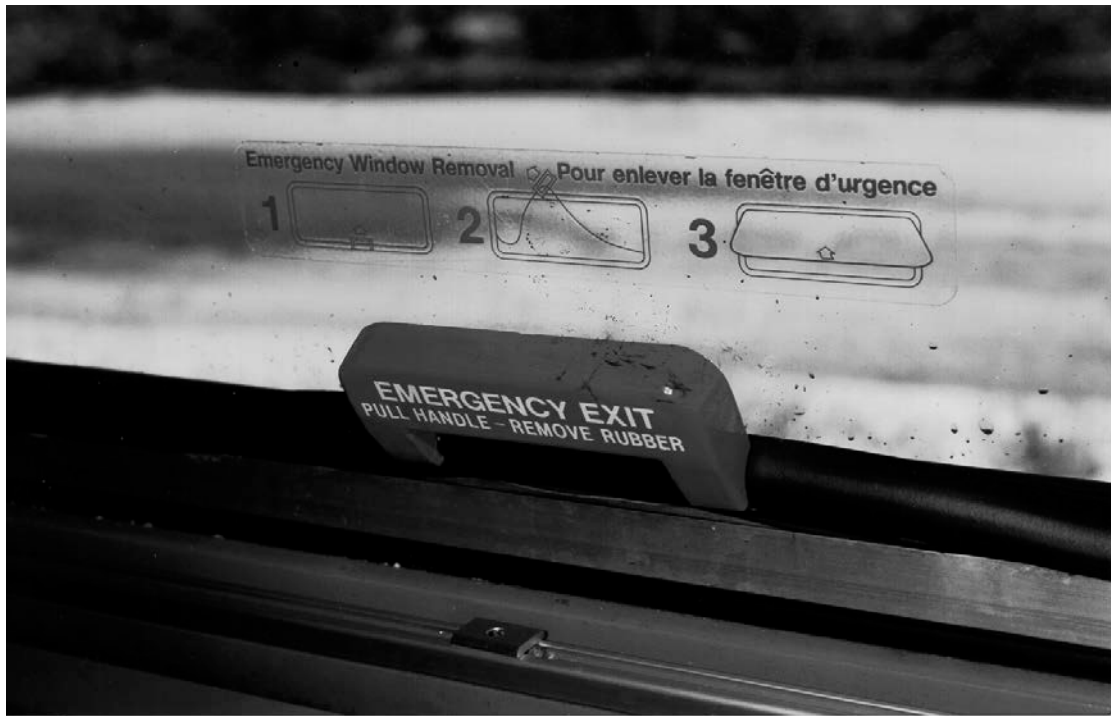
windows in coach 611 did not have a pictogram). Each emergency window is identified by a large red handle with the words “Emergency Exit / Pull Handle - Remove Rubber.” The gasket is to be removed by pulling on the handle. A second handle, fixed to the window and exposed by pulling the first handle away, is to be pulled and the window is designed to swing inward as though on hinges at the top (according to the pictogram), toward the interior of the coach (Figure 7).

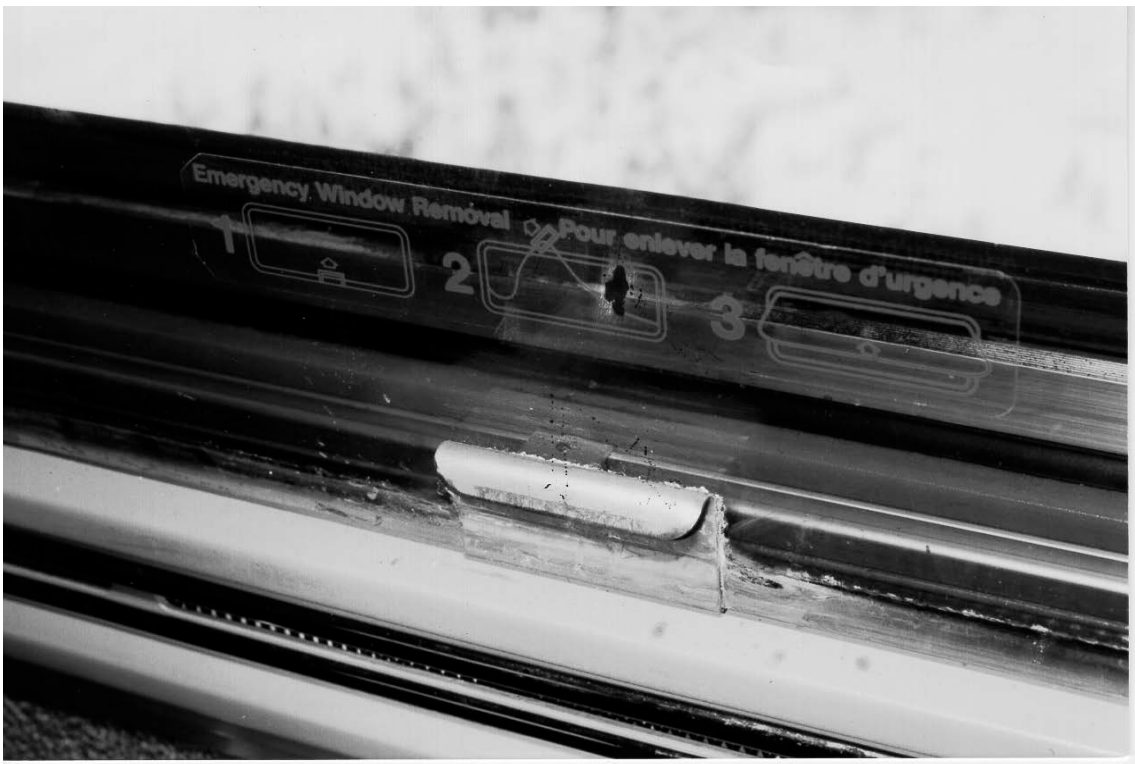
The gasket was removed on the second window by using a jerking motion. Once the gasket was removed, a small metal handle used to pull the window inward was exposed (Figure 8). However, the window remained stuck tightly in the frame. Loosening the window required considerable pulling and jerking on the small metal handle. Once the window was loose within the window frame, it became jammed and could not be removed. It was determined that the window must first be lifted upward using a jerking motion and then pulled inward. At this point, the window fell away from the frame. Considerable effort was then required to manoeuvre the heavy window to clear the path for exit.

- i) the little metal handle on the emergency exit windows limits the force that can be applied to it and causes the windows to jam on the window frame;
