RAILWAY INVESTIGATION REPORT

R99T0031

DERAILMENT

Canadian National
Train No. CN M-304-41-05
Mile 255.1, Ruel Subdivision
Neswabin, Ontario
06 February 1999

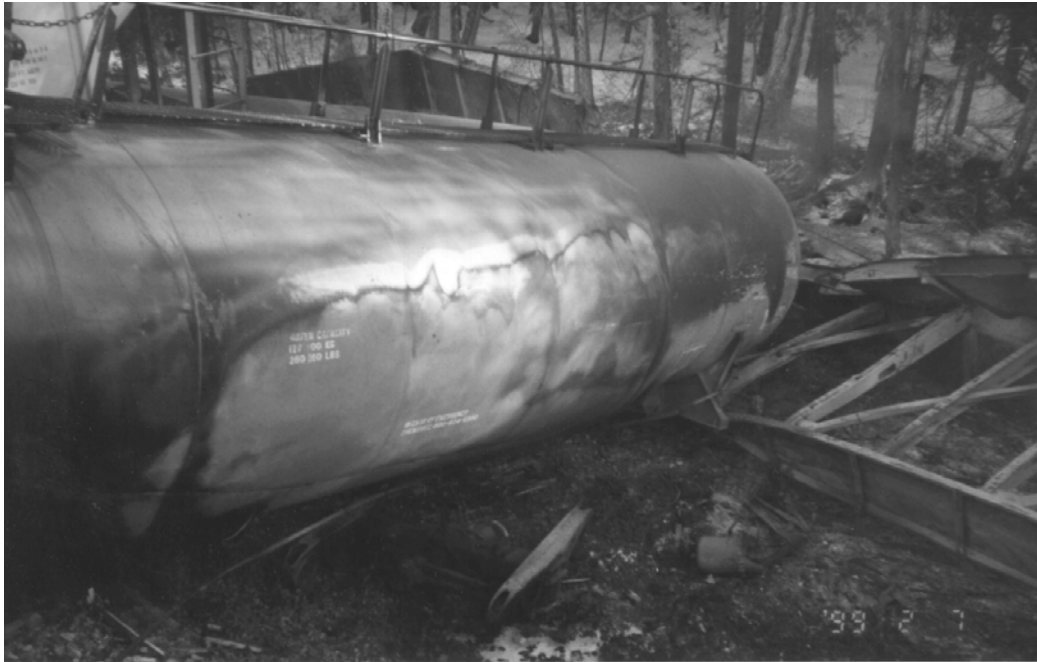
A subsequent aerial inspection of the train revealed that 20 cars had derailed: the 21st to the 40th behind the locomotives. The bulkhead flat car, CN 604697, was found to have a burnt-off axle journal (BOJ)⁵, later determined to have been located at the L-3 position, which was adjacent to the lead wheel of the trailing truck on the south rail (95th axle). The derailed cars included a loaded tank car of liquefied petroleum gas (LPG) and two tank cars of benzene, a flammable liquid mixture (see section 1.3). One of the tank cars of benzene, AGEX 1001, was badly damaged resulting in a total loss of product. The liquid benzene and some lumber that was strewn about the accident site from some bulkhead flat cars that were destroyed in the accident fuelled a large fire that burned for several days. The jacket of the loaded tank car of LPG, CGTX 63501, was scorched by the heat from the fire; however, there was no release of product (see Figure 3). The emergency response procedures were carried out in a timely and effective manner.

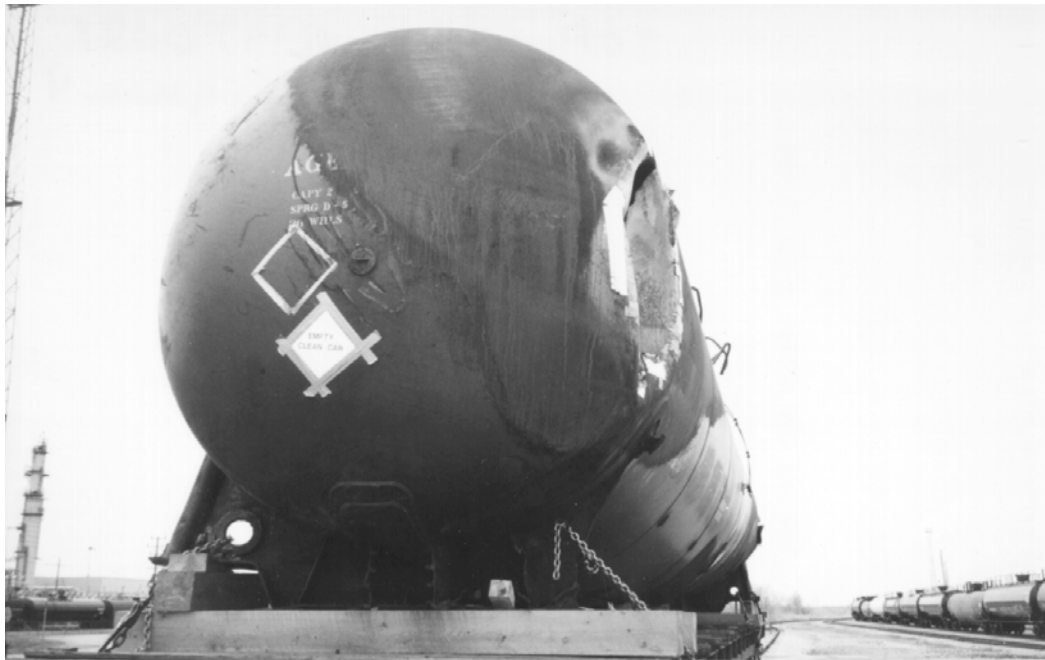
Figure 4 - Damaged Benzene Tank Car (AGEX 1001) 7

The tank cars of benzene, AGEX 1001 and PROX 41841, were built to specification DOT-111A100W1. Car AGEX 1001 was badly damaged during the derailment sequence and lost its entire contents (see Figure 4). The susceptibility of minimum standard Class 111A cars to experience damage during a derailment has been known throughout the North American railway industry, including railway safety regulators, for a considerable time.

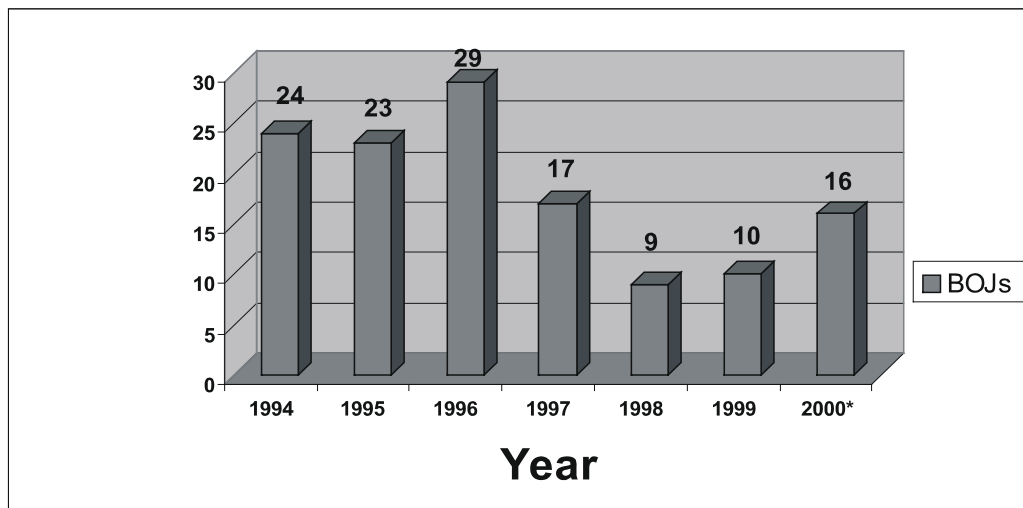
Overheated roller bearings occur when inadequate lubrication or mechanical flaws result in an increase in bearing friction. This phenomenon is called a “hot box” in railway jargon. The bearing temperature can continue to rise and lead to complete failure of the axle, commonly referred to as a “burnt-off journal” (see Figures 8, 9, and 10).

A BOJ normally results in the derailment of the car on which it occurs. Should axle failure happen while the train is proceeding at a high speed, the derailment frequently results in multiple cars derailed and/or damaged. Figure 11 shows the total number of BOJs since 1994 provided to the TSB during the investigation by the three Class 1 Canadian railways.
