**AVIATION INVESTIGATION REPORT
A13P0127**

MID-AIR COLLISION

CESSNA 150F, C-FSQQ

STEMME S10-VT, C-FHAB

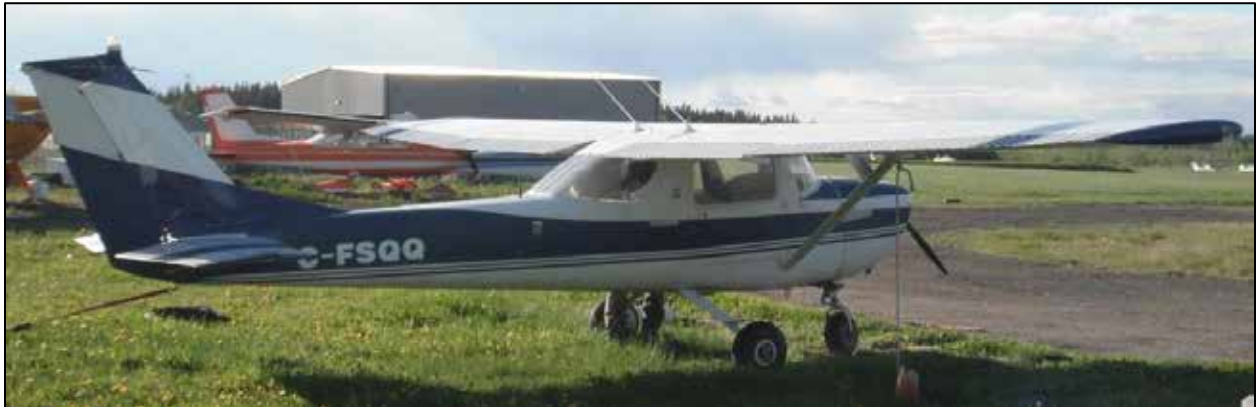
The Cessna (Photo 2), manufactured in 1965, had accumulated 6319 hours since new. The aircraft was powered by a Continental O-200-A engine. Records indicate that the aircraft was certified, equipped and maintained in accordance with existing regulations and approved procedures. Strobe lights had been added to the Cessna. A circuit breaker labeled STROBE LIGHTS PUSH ON was found on the instrument panel. The circuit breaker was destroyed in the accident, and it could not be determined whether the strobe lights were functioning during the flight. It could also not be determined whether the landing light of the Cessna was on at the time of the occurrence.

Photo 2. Cessna 150F, C-FSQQ

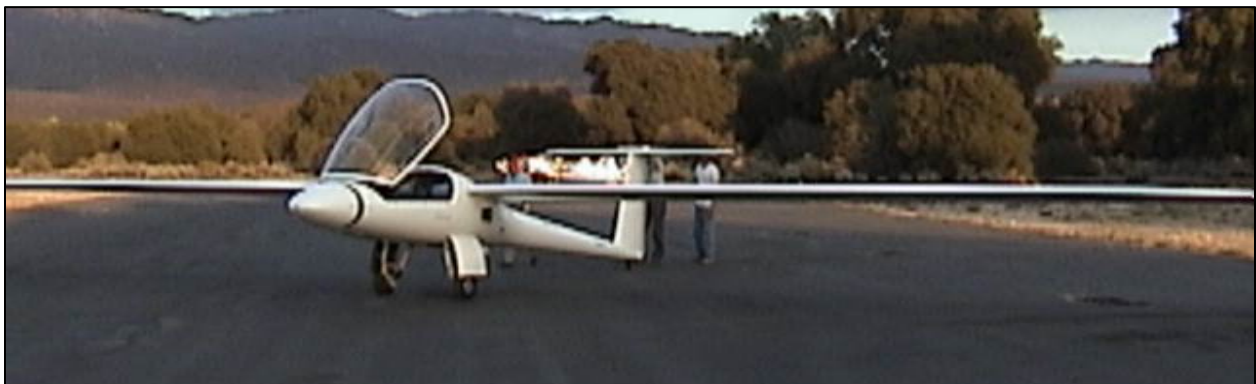
The glider (Photo 3), manufactured in 1998, had accumulated just over 600 hours since new. It was powered by a Rotax 914 F2 engine for self-launch capability. After take-off, landing gear is retracted. At altitude, the engine is shut down and the propeller retracts into the moveable nose cone. The pilot and passenger sit side by side in a semi-reclined position behind the glare shield of the instrument panel.

Photo 3. Stemme S10-VT, C-FHAB

The Canadian Type Certificate Data Sheet A-181 for the Stemme S10-VT states, “All external portions of the powered sailplane exposed to solar radiation must be painted white...”² Also, by design, the wings of the glider are very thin when viewed from in front or behind.
