OPERATIONAL SERVICES BRANCH
ENGINEERING LABORATORY REPORT

LP165/2013

Tank Car Volume Measurements

Montreal, Maine & Atlantic Railway, Train MMA-002

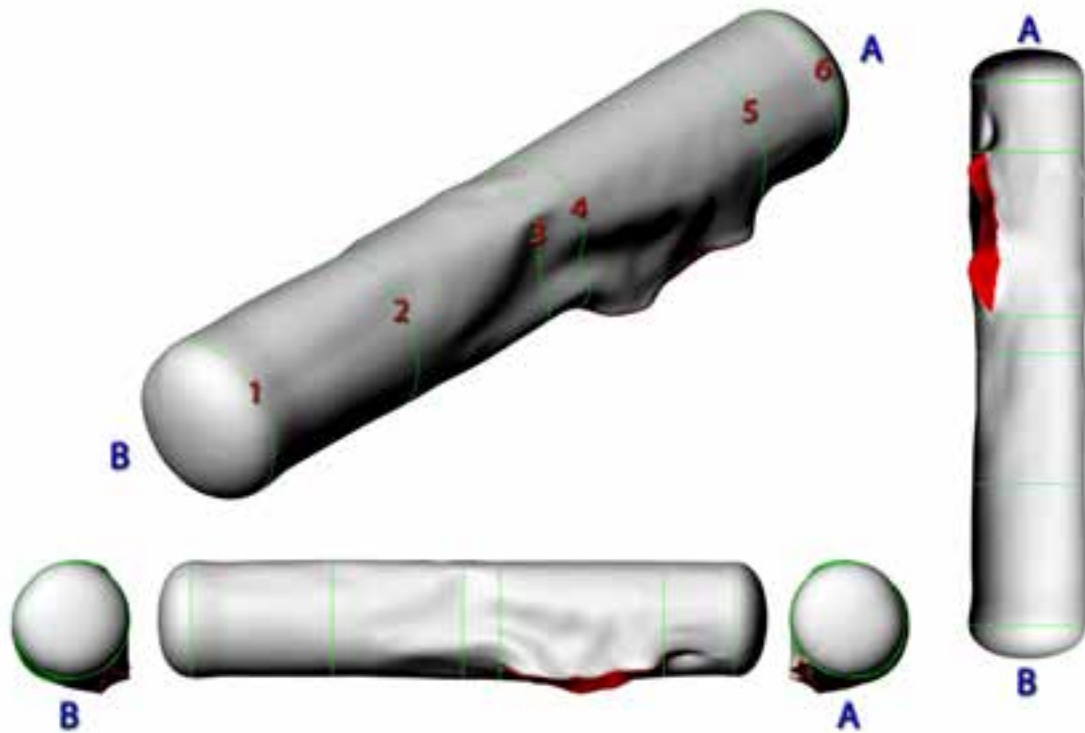
Figure B-1: Oblique views of reconstructed surface volume for tank car WFIX 130608 showing A & B ends with labelled cross-sections

The volume of WFIX 130608 could not be calculated over the entire surface constructed from the laser scanned point cloud due to the shell rupture at the A end of the tank car. The shell rupture resulted in a deformed expansion of the shell along the length of the rupture so the cross-sections in this area are not representative of the actual volume of the tank car prior to the rupture.

The separation in the rupture increased when moving from its A end extremity towards the middle. Up until half way along the rupture the separation distance was measured to be 0.52 m with some fluctuations and extended to as much as 0.82 m approaching the B end extremity. The length of the rupture was approximately 4.4 m and the surface area across the rupture was measured to be approximately 2.5 m².

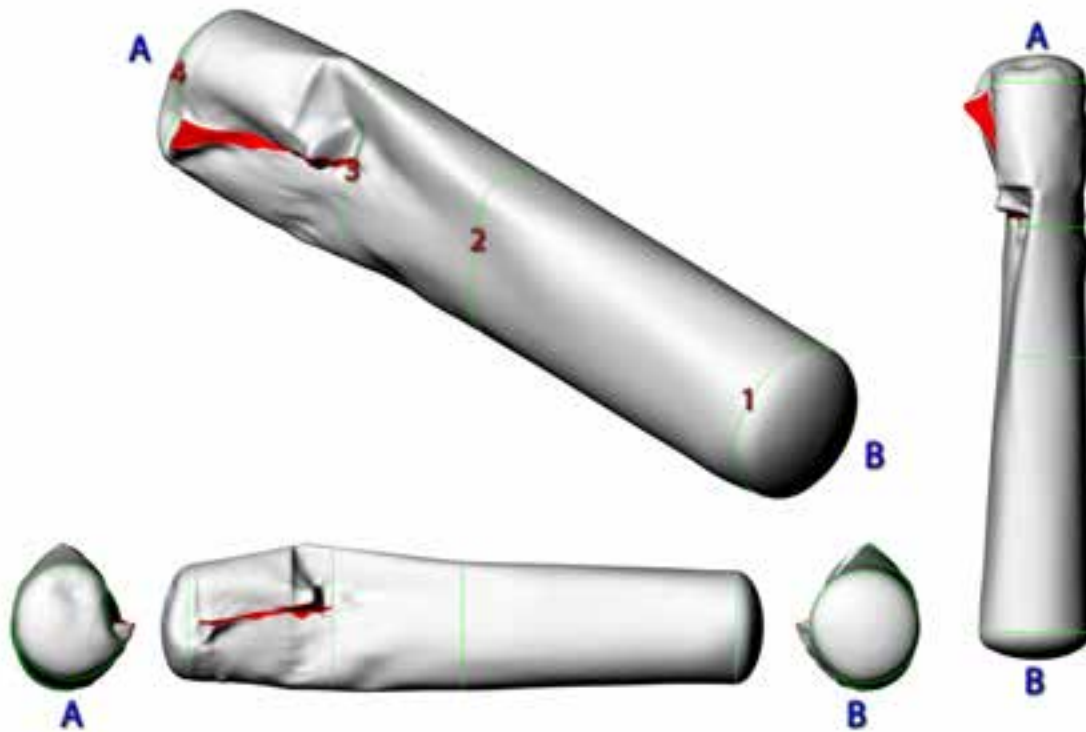
Figure B-4: Oblique views of reconstructed surface volume for tank car TILX 316570 showing A & B ends with labelled cross-sections

3.5.1 This tank car contained a large rupture on the left side near the A end resulting in the expansion of the shell in this area. Moving from the B end towards the A end,

the tank car was compressed on the left side towards the center. The compression increased the vertical dimension of the tank reaching a maximum at the point where the rupture began at approximately 3.5 m from the center of the tank.

- 3.5.2 Analysis of the tank car volume could only be performed up until the start of the rupture. The rupture resulted in a deformed expansion of the shell so the cross-sections in this area are not representative of the actual volume of the tank car prior to the rupture. The volume in this portion of the tank car decreased by 5.52% as compared to the volume of an undamaged COC L116012A tank car.

- 3.5.3 There was a reduction of 0.77% in the length of the tank car as compared to the length of the comparison tank car.
- 3.5.4 The length of the rupture was approximately 3.9 m and the surface area across the rupture was measured to be approximately 1.1 m².

The volume of TILX 316570 could not be calculated over the entire surface constructed from the laser scanned point cloud due to the shell rupture at the A end of the tank car. The rupture resulted in a deformed expansion of the shell so the cross-sections in this area are representative of the present state of the tank car and not the actual volume of the tank car prior to the rupture.

There was a decrease in the tank car volume moving from the B end towards the A end. A rupture started at approximately 3.5 m from the center of the tank car moving towards the A end of the shell. The upper portion of the rupture extends beyond the deformation by 0.68 m and then switches to the lower portion that extends by 0.57 m approaching the B end. There is a buckle in the top portion of the tank that extended upward due to the compression in the left side of the tank. Following the rupture the cross-section of the tank returns to the original shape near the B end of the tank. The length of the rupture was approximately 3.9 m and the surface area across the rupture was measured to be approximately 1.1 m².

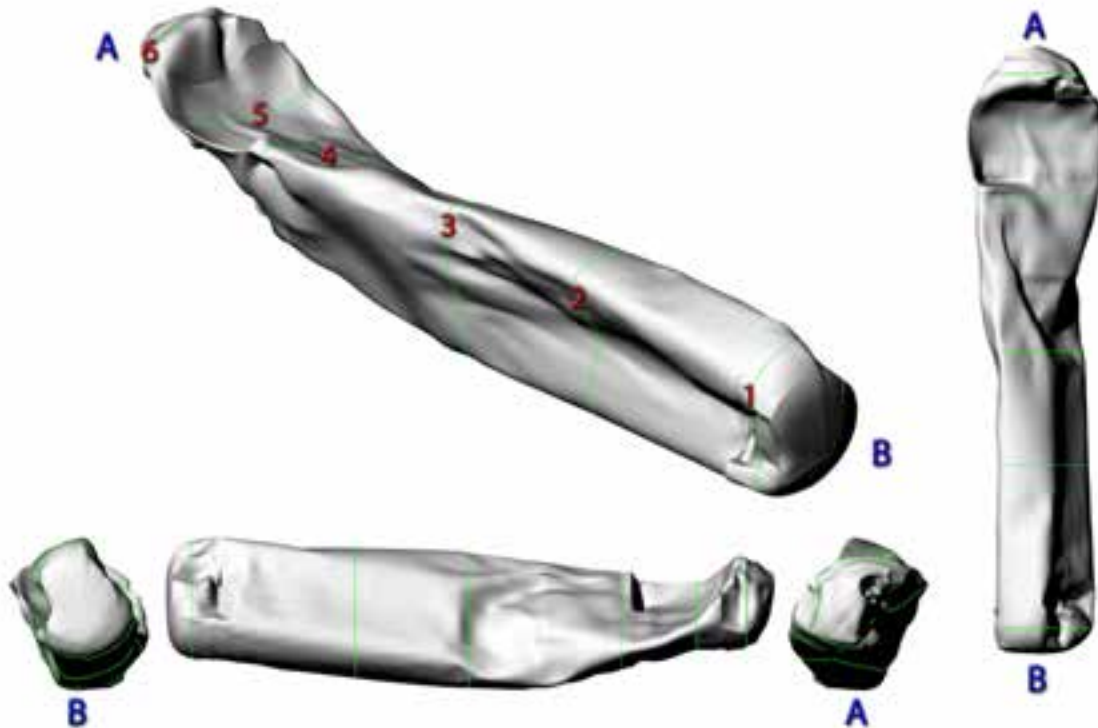
Figure B-7: Oblique views of reconstructed surface volume for tank car ACFX 76605 showing A & B ends with labelled cross-sections

- 3.6 Tank Car ACFX 76605
- 3.6.1 This tank car exhibited extensive deformation and compression of the shell and heads. There was a large puncture in both heads, a transverse rupture in the shell, and several other shell breaches.

The cross-sections of ACFX 76605 exhibited nearly a three-quarter reduction in area at about 1 metre from the A end of the tank car. The compression of the shell reduced the volume by more than one-third of the volume of the undamaged tank car.

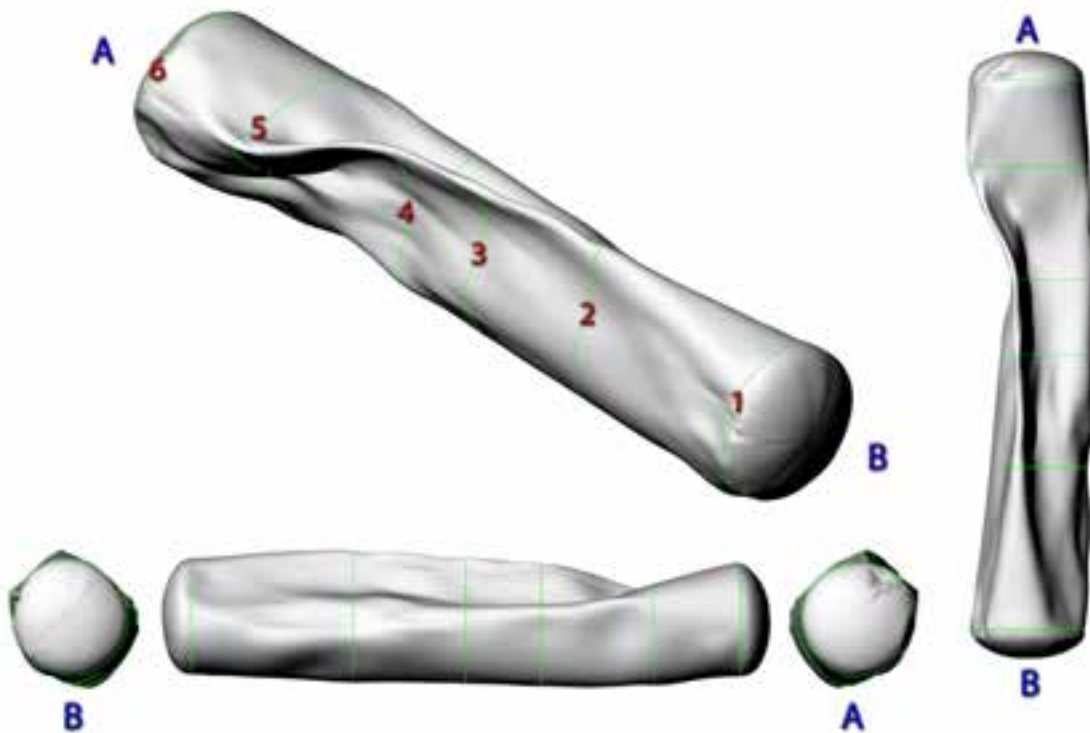
Figure B-9: Oblique views of reconstructed surface volume for tank car WFIX 130545 showing A & B ends with labelled cross-sections

There was a significant change in volume of WFIX 130545 due to the deformation. The cross-sections exhibited nearly a one-half reduction in area at about 2 m from the centre of the tank car towards the A end. The compression of the shell in turn reduced the volume by almost one-third of the volume of the comparison tank car.

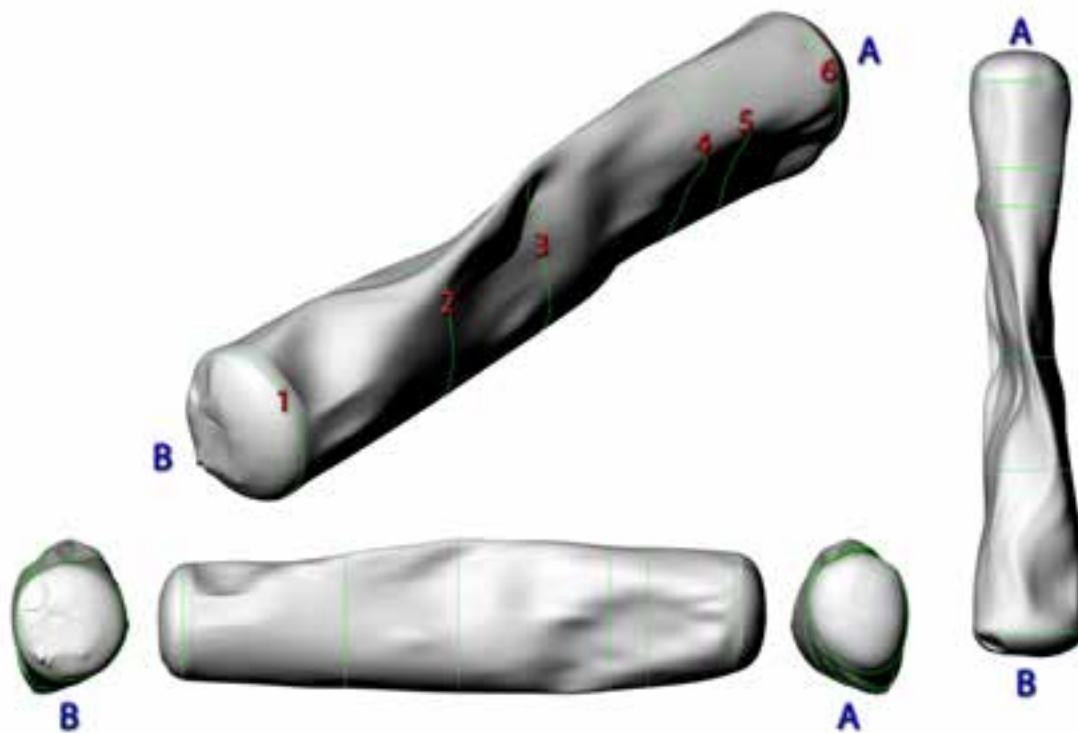
Figure B-11: Oblique views of reconstructed surface volume for tank car ACFX 71505 showing A & B ends with labelled cross-sections

Length of ACFX 71505: 16.02 m (52'-6 13/16")
 Length of COC A841016: 16.42 m (53'-10 1/2")
 Δ Length: -0.40 m (1'-3 11/16")
 % Difference: -2.42%

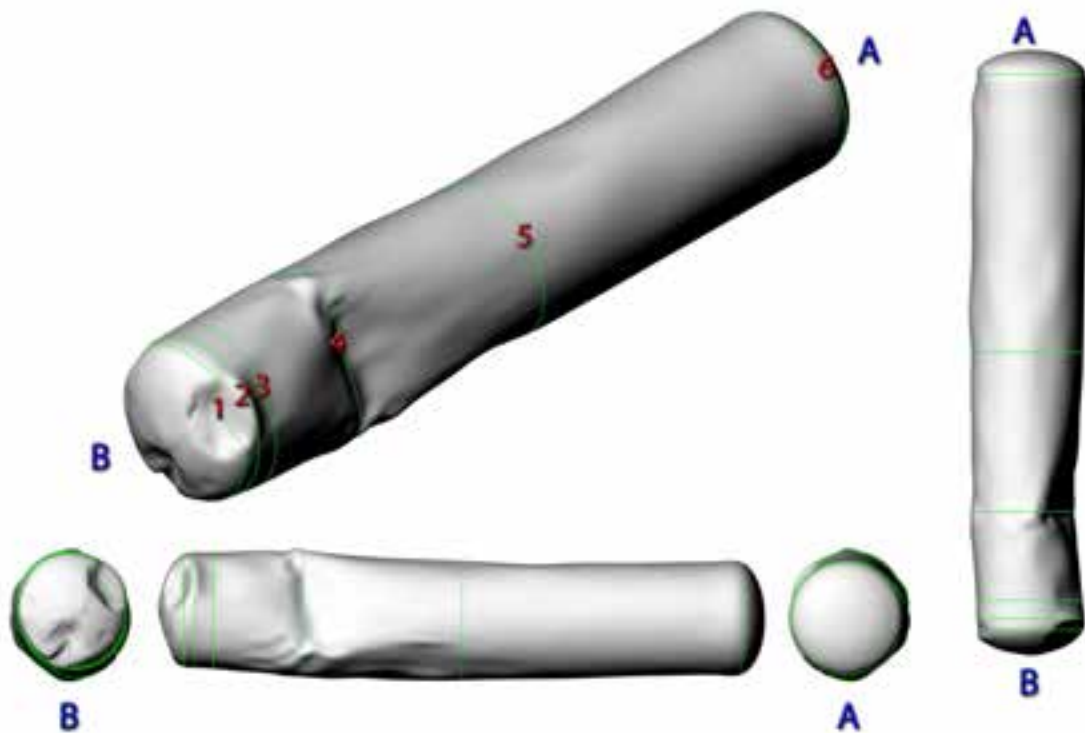
Figure B-18: Oblique views of reconstructed surface volume for tank car TILX 316533 showing A & B ends with labelled cross-sections

As there was no shell rupture to deform the shell of this tank car the change in volume can be represented by comparing the volume from the comparison car to the volume of the tank car for the entire tank car shell.
