**AVIATION INVESTIGATION REPORT
A10A0122**

**CONTROLLED FLIGHT INTO TERRAIN
AERO PENINSULE LTEE (DBA AIR OPTIMA)
CESSNA 310R, C-GABL
POKEMOUCHE, NEW BRUNSWICK
14 DECEMBER 2010**

Report Number A10A0122

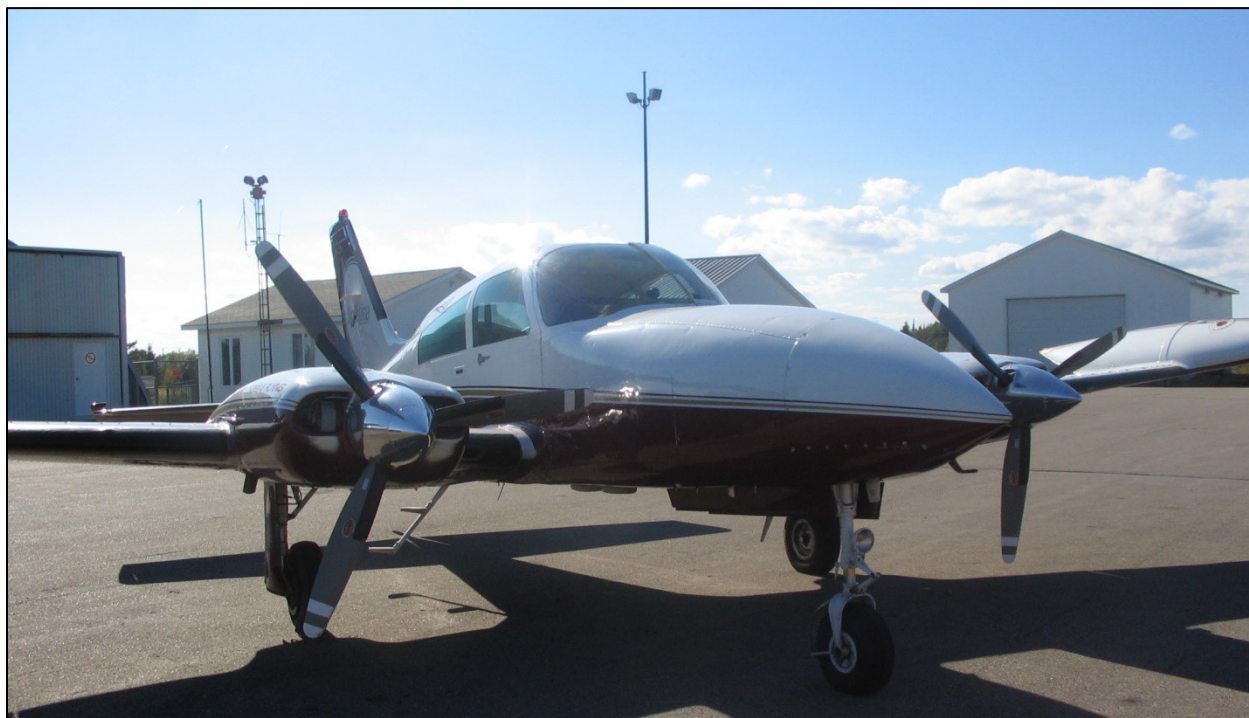
certified for IFR flight, flight into known icing and could carry a pilot and 5 passengers (see Photo 1).

Photo 1. Occurrence Aircraft C-GABL
