**AVIATION INVESTIGATION REPORT
A11H0001**

INADVERTENT DESCENT DURING DEPARTURE

**COUGAR HELICOPTERS INC.
SIKORSKY S-92A (HELICOPTER), C-GQCH
ST. JOHN'S, NEWFOUNDLAND AND LABRADOR, 200 NM E
23 JULY 2011**

Report Number A11H0001

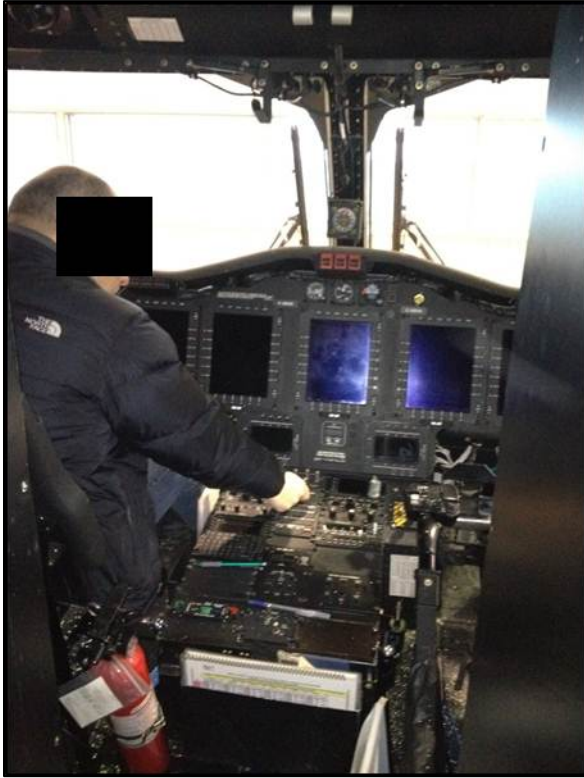
Photo 1. S-92A pilot reaching for flotation switch

In the "After Take-Off Check" section of the Cougar Helicopters' SOPs, it is stated that after take-off checks should be completed at a convenient time, but not below 400 feet above the aerodrome or heli-pad elevation. The SOPs also dictate that the helicopter must be coupled in three-cue prior to 400 feet asl. There are no flight restrictions when the landing gear is extended. However, when departing from a rig or a vessel, the SOPs state that the landing gear shall be raised after the V_{TOSS} and positive rate of climb calls have been made. The SOPs also state that "automation should not be engaged prior to the 'Gear up' call during the departure, as this can be a critical stage of flight while under IMC conditions." In addition, the SOPs require that the flotation be switched to safe before reaching 80 KIAS, as the floats should not be deployed above 80 KIAS. The caution/warning system will be triggered if the flotation is armed at airspeeds above 80 KIAS. At Cougar Helicopters, the standard practice was for the PM to raise the gear and select flotation to safe on the PF's command, after the "positive rate" call was made by the PM. The flotation switch is located in the middle of the console between the pilots (Photo 1). From the left seat, the PM is required to lean a considerable amount in order to reach the landing gear switch (Photo 2).
