## AVIATION INVESTIGATION REPORT A13C0150

**LOSS OF ENGINE POWER - COLLISION WITH TERRAIN**

**BEARSKIN LAKE AIR SERVICE LP (BEARSKIN AIRLINES)**

**FAIRCHILD SA227-AC METRO III, C-FFZN**

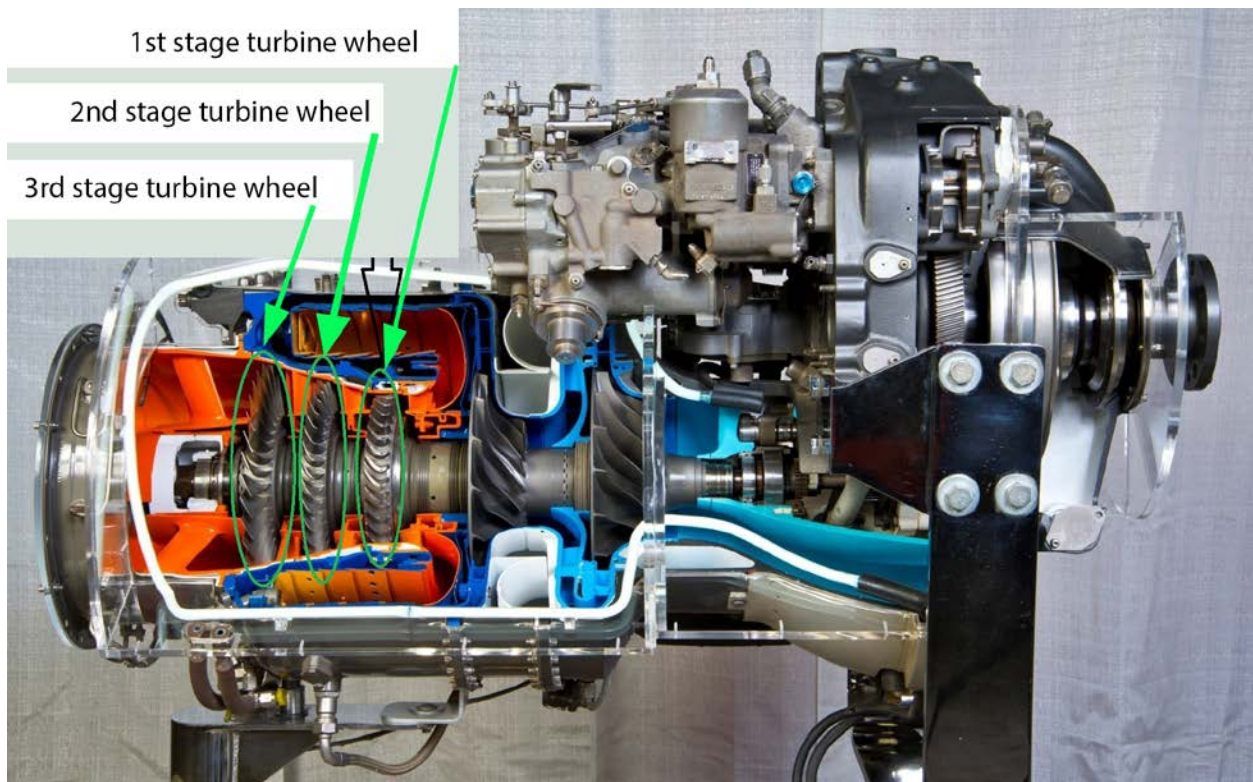
Photo 6. Engine cut-away view (Source: Honeywell, with TSB annotations)

The first-stage wheel (Photo 4, Photo 5 and Photo 6) was stripped of all blades down to the blade roots with 1 blade failing at the fir tree<sup>11</sup> blade root area. The area of failure exhibited a distinct fatigue zone near the trailing edge of the blade and was sent to the TSB Laboratory for metallurgical examination. The examination concluded that the blade failure occurred as a result of high-cycle fatigue in an area of high porosity.
