**AVIATION INVESTIGATION REPORT
A13H0003**

RUNWAY INCURSION AND RISK OF COLLISION

**NAV CANADA
OTTAWA CONTROL TOWER
OTTAWA/MACDONALD-CARTIER INTERNATIONAL
AIRPORT
OTTAWA, ONTARIO
01 DECEMBER 2013**

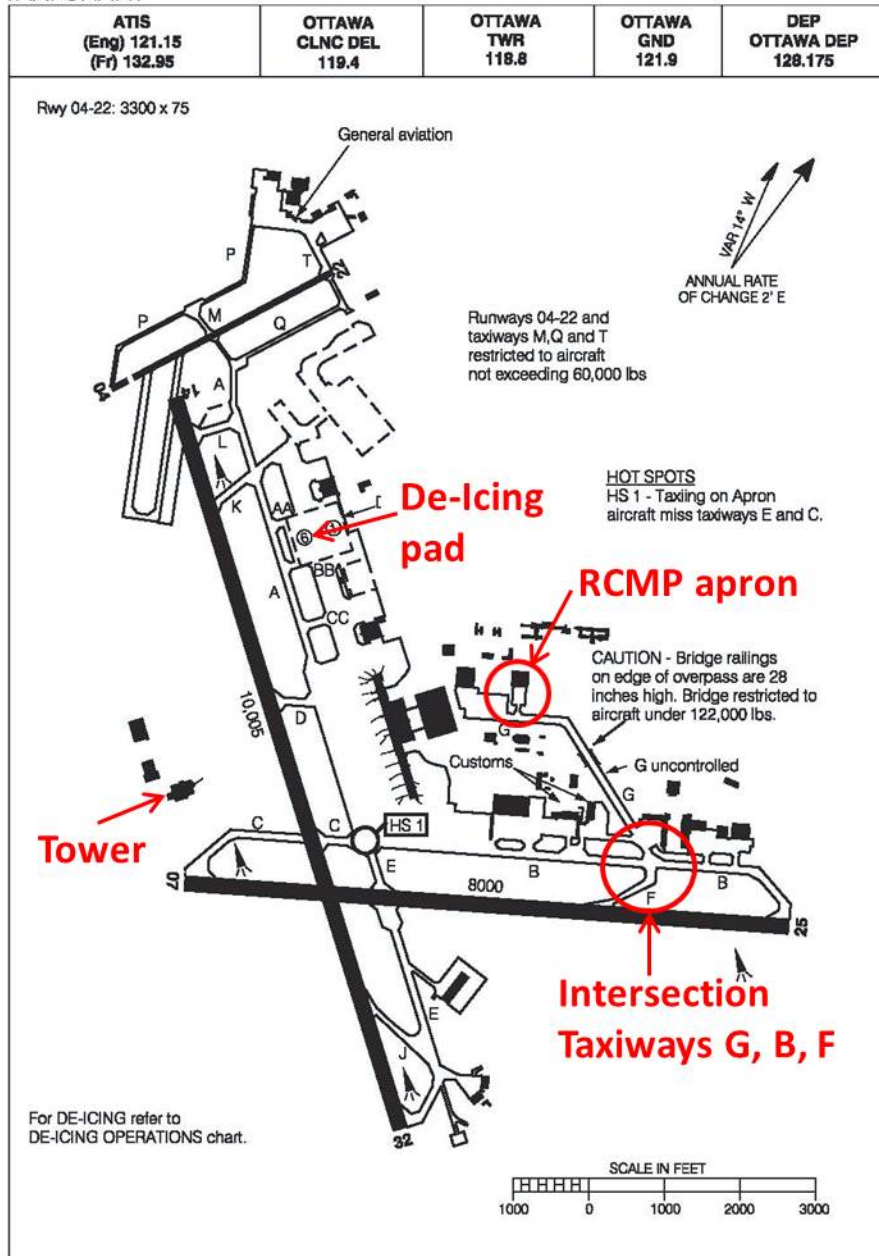
TAXI CHART

At 1917, the ground controller issued instructions to Jazz (JZA) 988 to taxi from the de-icing pad to Runway 14 via taxiways A and L (Appendix A). JZA988 was instructed to contact the tower once holding short of Runway 14, on Taxiway L.
