**AVIATION INVESTIGATION REPORT
A14Q0068**

**UNCONTAINED TURBINE ROTOR FAILURE
BOMBARDIER INC.
BD-500-1A10 (C SERIES CS100), C-FBCS
MONTRÉAL INTERNATIONAL (MIRABEL) AIRPORT, QUEBEC
29 MAY 2014**

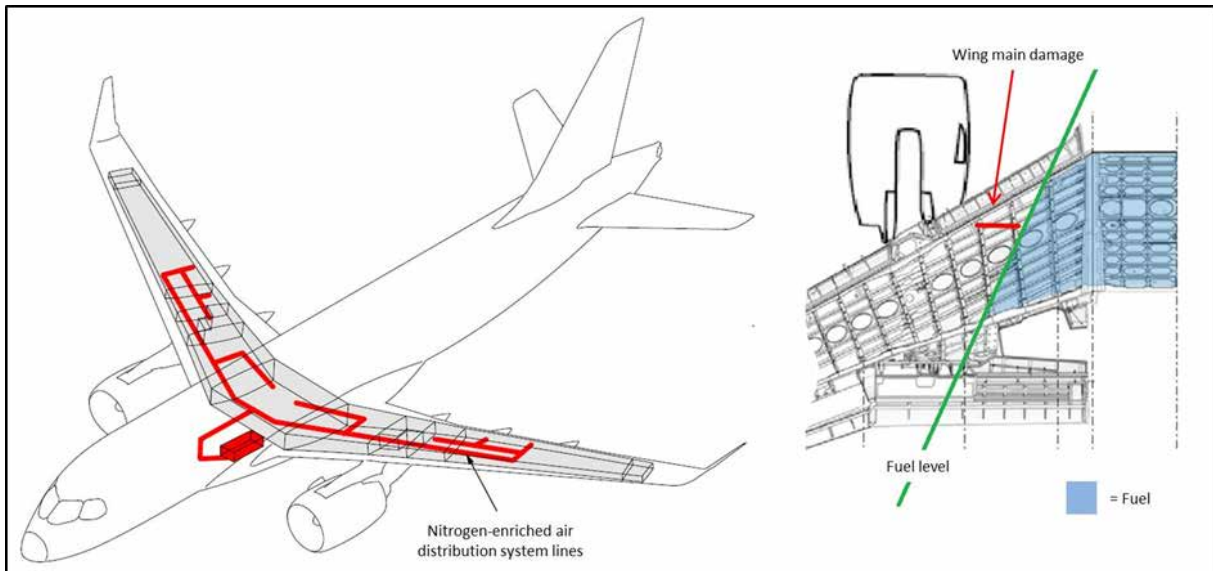
The main piece of debris that entered the centre fuel tank penetrated the tank just outboard of the fuel level (Figure 4), traversed the ullage space, and burst through the top skin of the wing, where it became stuck. The absence of any large-scale traces of fire demonstrates that the FTIS functioned as designed during this occurrence.

Figure 4. Schematic of fuel tank inerting system and overhead view of fuel level in the tank at the time of the occurrence (Source: Bombardier Inc., with TSB annotations)

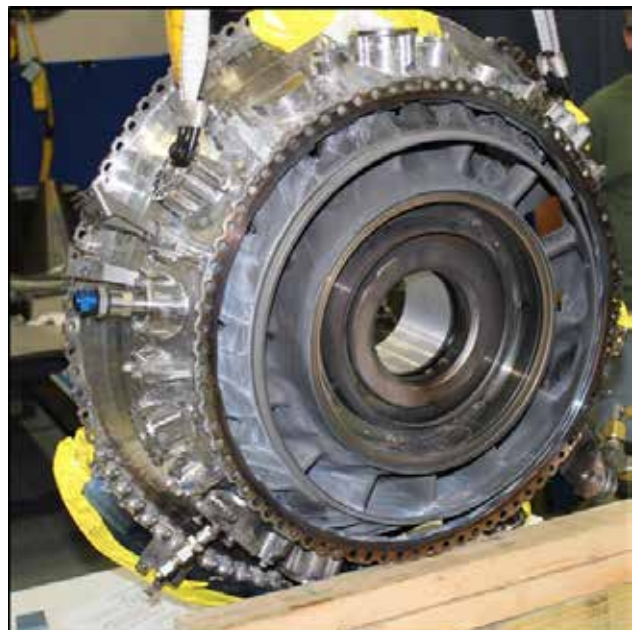
The turbine intermediate case (TIC) consists of outer and inner case assemblies joined by 14 shrouds. As the hot gas exits the HPT, it flows between these shrouds on its way to the LPT (Photo 1).

Photo 1. Front face of turbine intermediate case

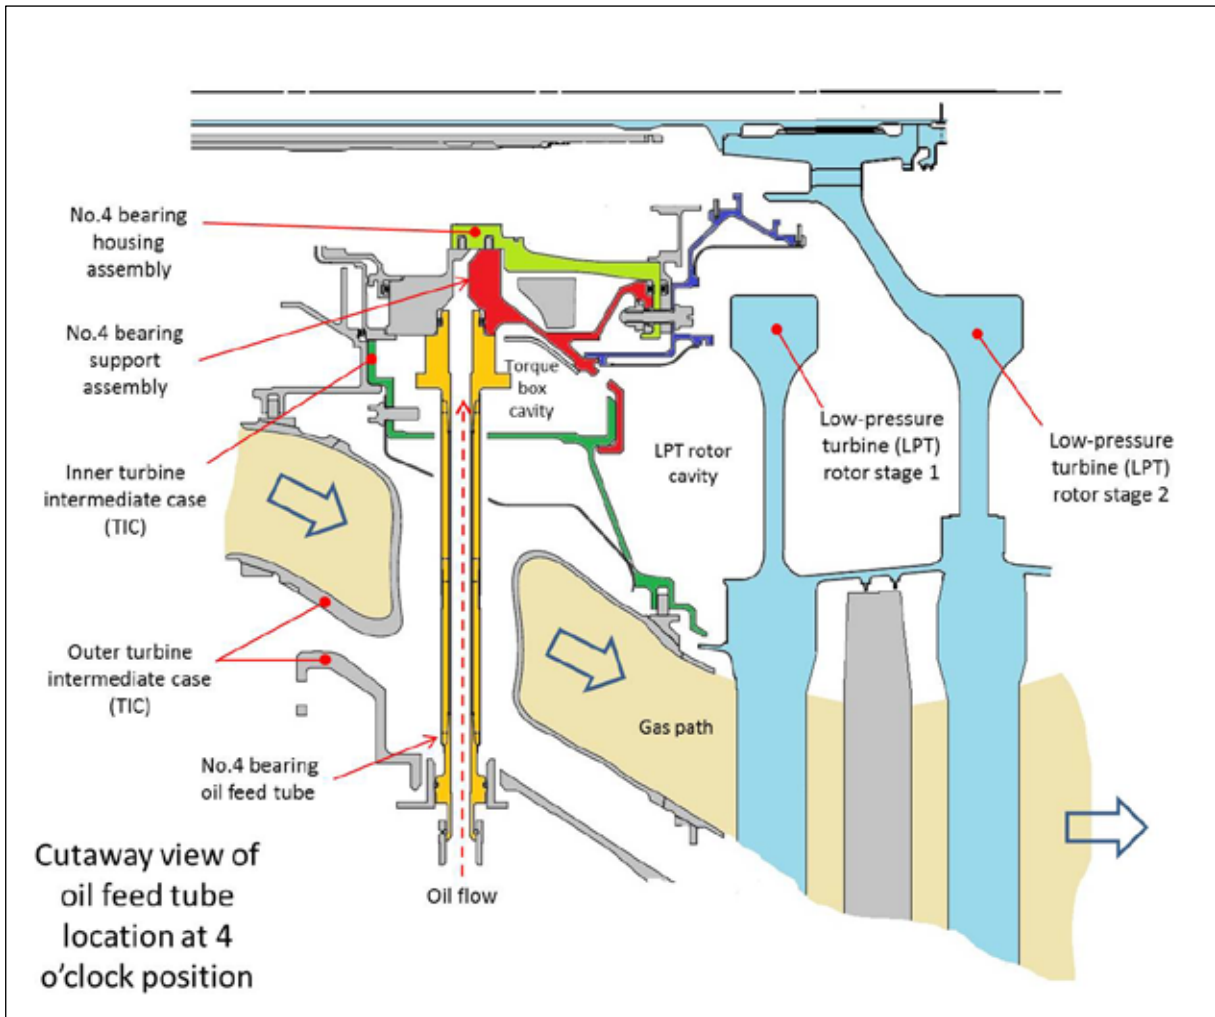
The 4 remaining shrouds house service tubes for the No. 4 bearing, namely, the oil feed tube (Figure 12), the oil scavenge tube, the oil scupper tube, and the buffer tube.

Figure 12. Cutaway view of the No. 4 bearing oil feed tube location at 4 o'clock position
