AIR TRANSPORTATION SAFETY INVESTIGATION REPORT A18W0129

CAPSIZE ON WATER LANDING

Simpson Air (1981) Limited
Cessna U206G, C-FNEQ
Little Doctor Lake, Northwest Territories
16 August 2018

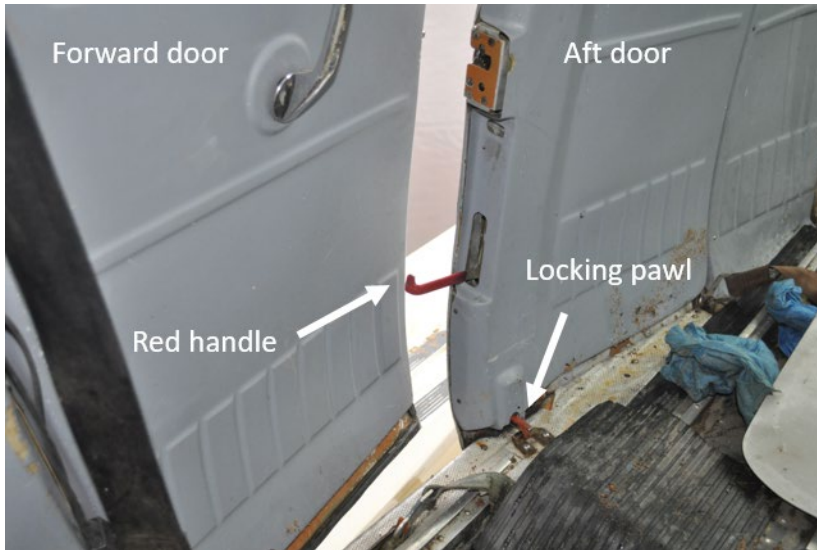
After the forward door is open, the aft door may be opened by grasping a red handle on the forward edge of the door and pulling downward to release the locking pawls (Figure 4).

Figure 4. Rear double cargo door in the open position (Source: TSB, with annotations)

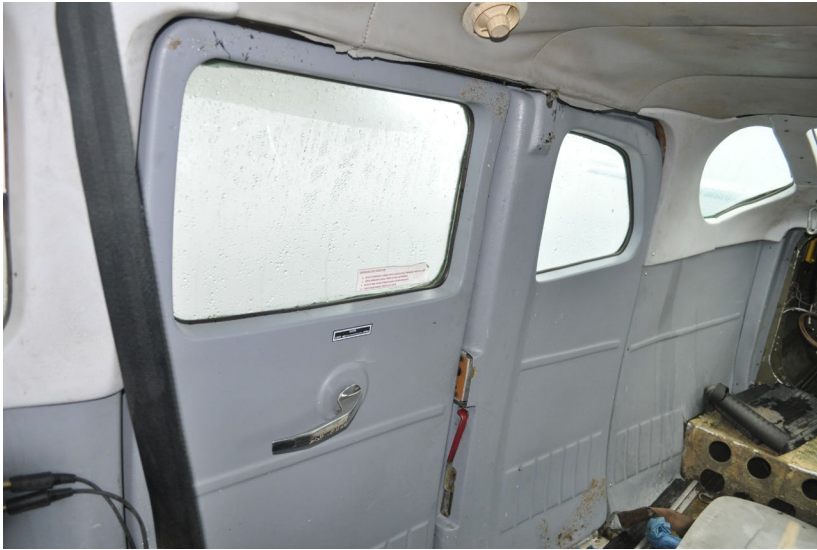
When closing the doors, the aft door must be closed first and must be held in the frame until the handle is manipulated to engage both locking pawls. Once the aft door is secured, the forward door can then be closed. Inside the door, there is a placard above the door handle with OPEN, CLOSE, and LOCK shown on it (Figure 5). Once the forward door has been closed and latched, the door handle must then be rotated forward to the LOCK position.

Figure 5. Interior view of the rear double cargo door in the closed position (Source: TSB)
