AIR TRANSPORTATION SAFETY INVESTIGATION REPORT A19P0112

CONTROLLED FLIGHT INTO TERRAIN

Seair Seaplanes
Cessna 208 Caravan, C-GURL
Addenbroke Island, British Columbia
26 July 2019

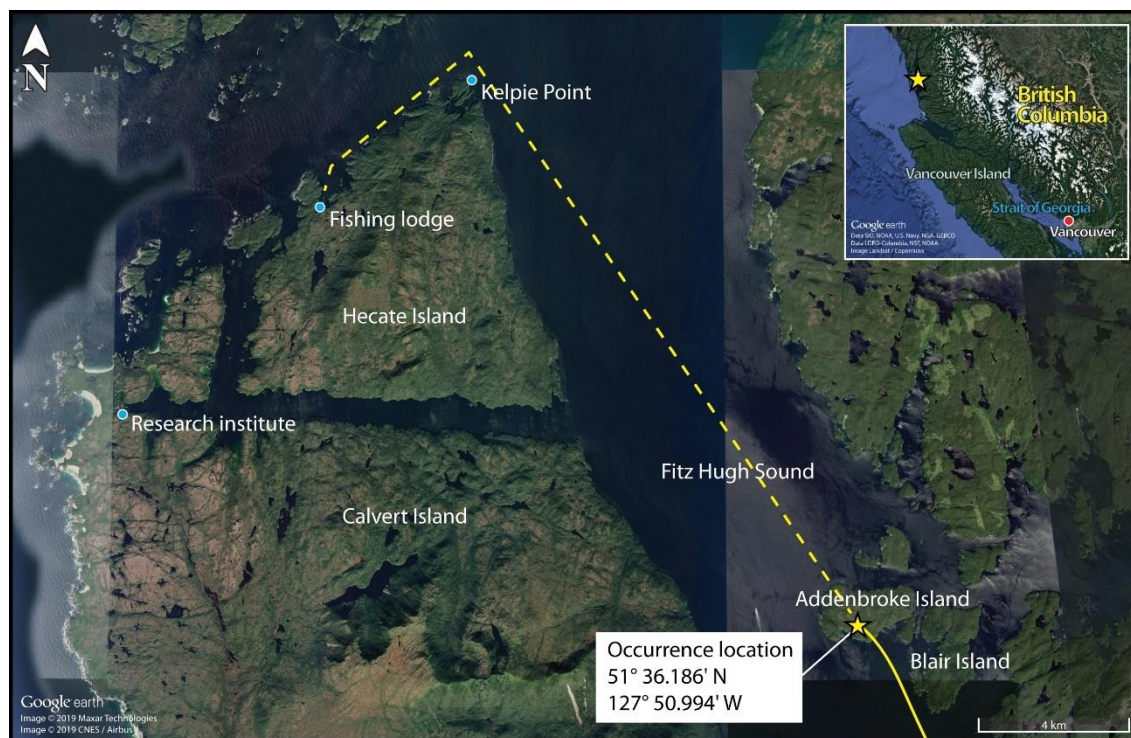
Figure 1. Intended flight path and occurrence site, with inset image showing a broader view of the location (Source of both images: Google Earth, with TSB annotations)

Seair Seaplanes (Seair) was contracted by a remote fishing lodge on the central coast of British Columbia (BC) (Figure 1) to provide seasonal transport of guests and supplies between Vancouver International Water Aerodrome (CAM9), BC, and the lodge, which is located about 66 nautical miles (NM) north-northwest of Port Hardy Airport (CYZT), BC, and about 29 NM southeast of Bella Bella (Campbell Island) Airport (CBBC), BC.
