AIR TRANSPORTATION SAFETY INVESTIGATION REPORT A19Q0010

RUNWAY EXCURSION DURING TAKE-OFF ROLL

Air Creebec Inc.
de Havilland DHC-8-102, C-GTCO
Rouyn-Noranda Airport, Quebec
23 January 2019

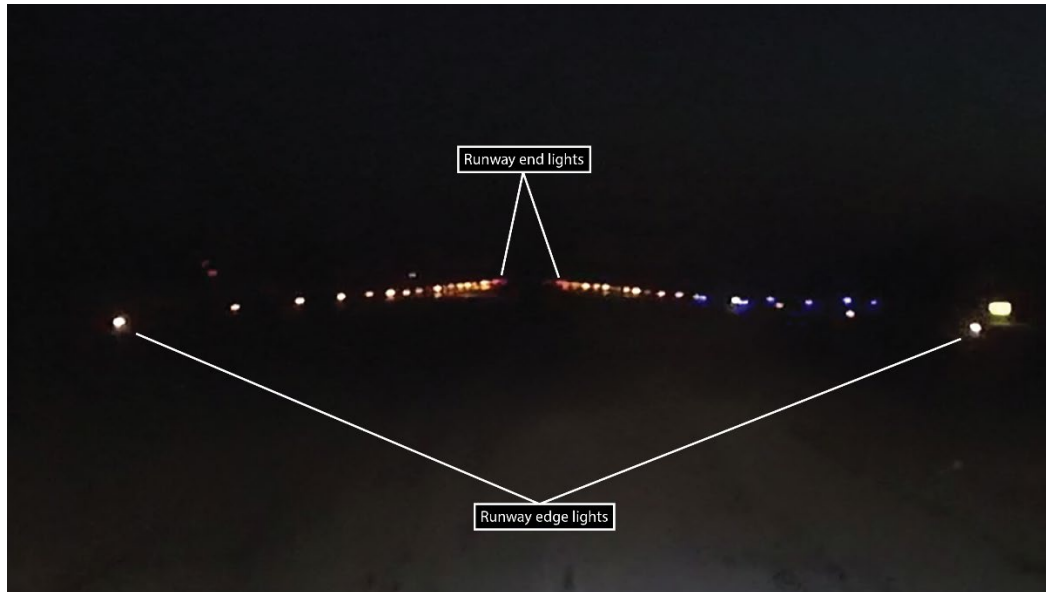
This lighting (Figure 5) consists of 1 row of runway edge lights on either side of the runway. They are raised fixed white lights, installed approximately 10 feet beyond the paved surface and spaced 200 feet apart. The lights are installed on opposite sides of the runway centreline, aligned at right angles to the runway centreline. The lighting also includes green

The evening of the accident, all runway edge lights were visible to pilots.

Figure 5. Markings on Runway 26 at the Rouyn-Noranda Airport, as seen at night (Source: TSB)
