AIR TRANSPORTATION SAFETY INVESTIGATION REPORT A21Q0138

RIGHT MAIN LANDING GEAR FAILURE ON LANDING

Air Canada

Airbus A330-343, C-GFAF

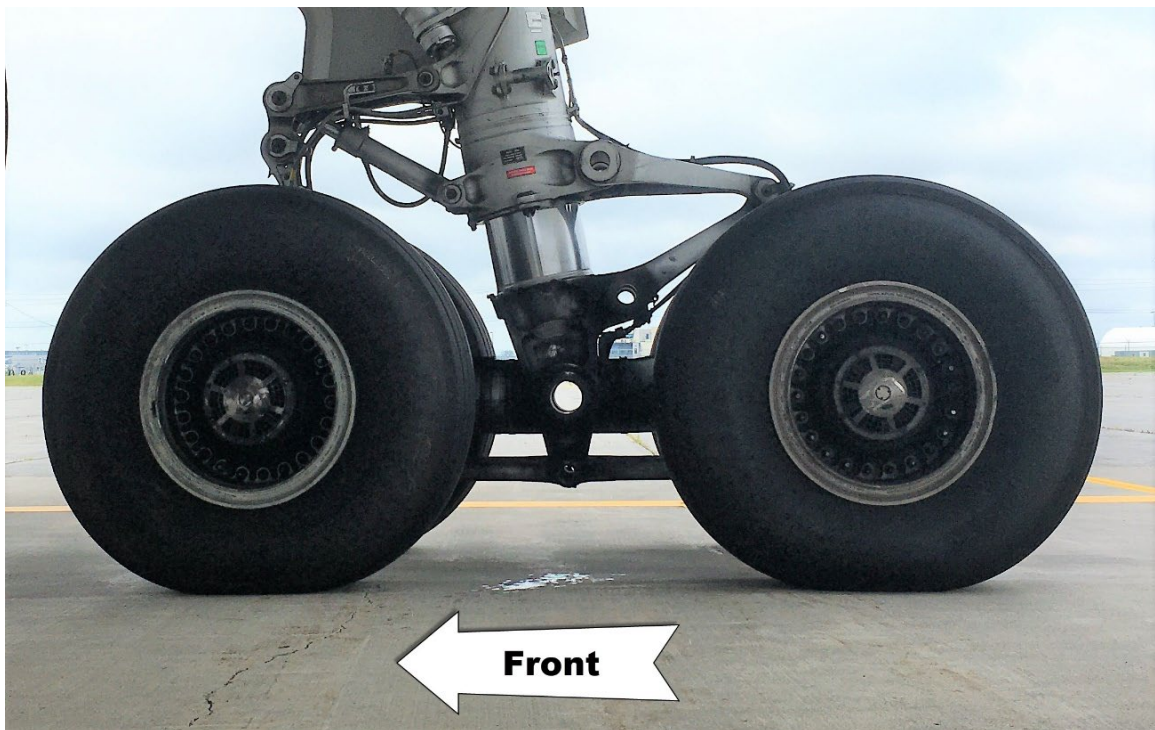
Figure 7. View of the right main landing gear in good condition, looking outboard (Source: Air Canada, with TSB annotations)

The bogie beam was broken in front of the shock strut hinge. The forward part, including the axle for the No. 3 and No. 4 wheels, was separated completely, and was only held in place by various hydraulic lines, electrical harnesses, and the pitch trimmer system arm. The tire on the No. 8 wheel had been perforated by debris produced by the fracturing of the beam. The lower part of the landing gear strut was abraded up to the hinge. The attachment points of the brake anti-rotation rods were abraded completely, and the rods were no longer being held to the strut (figures 6 and 7).
