AVIATION INVESTIGATION REPORT

A97F0059

UNCONTAINED ENGINE FAILURE

BOEING 767-375ER C-FTCA

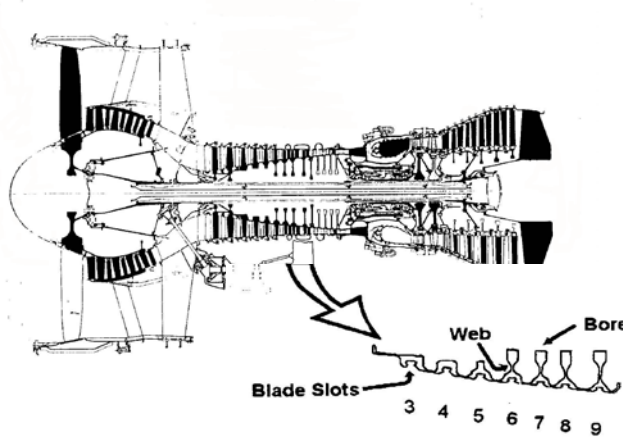
sections: the fan section (N1), driven by the low-pressure turbine (LPT); and the high-pressure compressor (N2), driven by the high-pressure turbine (HPT). The HPC has 14 stages of compression and consists of several attached units, one of which is the 3-9 spool section. The blades of the 3-9 stages of the HPC fit into slots known as dove-tail slots, as shown in Figure 3.

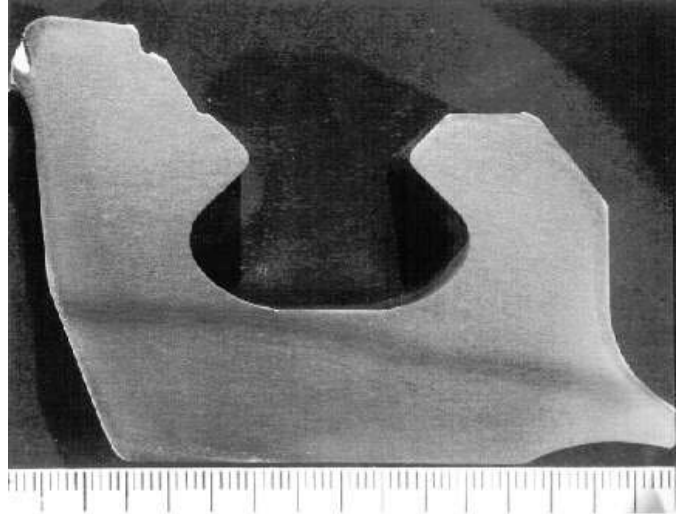
An attempt was made to count the number of striations in the fatigue area, but this was very difficult because the striations were irregular in shape, ran in many directions, and were interspersed with faceted areas. One estimate of the number of striations was about 800. It was not possible to estimate the time (cycles) of the crack propagation based on a striation count. The engine manufacturer indicated that faceted-type failures were typical of fatigue in Ti 6242. However, the NTSB in its investigation of another fatigue failure due to a "hard alpha" inclusion noted that the fatigue zone had a typical striated pattern. The manufacturer also indicated that propagation rates were accelerated within the segregate.

The microstructure of the titanium alloy near the fracture was also examined. To that end, slices parallel to the principal fatigue fracture surfaces (about 6 mm from the fracture) were removed and studied. The surface preparation consisted of grinding, polishing and etching the full cross-section. The etching showed that a microstructural anomaly existed on both sides of the fracture. The anomaly appears as a dark, diffused band approximately 2 mm wide, arcing rearward from the front of the third stage, almost touching but not intercepting the slot bottom in the vicinity of the rear transition radius, and finally exiting slightly below the rear face edge (as seen in Figure 7). Examination of the microstructure anomaly band at higher magnification revealed enlarged alpha grains as well as a higher proportion of the alpha phase within the band.
