MARINE INVESTIGATION REPORT

M00W0044

CAPSIZING

THE FISHING VESSEL "LORI CATHLYNN"

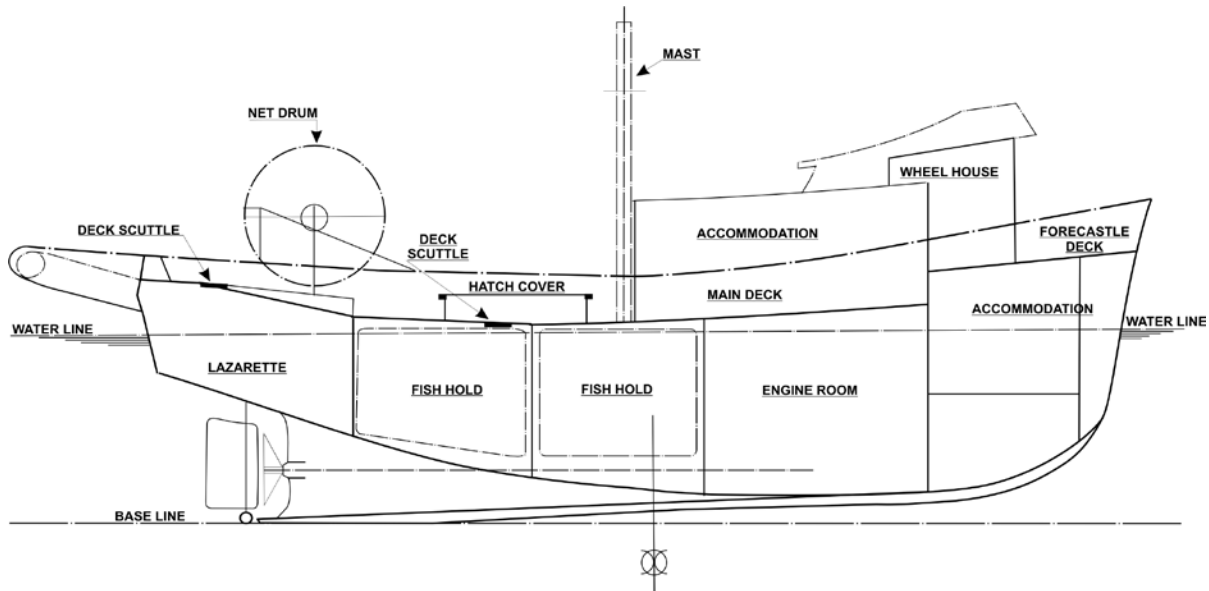
The fish hold is subdivided into three parts. As fish cargo is often transported in a slush-mix of ice and water, the compartments are also termed "fish tanks." The fish holds extend aft, enclosed by the weather deck, upon which a net drum (or reel) is mounted at the stern. Located aft of the superstructure, one deck hatch, with a coaming, gives access to three watertight compartments, which comprise the centrally divided forward port and starboard and the after fish holds. Two small flush deck scuttles are located on each side of the deck hatch, and one small flush deck scuttle located aft gives access to the lazarette. (See Figure 1, Typical layout)
