MARINE INVESTIGATION REPORT M06L0045

EXPLOSION

**GENERAL CARGO VESSEL *NILS B*
GRANDE-ANSE TERMINAL,
PORT SAGUENAY, QUEBEC
22 APRIL 2006**

Report Number M06L0045

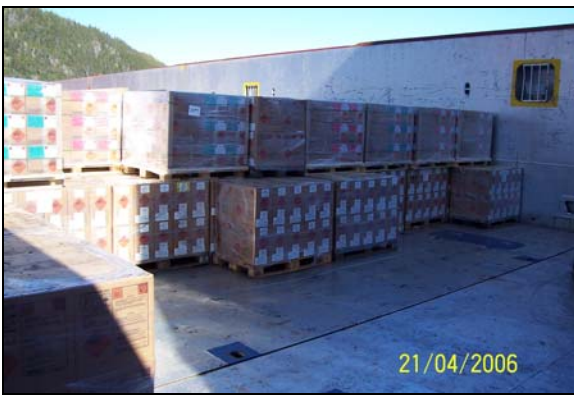
Loaded to a maximum of two tiers (approximately 2 m high), the cargo from Sweden had been stowed in a compact manner and arrived undamaged: the dunnage and the pallets were solidly set, the deck had no trace of detritus, and the packaging was solid and clean (see Photo 4 and Photo 5).¹⁵

Photo 4. Two-tier load from Sweden

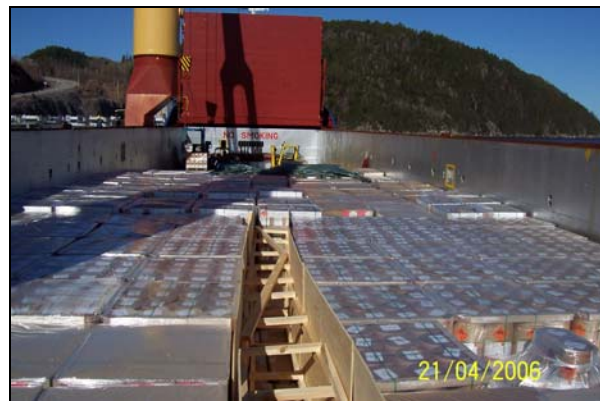
Photo 5. Dunnage between pallets from Sweden

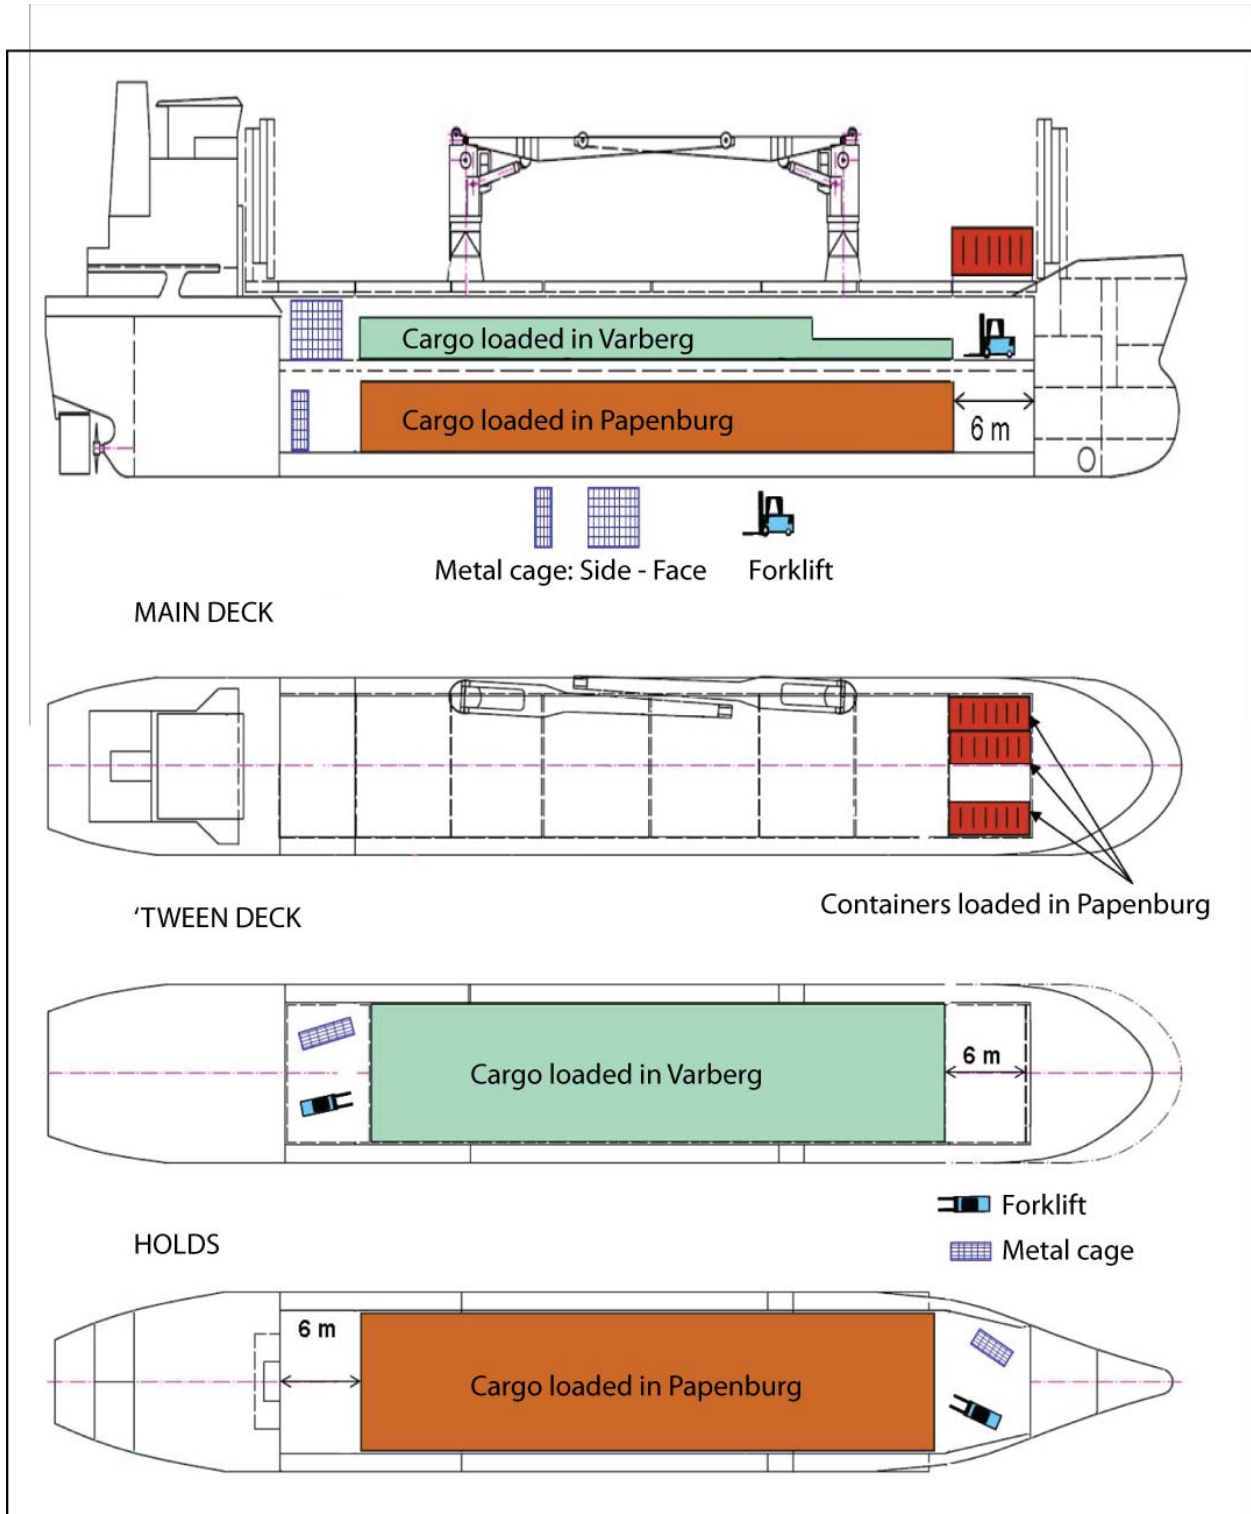
Appendix B – Cargo and Cargo Plan on the Nils B

In this occurrence, the three containers on the forward part of the cargo hatch covers, as well as the cargo in the lower hold, were loaded in Germany. The cargo on the 'tween deck was loaded in Sweden. On both decks, a 6 m space was left void at each end of the hold, between the cargo and bulkheads, to allow manoeuvring room for forklifts.
