MARINE INVESTIGATION REPORT

M07C0034

ENGINE ROOM FIRE

SAIL TRAINING VESSEL *FAIR JEANNE*
OFF AMHERST ISLAND, LAKE ONTARIO, ONTARIO
13 JULY 2007

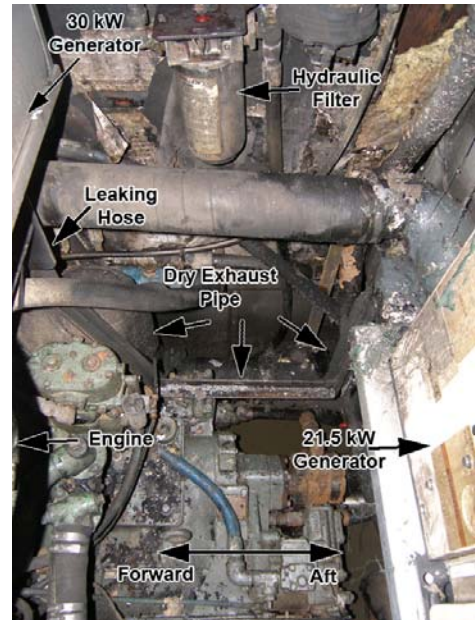
The *Fair Jeanne's* auxiliary propulsion is provided by a single diesel engine connected to a reduction gear and propeller. The engine's water-jacketed exhaust manifold runs along the starboard side of the engine, which is connected to a dry-exhaust pipe. This section of pipe runs aft, down toward and along the bilge, and then back up and aft, out of the engine room.

Post-occurrence testing revealed that, when the engine was running, transmission oil sprayed from a leak in the transmission hose onto the hot section of the dry-exhaust pipe. Further investigation found that the hose had a small slit, which likely pre-dated the fire. In addition, when the engine was shut down, the transmission oil level was checked and the sump was almost empty.

The investigation revealed that the hose was worn and may have been part of the original equipment installed on board in 1981. An examination of other hoses and lines in the engine room did not reveal any components that may have broken or failed prior to the fire.

Photo 5. General view of layout of the auxiliary engine
